Aviation Investigation Final Report

Location:	Sitka, Alaska	Accident Number:	ANC18FA044
Date & Time:	June 8, 2018, 20:00 Local	Registration:	N1203A
Aircraft:	Piper PA18	Aircraft Damage:	Substantial
Defining Event:	Aerodynamic stall/spin	Injuries:	2 Fatal
Flight Conducted Under:	Part 91: General aviation - Personal

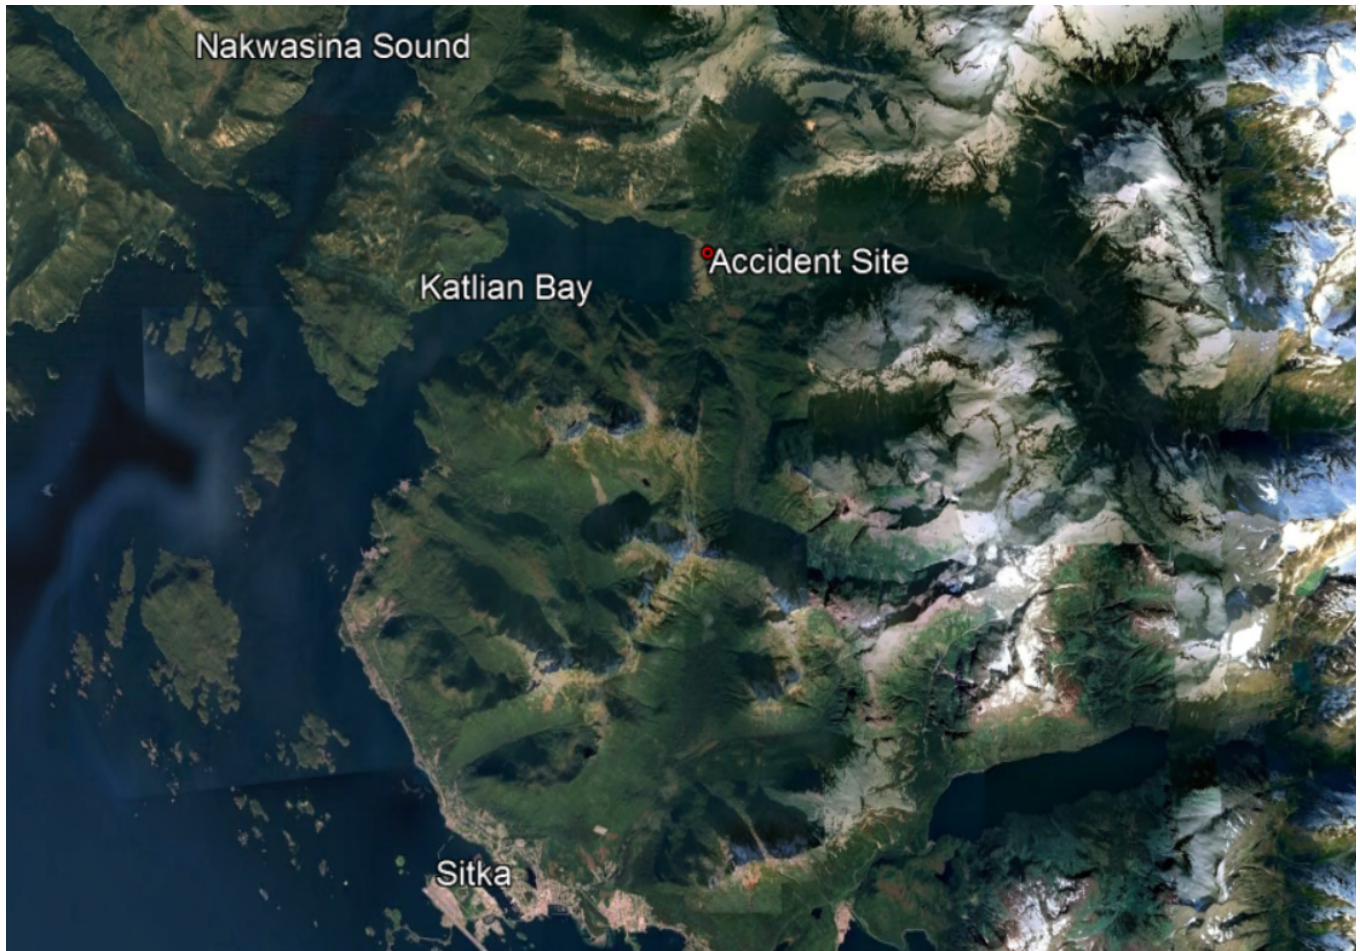
Figure 1. The accident site on a Google Earth image.

On June 10 about 2210, a USCG MH-60T helicopter located the wreckage about 0.2 mile upriver from Katlian Bay on an arm of the Katlian River (see figure 1). The pilot was located in the front seat of the wreckage and the passenger was missing. The fatally injured passenger was located the next day at 1009, downriver from the airplane, according to USCG records.
