Aviation Investigation Final Report

Location:	Chicago, Illinois	Incident Number:	OPS18IA015
Date & Time:	June 21, 2018, 09:58 Local	Registration:	B-18711
Aircraft:	Boeing 747	Aircraft Damage:	None
Defining Event:	Miscellaneous/other	Injuries:	4 None
Flight Conducted Under:	Non-U.S., commercial

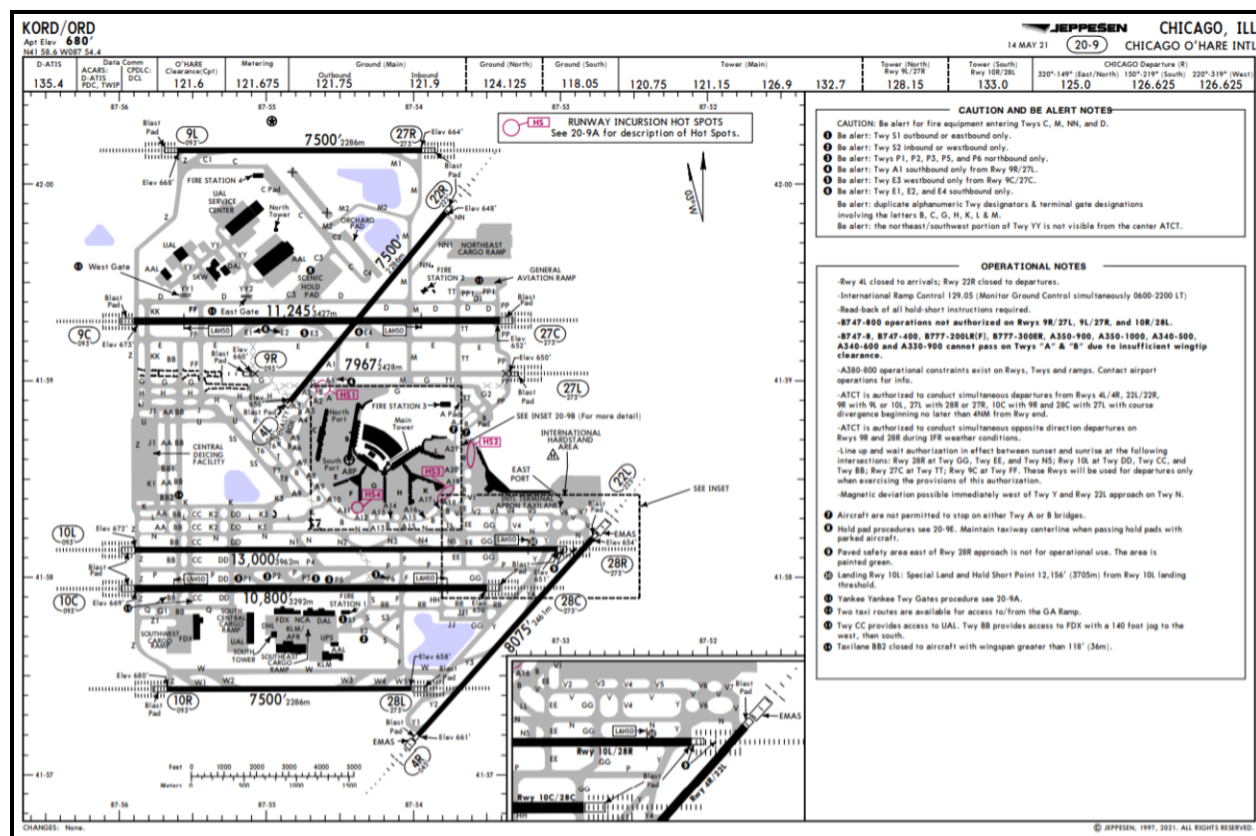
Deep ground scarring was visible near where the aircraft had touched down left of the runway on the paved surface and extending into the grass between taxiway DD and taxiway N1 (see figure 3).

Figure 3. Photographs of the ground scarring caused by the left main landing gear of CAL5148. [Source: FAA]
