# CAPITAL NEEDS ASSESSMENT

## Meany Lodge

47.2804, -121.3203 Stampede Pass Road, Easton, WA 98925

**April 5, 2022**

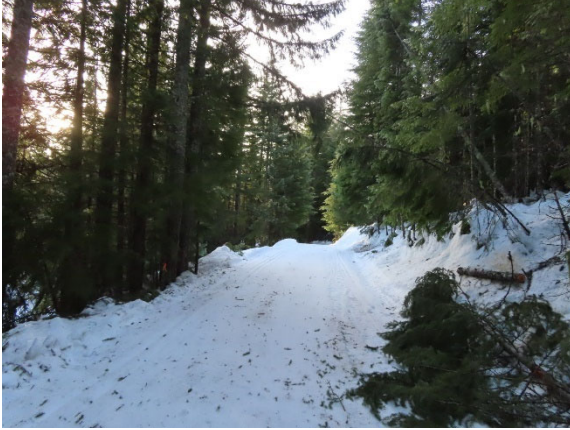
Access Road

There is an access road leading from the Stampede Pass Road to the lodge that is maintained by the Mountaineers. This road was covered in snow at the time of our visit to the property. We understand that there is a need for significant road maintenance of this road. We have budgeted for \$25,000 to grade the road, add gravel, and to apply lignin sulfonate for dust control to this road in 2022 and every 10 years thereafter.

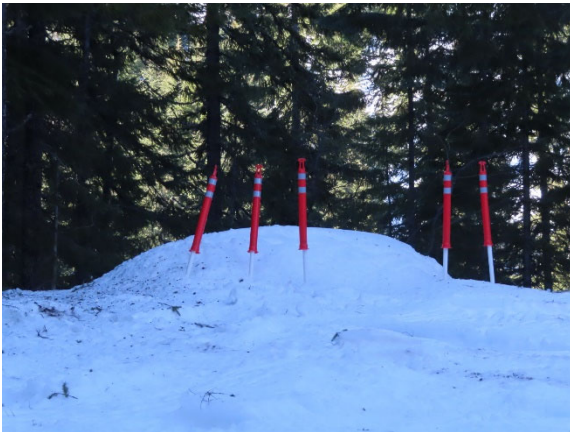
There is a 1,000-gallon propane tank on this property. We understand that this propane tank is leased. Therefore, we have not budgeted for replacement of this propane tank.

Propane Tank Buried Under Snow

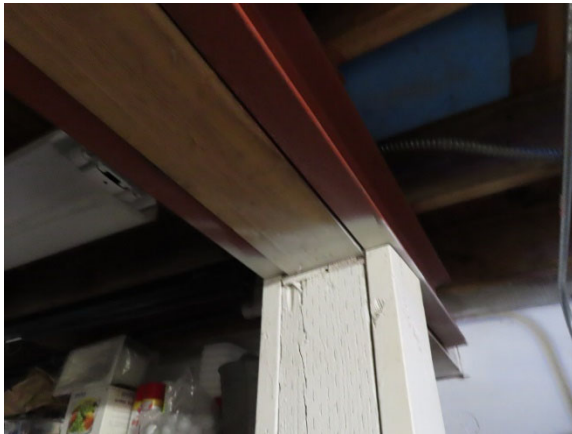
Lower-Level Wood Beam Reinforced with Steel C-Channels

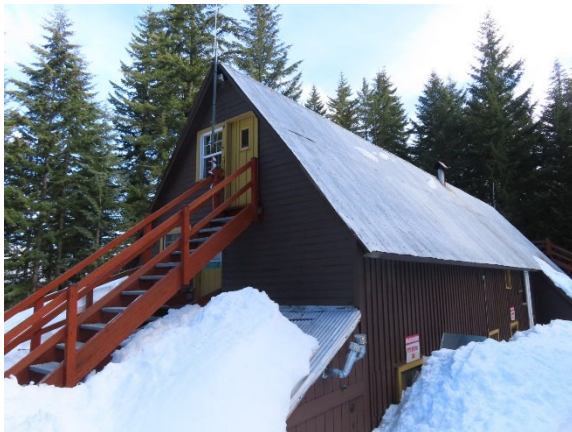
West Side of the Lodge

There are stairwells/fire escapes on the west and east sides of this building. We have included rot repairs and painting of these stairwell/fire-escapes on the same schedule as the rest of the buildings and have factored this into the budget.

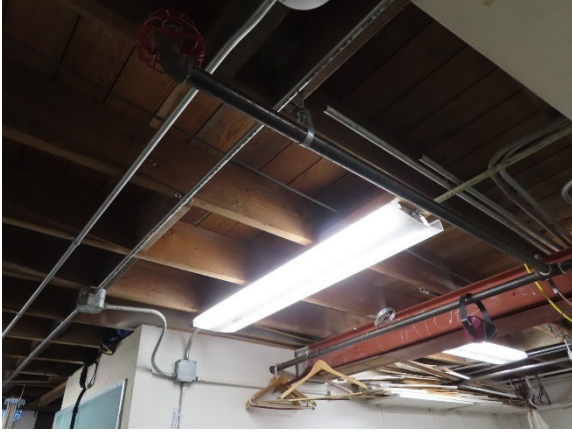
Typical Basement Light

The interior and exterior lighting in this lodge has been upgraded to LED lighting over the past 5 to 10 years. We have budgeted for general lighting upgrades every 20 years.

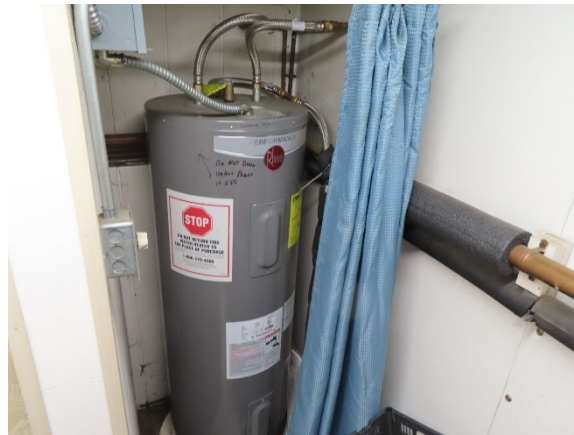
50-Gallon Lower-Level Water Heater Manufactured in 2017

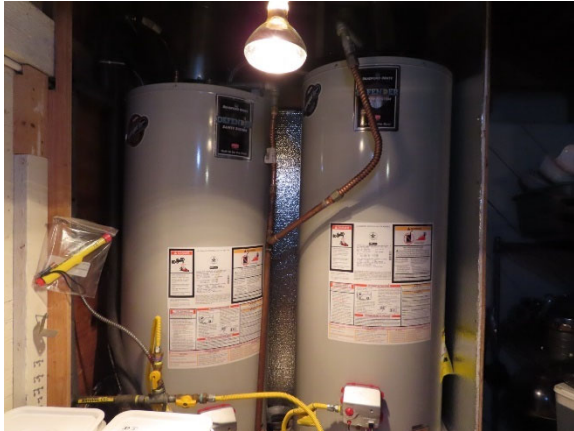
Two Second-Floor 50-Gallon Water Heaters Manufactured in 2018

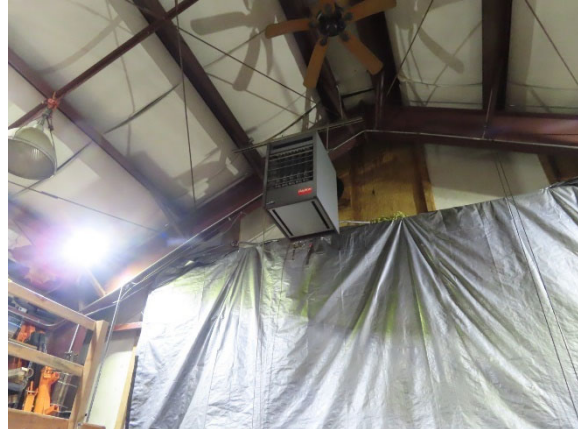
The "Zoo" garage has a hanging Reznor gas furnace. We understand that there are no plans to replace this garage furnace in the future.

Hanging Reznor Furnace in the Zoo

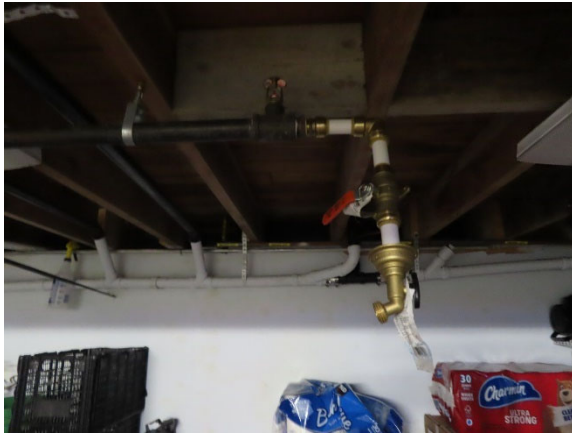
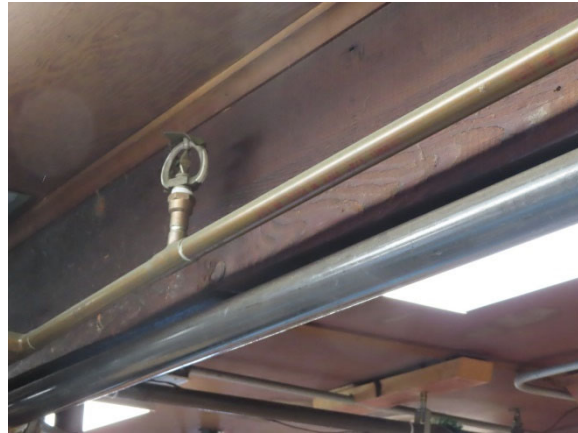
There is a wet fire suppression system in this building. This system is relatively simple; therefore, no significant expenditures are anticipated with this fire suppression system.

Typical Fire Sprinkler Head

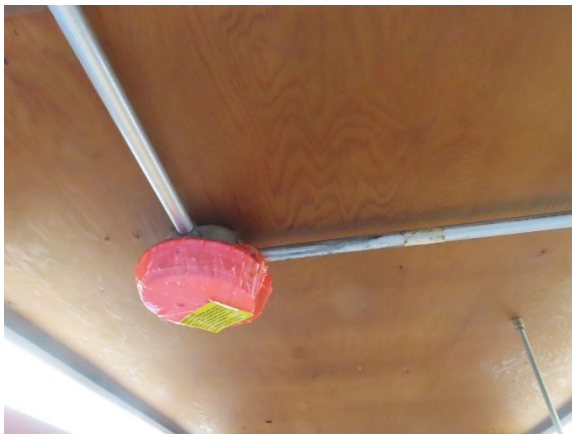
A new fire detection system is in process of being installed at this time. The majority of the components have already been installed; however, the fire alarm control panel has yet to be purchased and installed, which we understand will be done in 2022. We have assumed that this fire alarm control panel will be replaced every 20 years.

Typical Smoke Detector

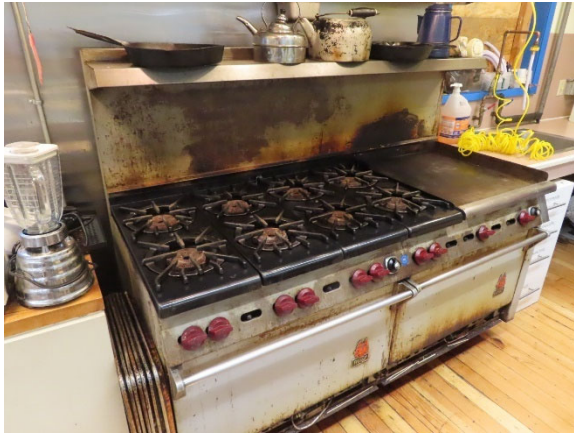
Kitchen Range

- Replacement of the commercial range every 20 years
- Replacement of the range hood with a properly sized commercial range hood (that includes fire suppression) every 20 years
- Replacement of the commercial refrigerator every 20 years
- Replacement of the basement freezer every 20 years
- Replacement of countertops and sinks every 30 years

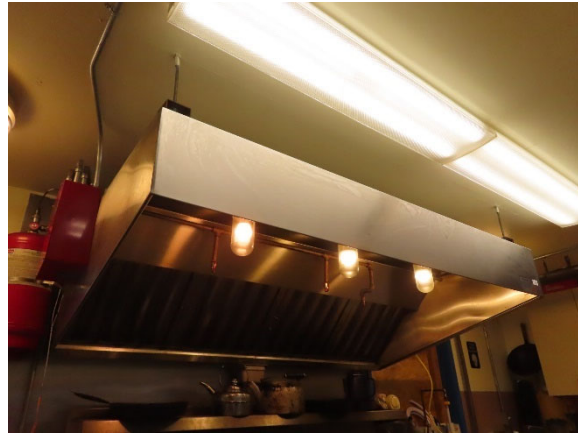
Kitchen Range Hood

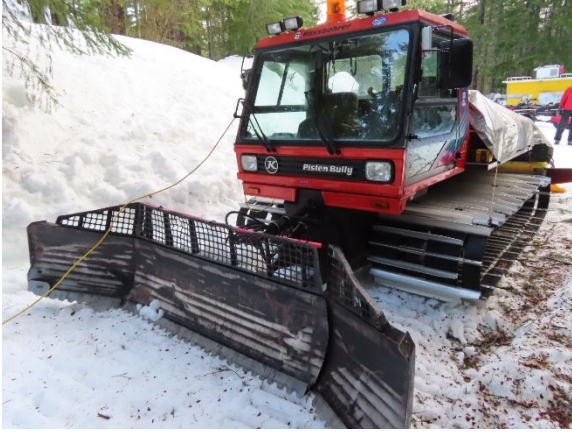
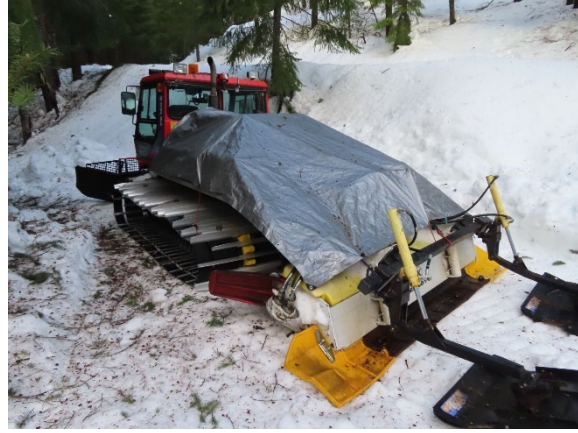
**Hippo** – This is a 1995 Piston Bully P160 snow cat and grooming machine. We understand that this machine is generally maintained via the operating budget indefinitely. The only expense that the committee would like to budget for this machine is for track replacement every 15 years. This was just performed in 2021 for \$25,000.

"Hippo" Snow Cat

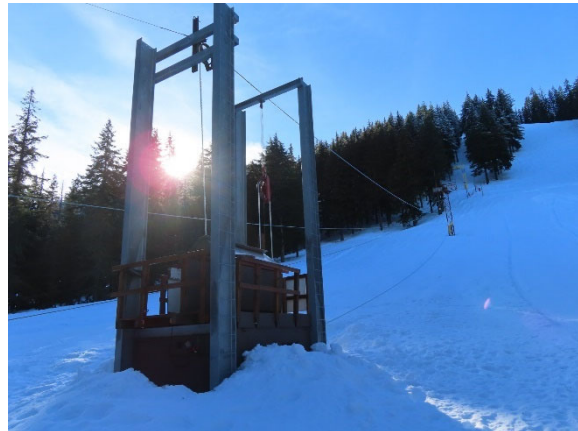
Mach Rope Tow

- Mach – 2,400 linear feet of rope that was replaced in 2021
- Super Worm – 1,200 linear feet of rope that was replaced in 2017
- Turtle – 750 linear feet of rope that was replaced in 2016

We have budgeted for replacement of the ropes every 7 years at approximately \$3.50 per linear foot for material owner, as we understand that all labor is typically performed via volunteers.

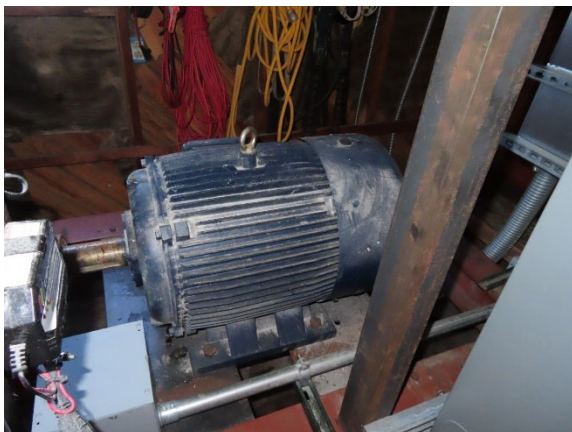
Mach Rope Tow Motor

We understand that a new electric motor was replaced on Mach in 2013. We have budgeted for replacement of this electric motor every 20 years. We understand that the committee plans to replace the Super Worm motor in 2023. We have budgeted for Turtle's motor to be replaced in 2023.

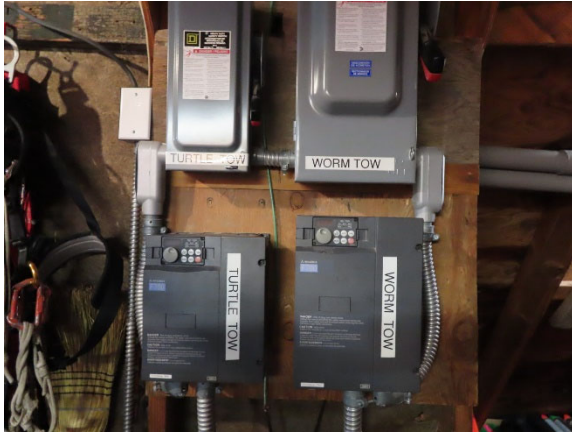
Controls for all 3 Rope Tows

We understand that the controls for all 3 rope tows were installed in 2013. We have also assumed that these controls will have a 20-year lifespan.
