Jesse Hunt IV
36128 Caraway Rd
Denham Springs LA 70706

INSPECTION REPORT INDEX

DATE OF INSPECTION:	24/01/2022
START TIME:	08:30
END TIME:	10:30
CLIENT NAME:	Jesse Hunt IV
CITY & STATE:	Denham Springs, LA 70706

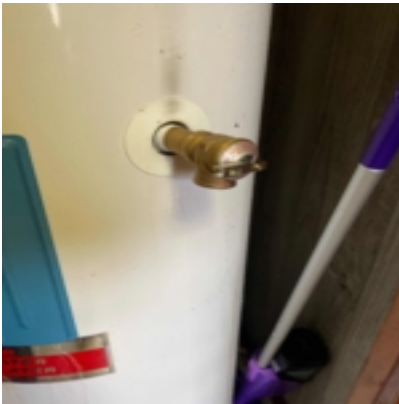
The following concerns were noted with water heater TPR valve:
Pressure relief valve drain line ends prematurely. We recommend this drain line be extended to a safe location/pointing toward and terminating within 6" of the ground.
No pan. Recommend installing an overflow drain pan with an exterior routed drain line

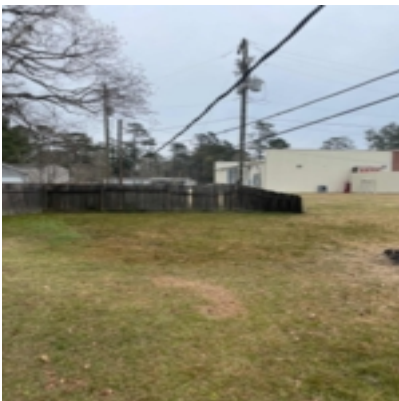
Too close to ground/porch/balcony (should be at least 10' off ground) Recommend contacting the power supply company about raising the main service line.

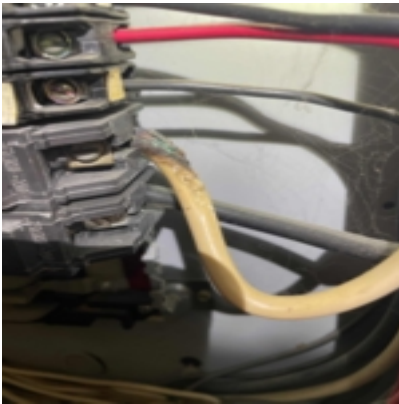
The following concerns were noted at the main electrical panel:
Signs of scorching noted at the 60 amp breaker circuit. Recommend further evaluation by a licensed electrician and repair/replace as needed.
Unused openings in the panel are missing covers, recommend corrections

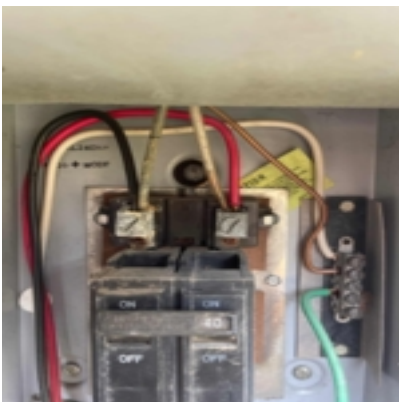
HVAC breaker has been double tapped to supply power to the shed. This is incorrect and can cause the breaker to overheat. Recommend further evaluation by a licensed electrician and repair/replace.

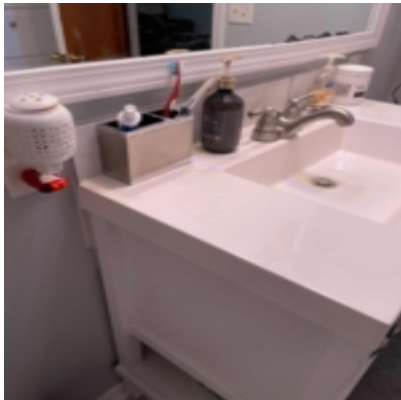
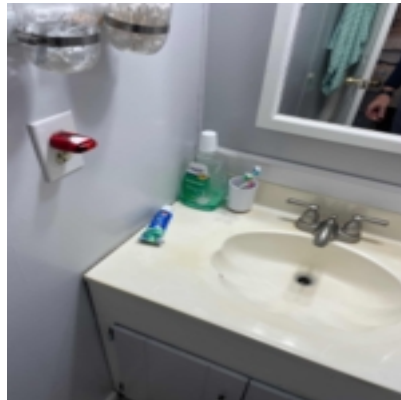
The following concerns were noted with the switches and receptacles:
Ground Fault Circuit Interrupter (GFCI) receptacles are recommended at all locations

where you can come in contact with water and electricity at the same time. Consider upgrading to comply with current codes and safety recommendations.

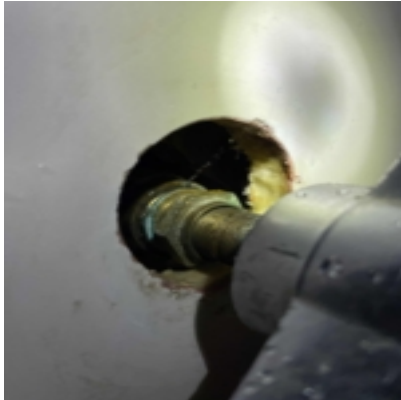
The toilet is loose at floor. A new wax seal should be installed under loose toilets. Flange may be broken. Recommend evaluation by a qualified licensed plumber and repair.

Leak noted at the hot water handler behind the shower wall. Recommend further evaluation by a licensed plumber and repair/replace.
Missing drain grate noted in the shower. Recommend repair.

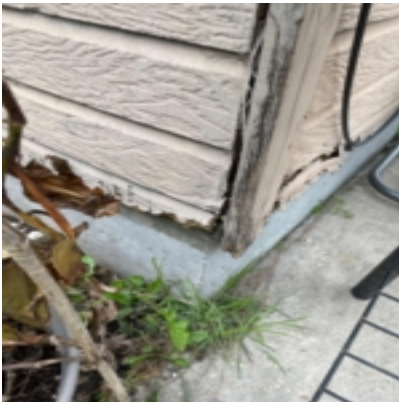
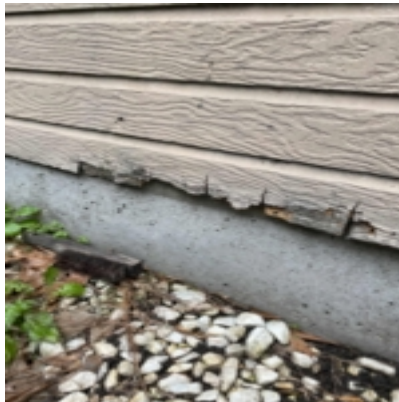
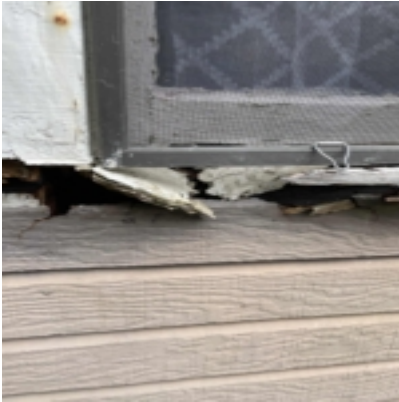
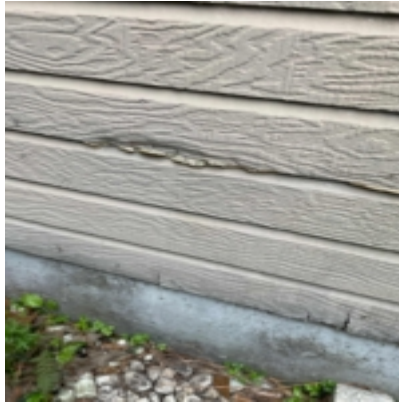
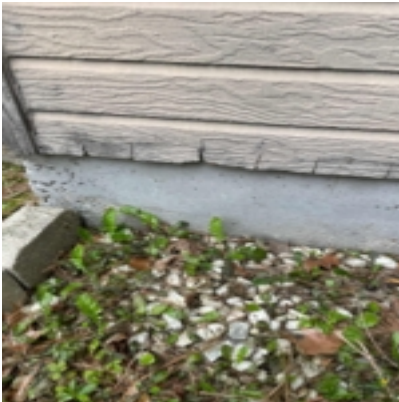
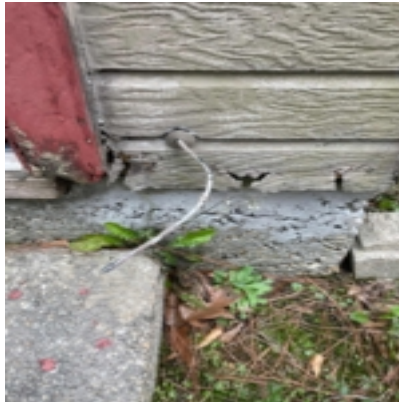
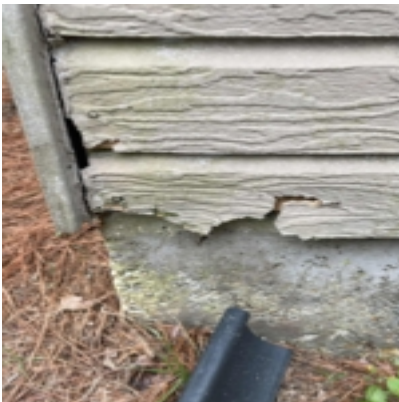
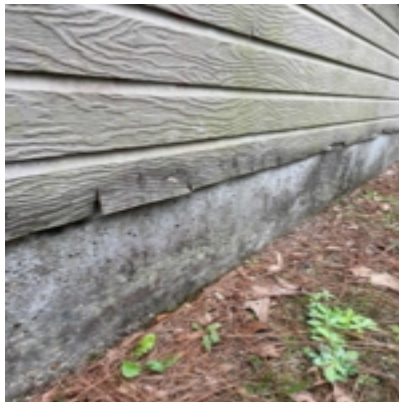
And bottom run of masonite siding is consistently damaged due to moisture around the perimeter of the home. Recommend further evaluation by a licensed contractor and remove/replace all moisture damaged wood.

Large opening in the masonite siding Noted under the front right window. Recommend further evaluation by a licensed contractor and repair/replace.

The following concerns were noted at the exterior walls:
And bottom run of masonite siding is consistently damaged due to moisture around the perimeter of the home. Recommend further evaluation by a licensed contractor and remove/replace all moisture damaged wood.
Large opening in the masonite siding Noted under the front right window.
Recommend further evaluation by a licensed contractor and repair/replace.

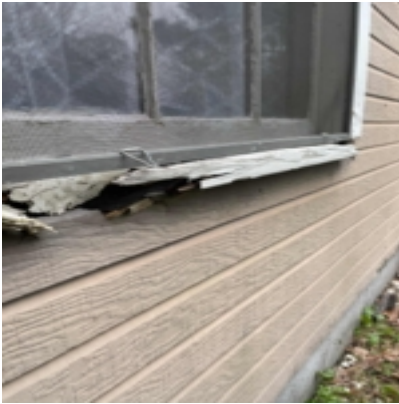
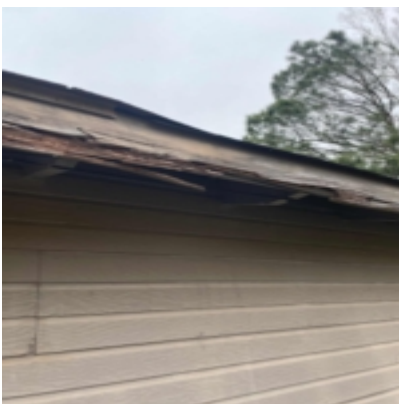
Moisture damage noted at the window trim at the front right window, left side window, right side window, and to rear windows. Recommend repair/replace all moisture damaged wood.

Several Moisture damaged pieces of corner trim Noted around the house. Recommend remove/replace all moisture damaged wood.

Damaged fascia board noted on the right end and rear of home. Recommend further evaluation by a licensed contractor and repair/replace.

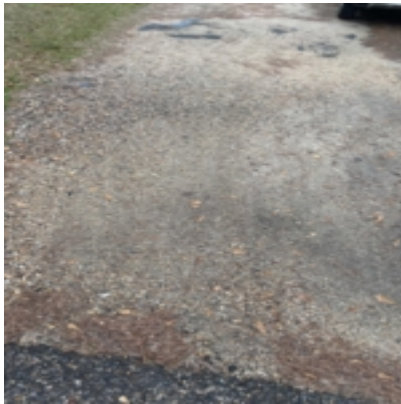
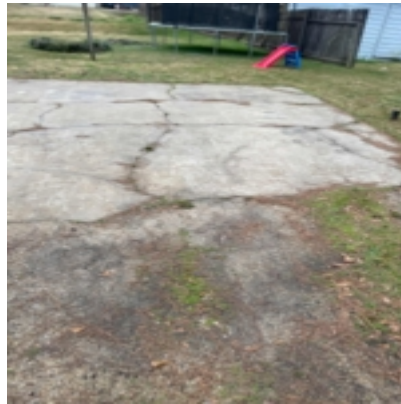
The following concerns were noted at the driveway:
Cracks noted. Some cracking is to be expected as the property settles with age.
Recommend monitoring for any future changes.

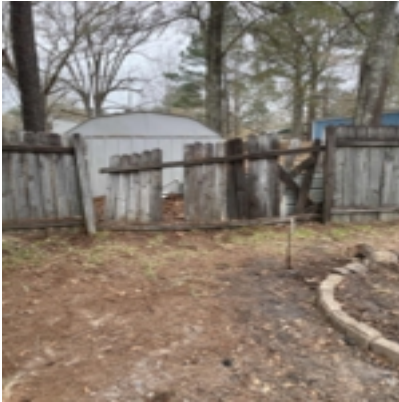
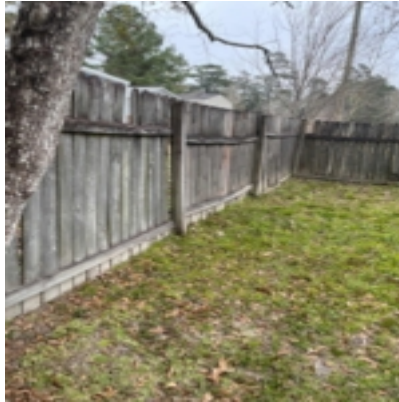
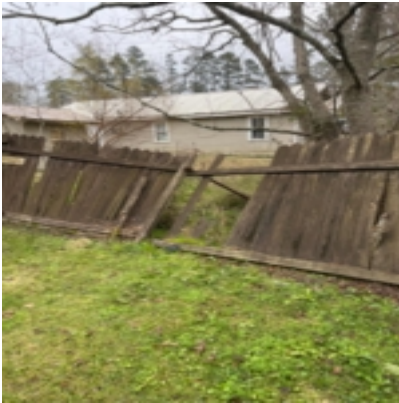
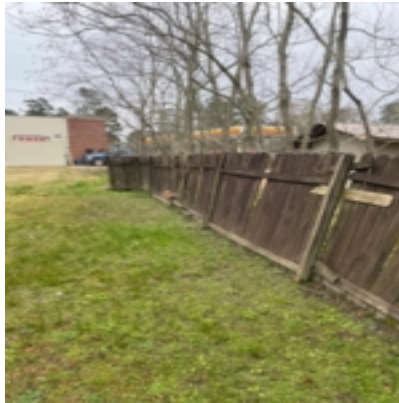
Wood fences in overall poor condition around the perimeter of the yard. Several damaged/leaning/missing sections of fencing noted. Recommend further evaluation by a licensed contractor and repair/replace as needed.

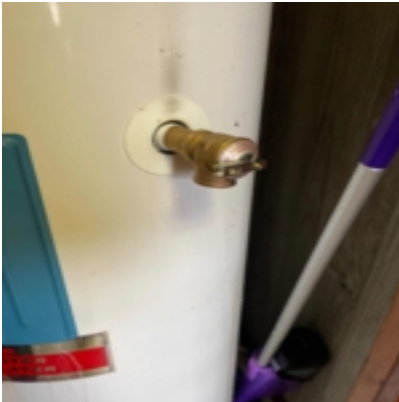
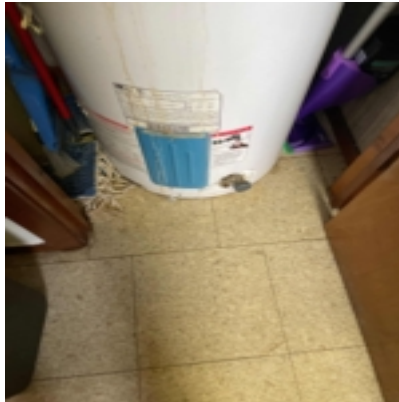
Pressure relief valve drain line ends prematurely. We recommend this drain line be extended to a safe location/pointing toward and terminating within 6" of the ground.

No pan. Recommend installing an overflow drain pan with an exterior routed drain line

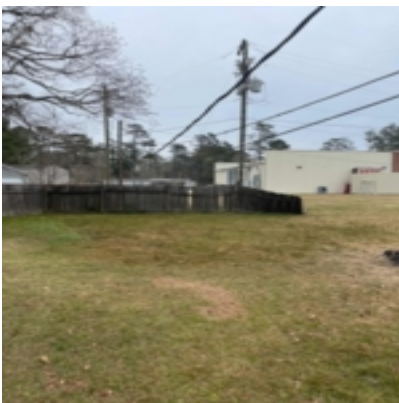
Too close to ground/porch/balcony (should be at least 10' off ground) Recommend contacting the power supply company about raising the main service line.

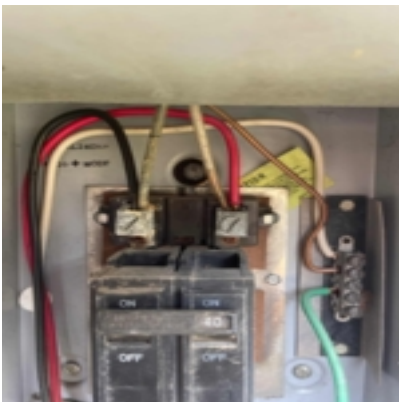
HVAC breaker has been double tapped to supply power to the shed. This is incorrect and can cause the breaker to overheat. Recommend further evaluation by a licensed electrician and repair/replace.

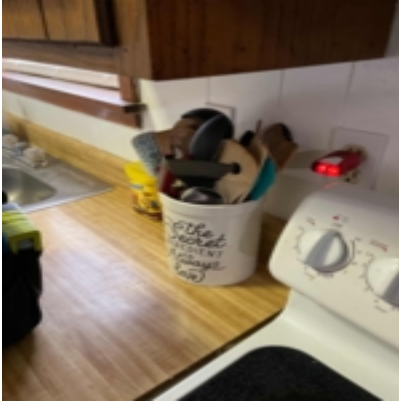
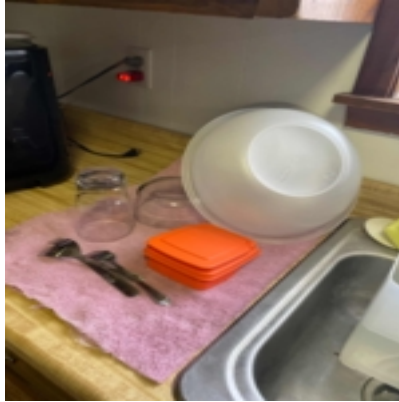
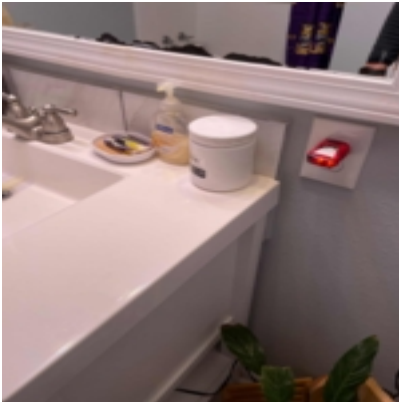
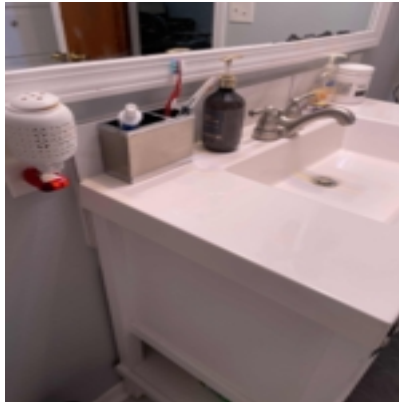
The following concerns were noted with the switches and receptacles:
Ground Fault Circuit Interrupter (GFCI) receptacles are recommended at all locations where you can come in contact with water and electricity at the same time. Consider upgrading to comply with current codes and safety recommendations.

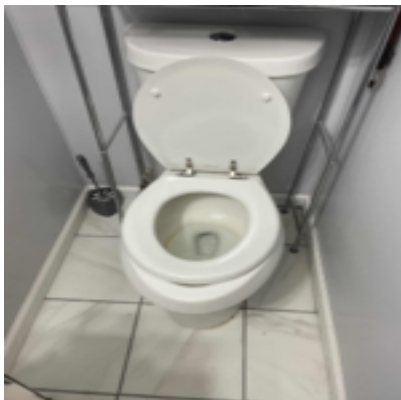
CONDITION OF TOILET

The following concerns were noted at the toilet:
The toilet is loose at floor. A new wax seal should be installed under loose toilets. Flange may be broken. Recommend evaluation by a qualified licensed plumber and repair.

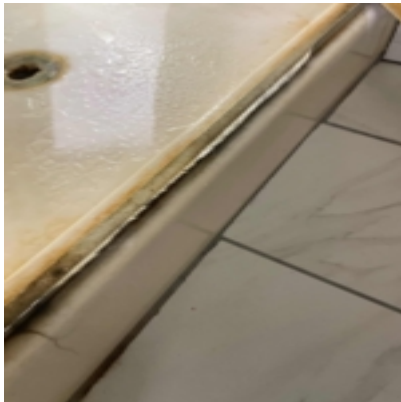
TUB OR SHOWER AND WALLS

Leak noted at the hot water handler behind the shower wall. Recommend further evaluation by a licensed plumber and repair/replace.

Missing drain grate noted in the shower. Recommend repair.

Enclosure appears serviceable with signs of wear and tear noted.

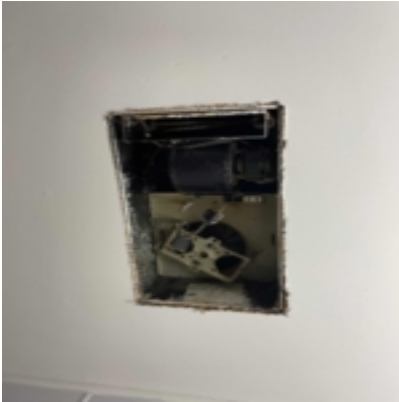
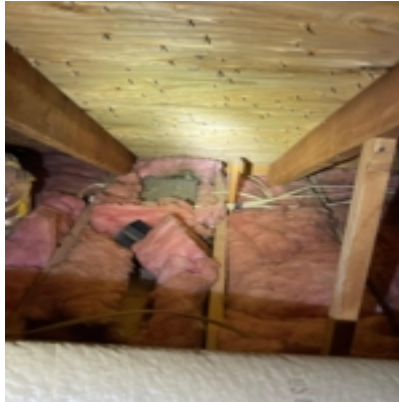
BATH HEAT OR VENTILATION

The following concerns were noted with bathroom ventilation:

Missing cover noted. Recommend replacing.

Bathroom exhaust vent terminates into the attic insulation. Recommend routing to the exterior.

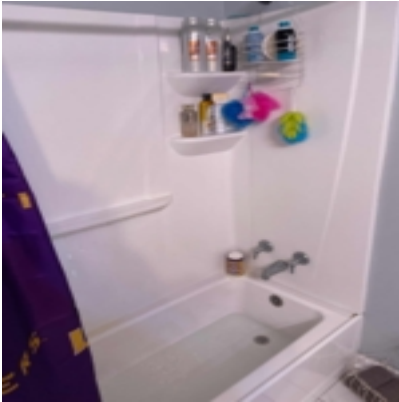
The following concerns were noted at the drain:
The drain is slow at tub. recommend corrections.

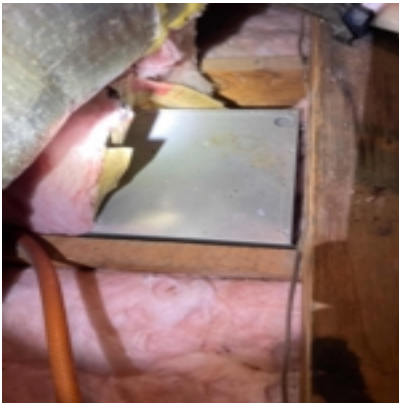
Bathroom exhaust vent terminates into the attic insulation. Recommend routing to the exterior.

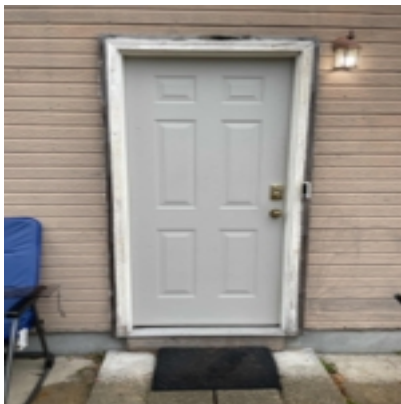
OTHER EXTERIOR DOORS

Appears serviceable but signs of wear and aging noted. Monitor for problems.
Recommend painting door slab and trim to help protect against the elements.

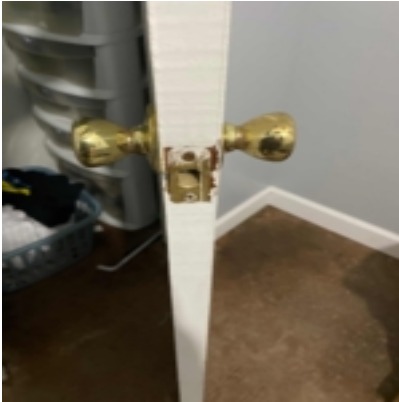
INTERIOR DOORS

The following concerns were noted at the interior doors:
Missing volt noted at front bedroom closet door. Recommend repairs.

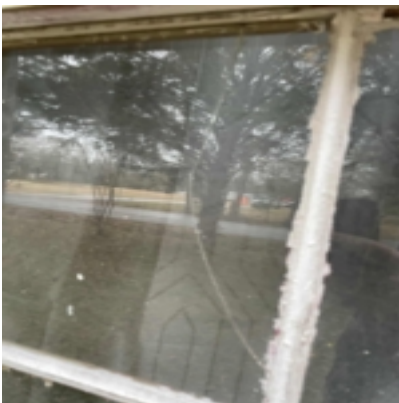
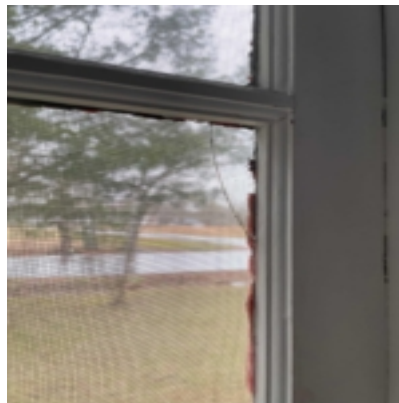
Appears serviceable but signs of wear and aging noted. Monitor for problems.

Cracked glass noted at the living room window and front bedroom window.
Recommend repair/replace.
Some windows are hard to operate.

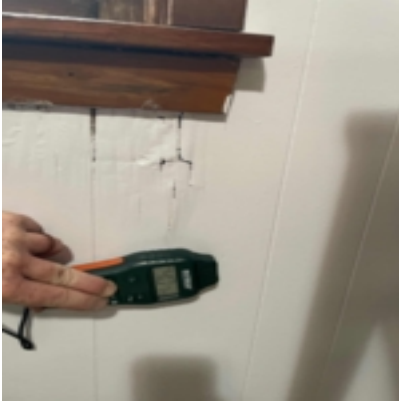
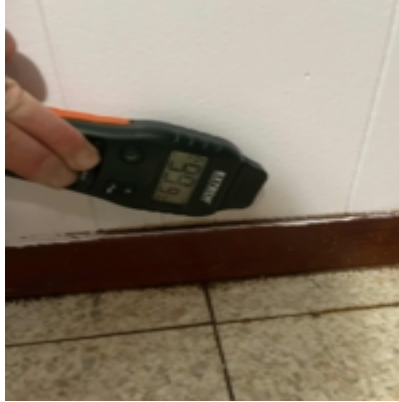
Moisture damage noted to the paneling under the dining room window. Recommend making appropriate repairs to the exterior siding as well as replacing the interior paneling and any other framing that was affected.

Elevated moisture levels noted under the dining area window.

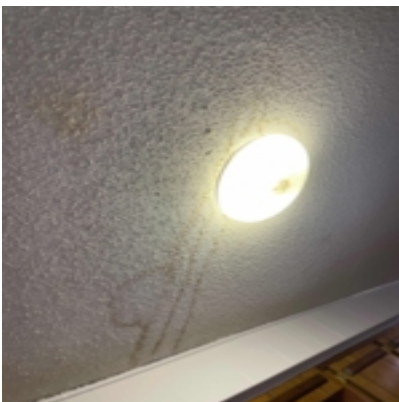
Signs of previous moisture stains noted at the kitchen ceiling above the kitchen sink. Recommend monitoring area for a future problems and make repairs as needed.

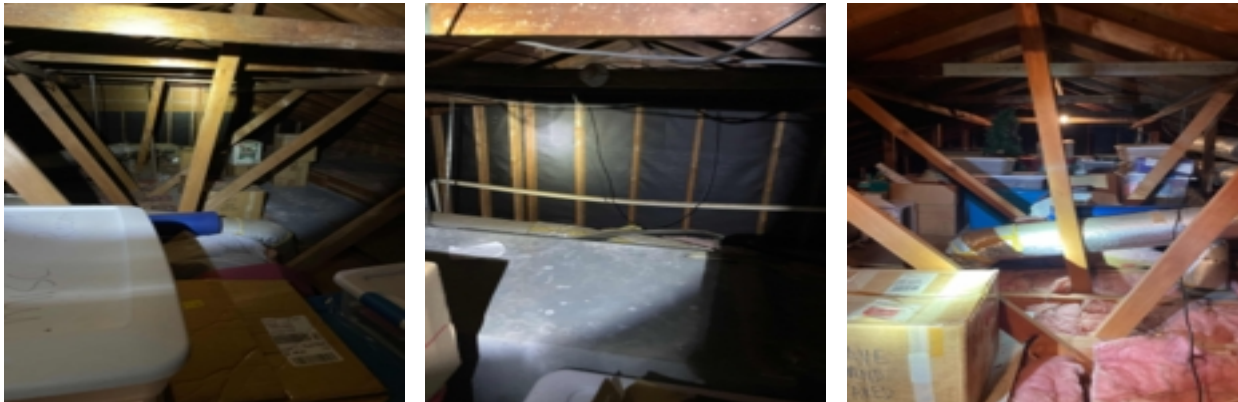
ATTIC ACCESS

The following concerns were noted at the attic access/stairs:

Ladder door does not fully close. Recommend repairing/replacing.

Recommend providing insulation/weatherstripping around attic access door.

Ladder is in need of trimming to ensure proper opening and operation. Make necessary repairs according to manufacturer's recommendations.

Missing Spring Noted on the left side of attic access stairs. Recommend repairs.

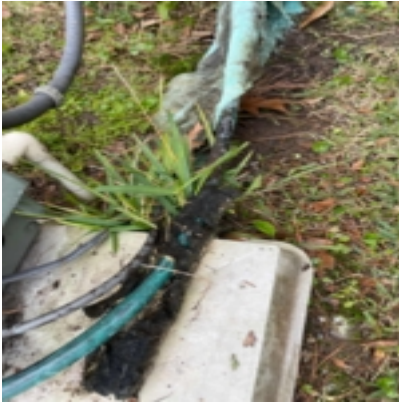
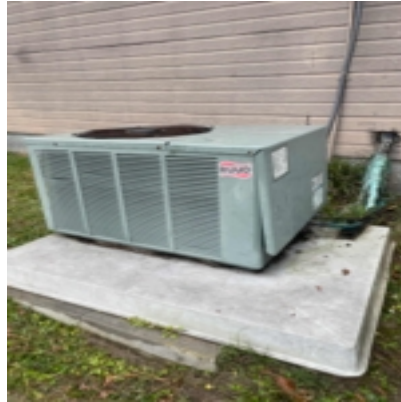
The following concerns were noted with the air conditioning condenser/compressor:
Unit is advanced in age and appears to be using older style R 22 refrigerant.
Recommend consulting with a licensed HVAC technician about the proper

The compressor unit is not level which may cause premature wear to the motor bearings. Recommend evaluation by a licensed HVAC technician and repair.

Missing/damaged insulation noted on refrigerant line outside, recommend repairs.

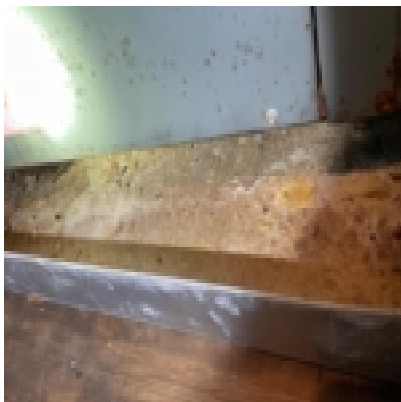
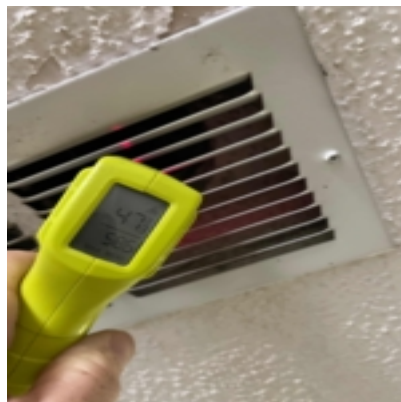
The following concerns were noted with overflow drain pan:

Damage/rusting noted at pan. Monitor for problems.
