CMD-HD Replica Design by toms01

A board review on revision 1.2 by M.Kanet / June 2021

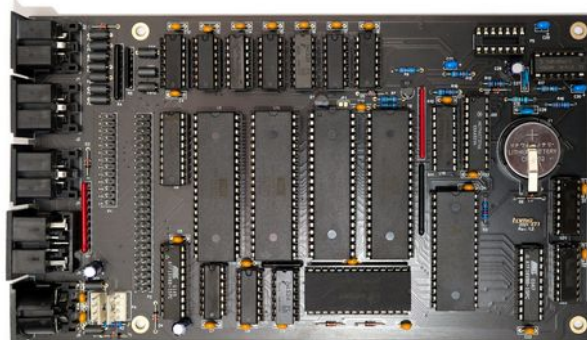
First of all here is a photo of the new replica board V1.2 from toms01 (Figure-01)

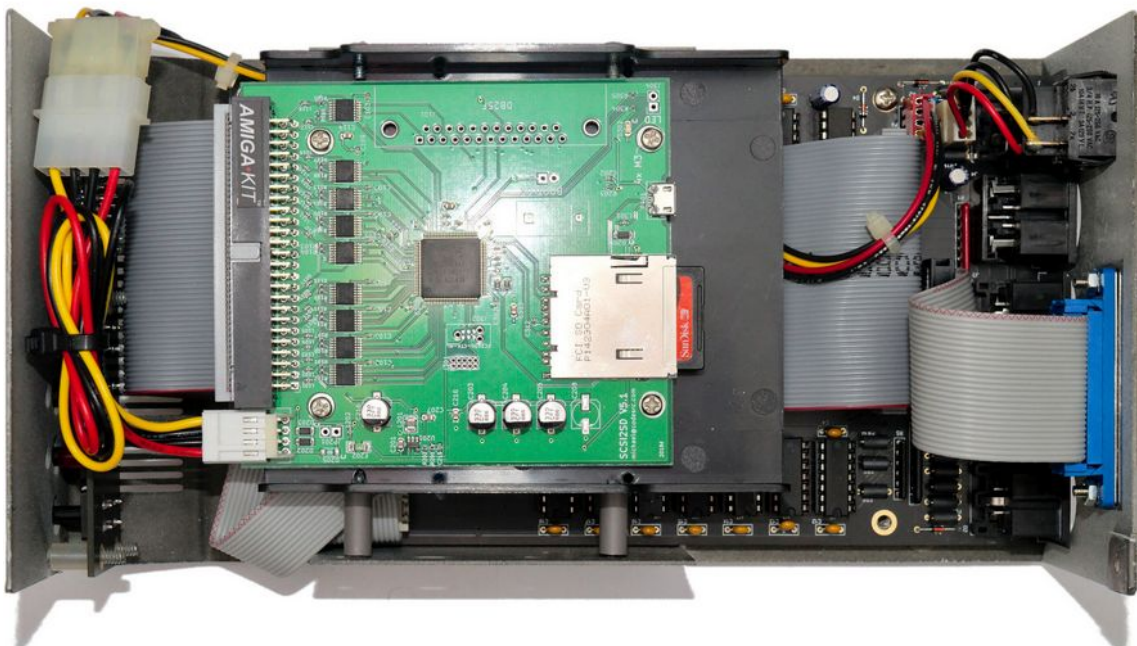
For the first tests I chose a SCSI2SD drive (version V5.1), which was equipped with an already formatted 1Gb sd-card. (Figure-07)

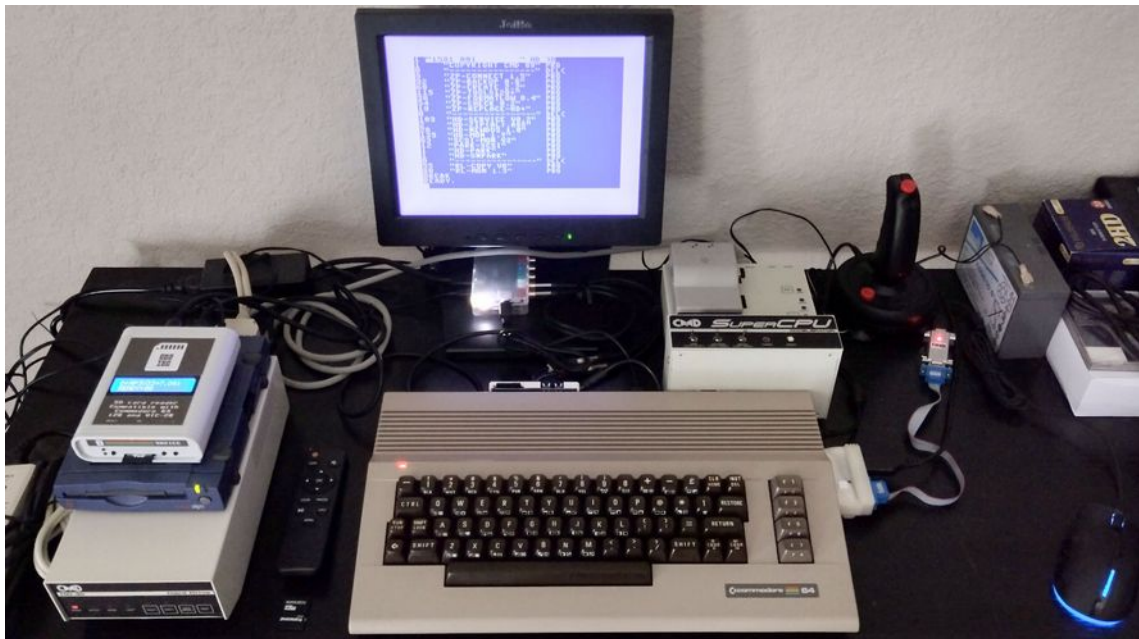
After switching on, the CMD-HD starts with the RESET procedure, the LEDs show the test progress. The SD card was already formatted, so the CMD-HD is ready for operation (Figure-08):

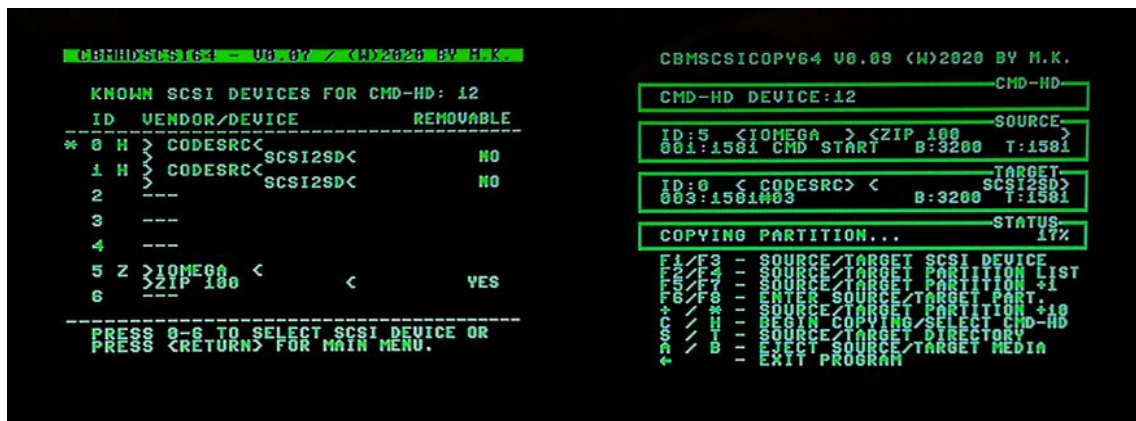
We now continue with the software tests, first with cbmHDscsi and cbmSCSIcopy (Figure-09):

cbmHDscsi replaces the LLFormat utility of CMD. The SD card can be formatted without problems and new partitions can also be created without difficulty.

The SD card has been set up so that two drives with different SCSI IDs are available. Therefore the SD card appears 2x in the drive menu.

cbmSCSIcopy is a DiskCopy utility to copy partitions between different SCSI devices on the CMD-HD. For testing an lomegaZIP 100 was connected to the DB25 socket of the CMD-HD.

Since both cbmHDscsi and cbmSCSIcopy recognize the lomega drive, the external SCSI connection via the DB25 socket should work. Finally, a partition was copied from a ZIP100 disk to the CMD-HD.

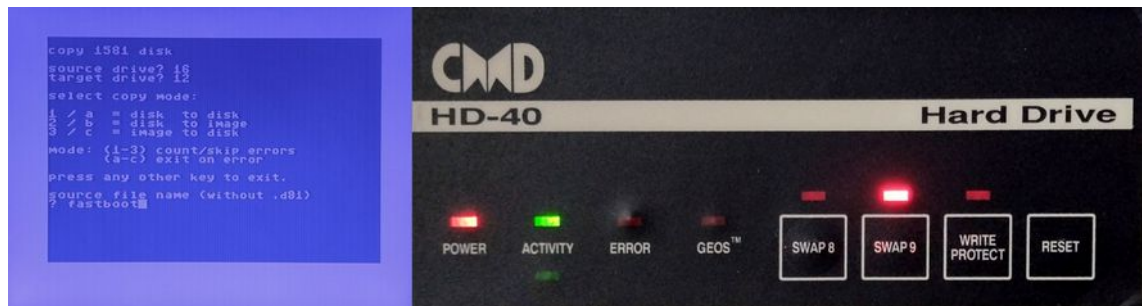
The next test was performed with copy1581. The program copies disks or partitions to D81 files. Test environment was the CMD-HD as source/destination and a NativeMode partition on the CMD-RAMLink as buffer for the D81 files (Figure-10).

During the tests with copy1581, the SWAP-8/9 and WriteProtect buttons on the CMD-HD were also checked. No problems detected.

The time shows that the parallel port of the CMD-HD works. The times of the SD2IEC are given as a reference to better classify the other results.

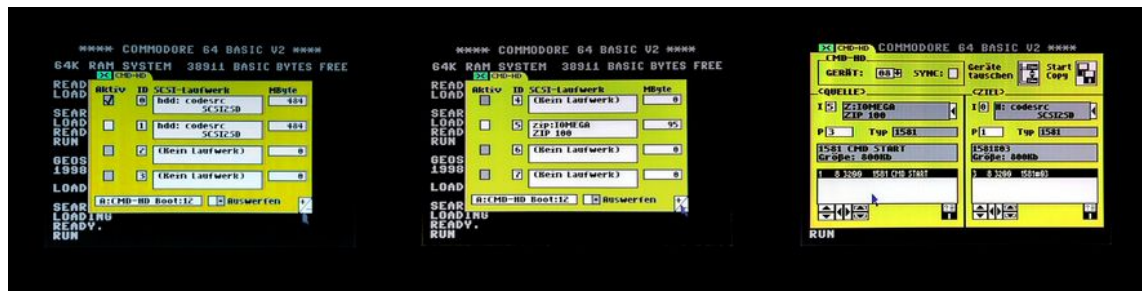
Next came the test of the GEOS-TurboDOS integrated in the CMD-HD (Figure-11).

All tests so far without problems.
