On-site investigation and analysis of flaking damage leading to rail break

Hiroyuki Matsuda^{a,*}, Yukio Satoh^b, Yoshikazu Kanematsu^b, Kengo Iwafuchi^b

In order to know the relationship between the occurrence of flaking leading to the rail breakage and wear of the rail, on-site investigations and analysis of the broken rail were carried out. As a result, it was found out that the occurrence rate of the flaking damage was high at gauge corner side of high rail in moderate curves with radius from 800 m to 1800 m. It was also found that the rail wear in the section where lubrication was applied was about a half of that in the section without lubrication. Moreover, it was found that flaking damage was generated on the running surface or in the close vicinity of the surface of rail head under the condition of repeated loading of shear and tangential forces caused by the rolling contact with wheels. It could be assumed that the balance between the wear and the accumulation of micro-strain or fatigue was a key to occur the flaking damage.

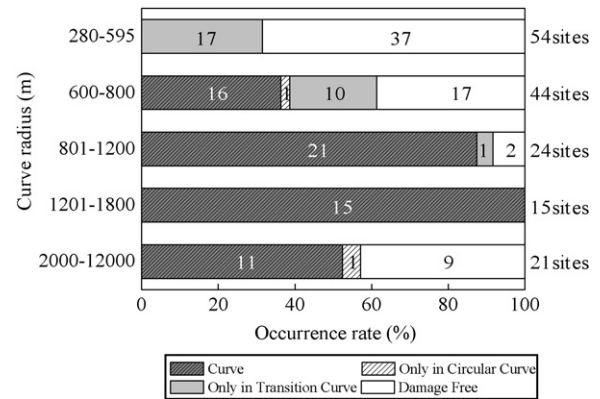
Fig. 4. Relationship between curve radius and flaking occurrence rate.

Fig. 4 shows the relationship between curve radius and flaking occurrence rate. A site was counted into the flaking occurrence site even if only a part of the curve in question was suffered from the damage. Of the 158 investigation sites, the flaking damages were found at 93 sites that were about 60% of the sites. It was recognized that the occurrence rate was higher at GC side of high rail in moderate curves with radius from 800 m to 1800 m. There was a site where the flaking was found only after 8 months (28.8 MGT) from the latest rail replacement. On the contrary, no flaking damage was observed in a line where no lubrication had been operated even though the line was parallel to the line for investigation.

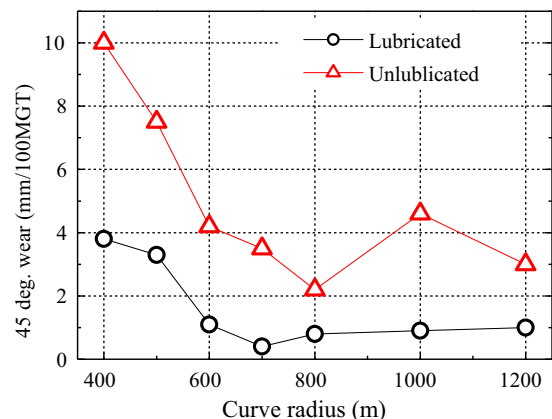
Considering the fact in mind, the rail wear was measured at two sites. The two sites were similar to each other in the track and vehicle conditions except for the lubrication. That is, oil lubrication was performed on one site and not performed on the other site. The relationship between curve radius and rail wear per 100 MGT is shown in Fig. 5. It was confirmed that the rail wear at the site with lubrication was about a half of that at the site without lubrication.

These field observations showed that the wear of rail was significantly suppressed by the oil lubrication. As a result, it could be considered that the rolling contact fatigue accumulated especially at the moderate curves with radius from 800 m to 1800 m where the pressing load from the passing wheel was relatively low. Such accumulation of fatigue could be thought of as a possible cause of flaking damage.

Fig. 5. Relationship between curve radius and rail wear per 100 MGT.

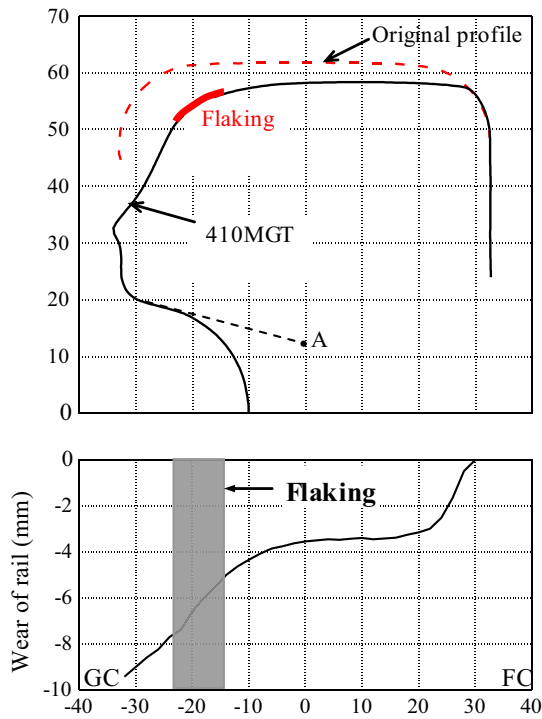
Fig. 9 shows the wear profile of the rail head of the broken rail measured at the train approaching side. The wear amount was defined as the distance between the two points. One was the point on the measured wear profile and the other was the point on the standard profile of a new rail. The distance was measured along the normal line to the worn surface of the broken rail after superposing the profiles of the worn rail and new rail making the side and neck of the rail head of both rails overlap to each other. Observing the result, it was possible to confirm that the wear amount was high on GC side while it gradually decreased when approaching to FC side. The area where the flaking damage occurred was located at the boundary between the area showing relatively uniform wear amount (running surface) and the area showing high wear amount

Fig. 9. Wear of rail.

(side surface), 14–23 mm from the center toward GC side. The wear amount was 5.0–7.5 mm at the boundary area where the flaking occurred.

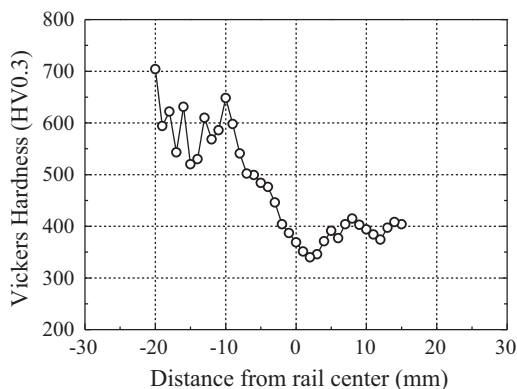
The measurement of the Vickers hardness of the running surface of the rail was performed. The specimen was taken from the approaching side of the broken rail. The surface of the specimen for the measurement was finished with chrome oxide abrasive treatment, then provided for the measurement by means of Vickers hardness tester. The hardness was measured at every 1 mm from the center to both FC side and GC side. The hardness distribution is shown in Fig. 10. The hardness of the flaking rail was higher than that of the new rail (HV about 270) at each point of measurement. The hardness was almost same at the area from FC side to the center of the rail. When the point of measurement approached to GC side, the hardness became higher. The highest hardness appeared at around 10–20 mm to GC side from the center. It was considered that the area where the flaking occurred was suffered from very hard work given by the rolling wheel of the trains.

Fig. 10. Hardness distribution along the traverse direction on rail running surface.

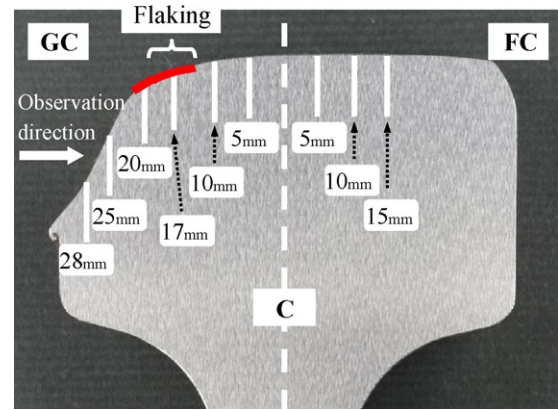
Fig. 11. Metallographic observation point.

Metallographic observation of the running surface layer was performed in order to evaluate the state of plastic flow caused by the repeated rolling contact with wheel. As shown in Fig. 11, the metallographic structure was observed at every 5 mm from the center to both of FC and GC sides. The observation of the running surface layer was made on sections. The sections were taken from the head of the rail keeping the observation surface parallel to the rail longitudinal direction. The observation was carried out from GC side. The sections for metallographic observation were finished with a standard process such as etching of a mirror polished surface with Nital (3% nitric acid with 97% alcohol). The magnification of 200-folds and 500-folds were employed for the observation.

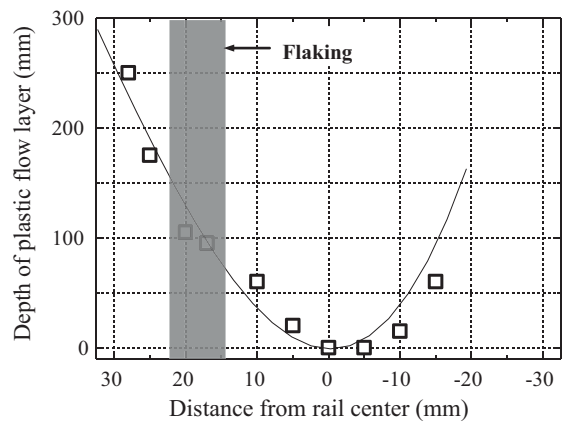
Fig. 12. Distribution of depth of plastic flow layer.

Fig. 12 shows the depth of the plastic flow layer at each observation point. The depth of the plastic flow layer was evaluated on the photographs of metallographic structure of each observation point. Although the existence of the plastic flow layer was verified at all observation point except the center, the layer reached deeper with the increase of the distance of the observation point from the center. The layer was deeper at GC side than FC side.

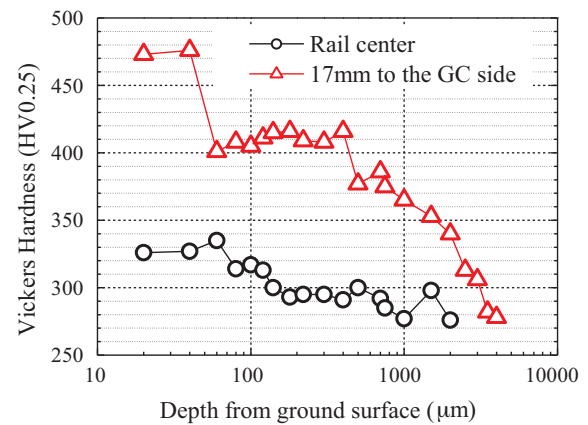
Fig. 14. Hardness distribution on section.

Fig. 14 shows the result of the measurement. At the position of the occurrence of the flaking, Vickers hardness was as high as 470 HV from the surface to a depth of 60 μm. Very strong plastic flow structure was detected in the metallographic observation at this point. The Vickers hardness decreased gradually from 470 HV at the depth of around 60 μm to 400 HV at 400 μm in the rail head. Then, the Vickers hardness decreased moderately to the normal value of the new rail material of 270 HV. The distribution of the micro-strain was presumably generated by the rolling contact with the wheel and accumulated in the subsurface layer of rail head material. Based on the measurement of Vickers hardness, the area where the hardness was higher than the normal value of the new rail material reached to the depth of 3000 μm. It could be considered that very strong tangential force acted on the area.
