Customer: Birla Carbon

Location: Centerville, LA

## TEAM Tank Consultants API-653 Inspection Report

Tank Number: 6

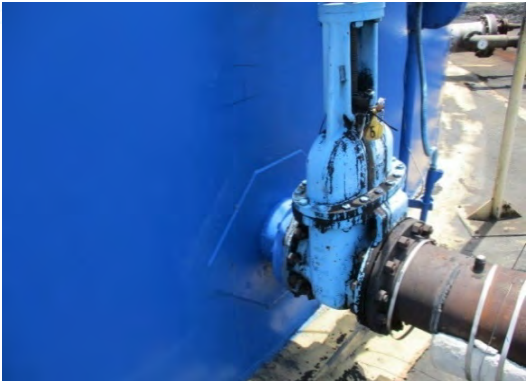
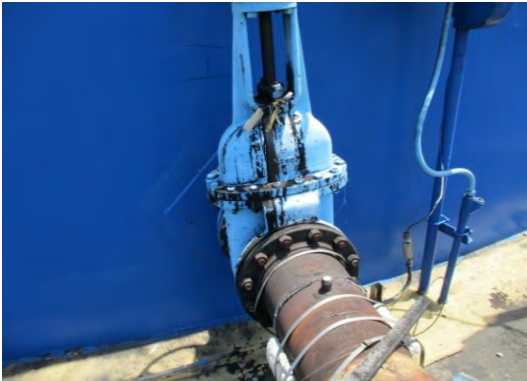
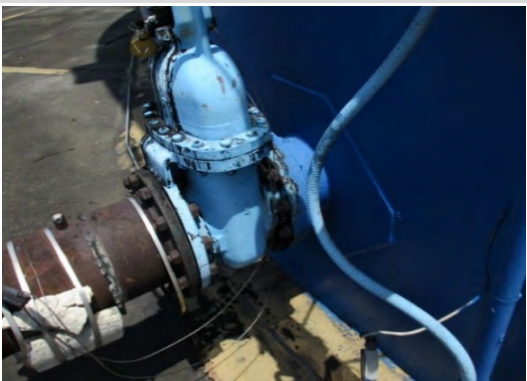
External Shell			
Level Gauge	Acceptable		
	Equipment Manufacturer Type/Model <b>Varec</b>		
Other/Details			
Product Leaks	See Comment(s)		
	Product Leak	Product Weep	Product Staining
	Packing Leak <b>See ES-69</b>	Sample Valve Leak	
Other/Details			
ID: ES-69	<p>The valve of Shell Nozzle I had a packing leak. Dried product was located on the packing gland, bonnet, and valve body housing. Product had accumulated on the concrete located beneath the valve. The epoxy sealant along the concrete containment had completely disbonded below this valve.</p> <p>When the tank is next out of service, the valve should be serviced. Consideration should be given to repairing the sealant.</p>

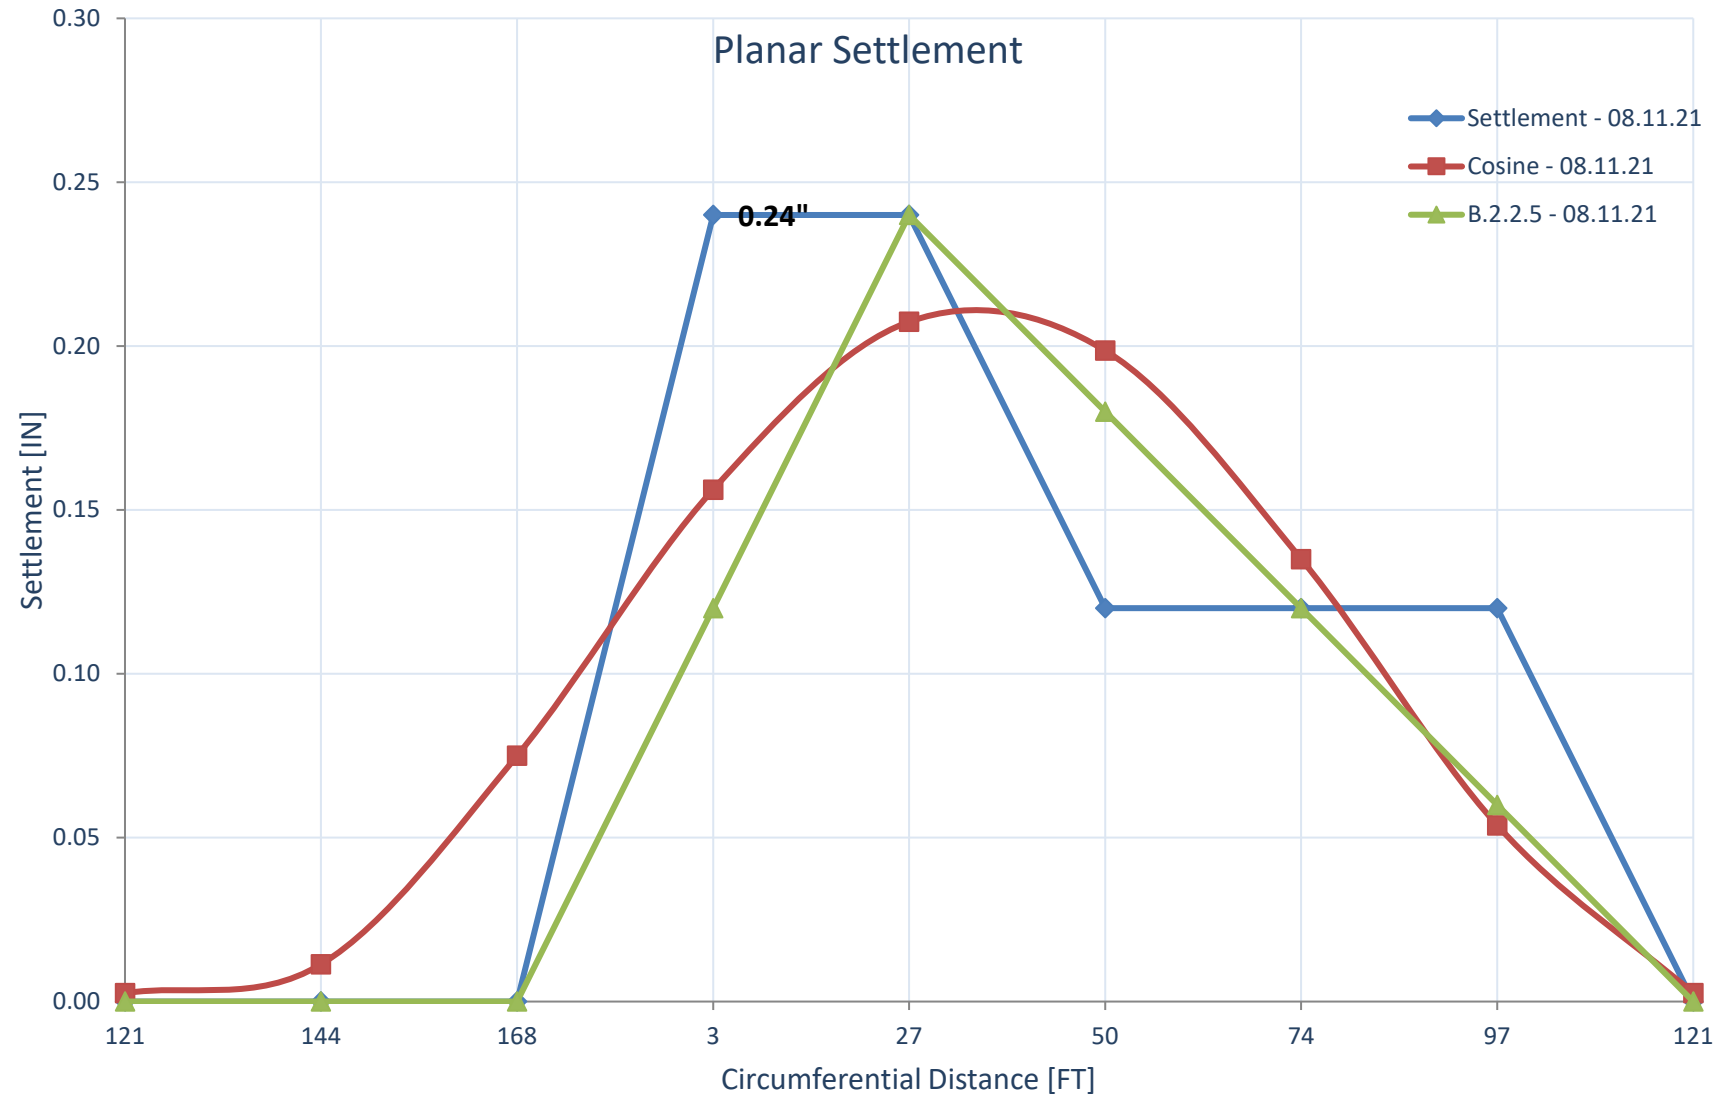
ID	Tank Component	Finding	Suggested Corrective Action	Action Taken/Result
SUR-EXT-1	Foundation	The tank was surveyed externally. The largest planar settlement value was 0.24 inches and located at Survey Radial 1, which was 3.00 feet counter-clockwise from East Shell Nozzle A. Survey Point 1 was located 3.00 feet counter-clockwise from East Shell Nozzle A, and the survey proceeded counter-clockwise around the tank shell perimeter. The largest out-of-plane settlement measurement was 0.12 inches and located at Survey Radial 5, which was 97.25 feet counter-clockwise from East Shell Nozzle A. Using the procedures of API 653, Annex B.2.2.5 to establish the settlement arc length, a maximum permissible out-of-plane settlement of 1.13 inches was determined in accordance with API 653, Annex B.3.2.2. The out-of-plane settlement of the tank did not exceed this value at any of the survey radials.	No corrective action is required.
