# Single Event Effect Test of the Embedded Local Monitor Board

H. Boterenbrood, H. J. Burckhart, B. Hallgren, H. Kvedalen and N. Roussel

**Abstract:** Embedded Local Monitor Boards (ELMB) were exposed to proton radiation up to an overall fluence of  $3.3 \cdot 10^{11}$  protons/cm<sup>2</sup>. The total number of soft SEEs detected amounted to 29, equally distributed among the different functional parts of the board. No destructive or permanent error occurred. The SRAM, EEPROM, flash memories of the master processor and the static registers were subject to a systematic study of the SEE cross-section.

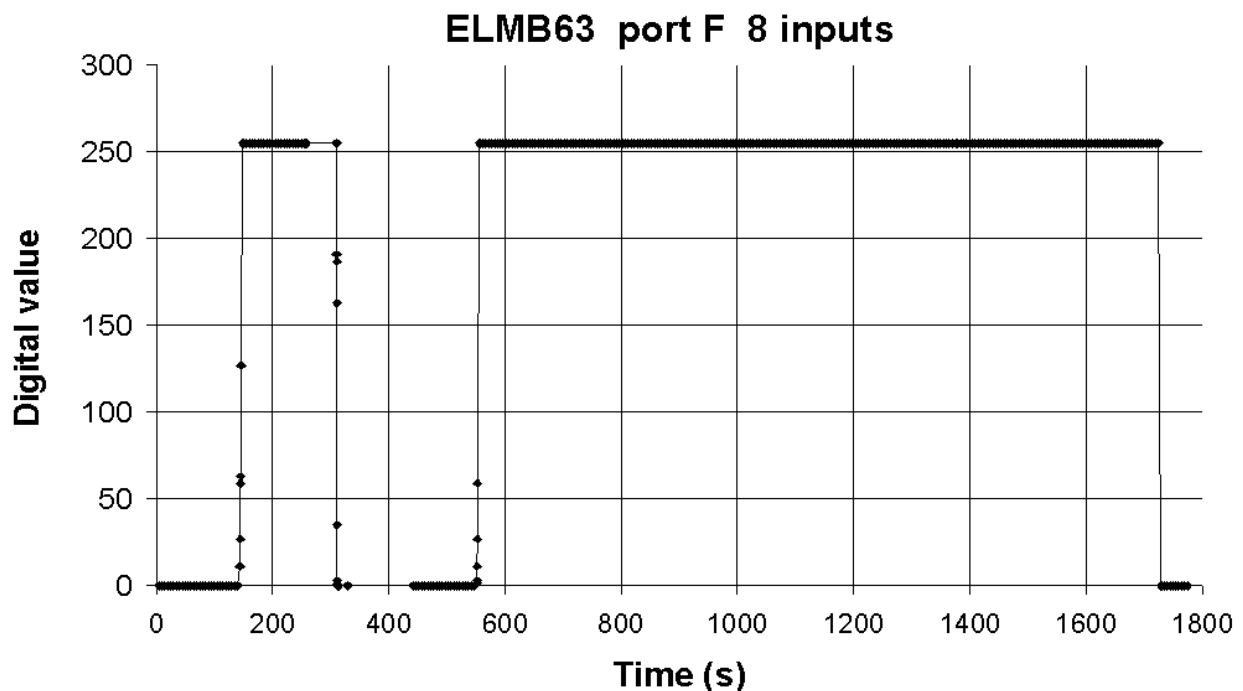
In the off-line analysis, the read-out of the 8-bit digital input was used to determine precisely the irradiation periods. In fact, during the test, the digital ports were left floating and the decimal value of the digital input, which was zero when the beam was off, switched to 255 when it was on. In other words, the 8 input bit values were all equal to 0 in the absence of protons and to 1 during the irradiation periods. Although this behaviour turned out to be very convenient in the analysis of the test, it would be better to avoid leaving the ports floating in future.

Figure 4: When ELMB 63 was tested, the beam was on  $\left\{ \begin{array}{l} \text{between } t = 144 \text{ s and } t = 311 \text{ s} \\ \text{between } t = 555 \text{ s and } t = 1729 \text{ s} \end{array} \right.$

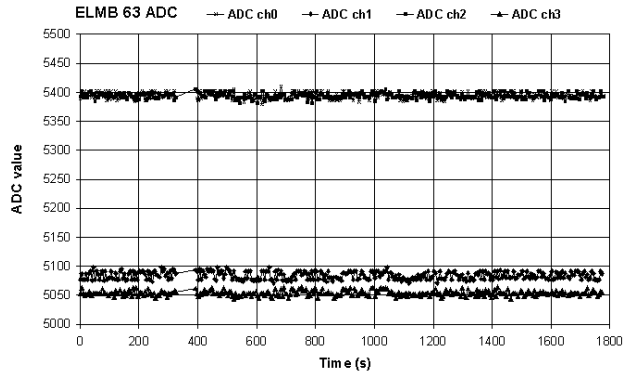
Only 4 of the 64 ADC channels were read. As indicated in the description of the experimental setup, different constant DC voltages were applied to them. The readings show small variations due to the noise. Their amplitude depends on the configuration of the ADC, which was set to 61.6 Hz and 1 V full scale during the test (see Figure 5).

Figure 5: Normal fluctuations of ADC readings
