LIGHT LEAKAGE DEFECTS

8000series

Light leak repair methods

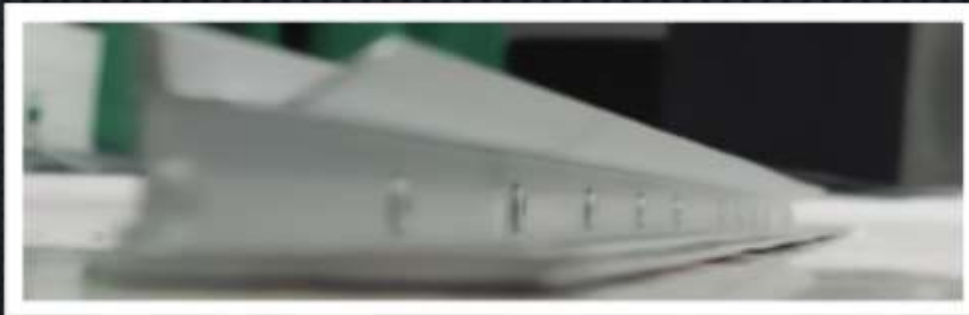
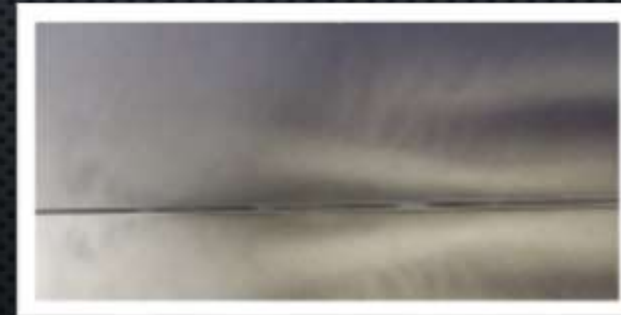
NG

Example of light leakage caused by point pressure under the OC - incorrectly glued rubber

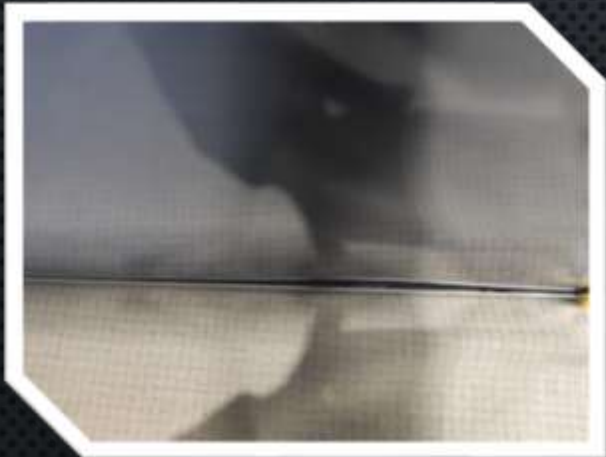
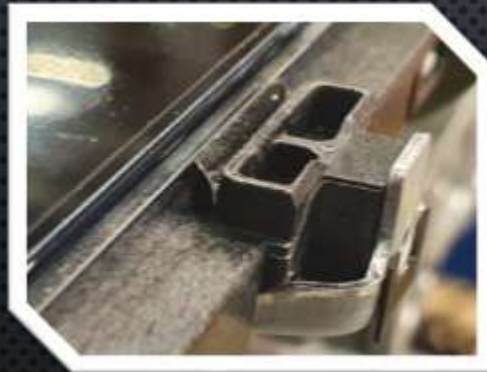
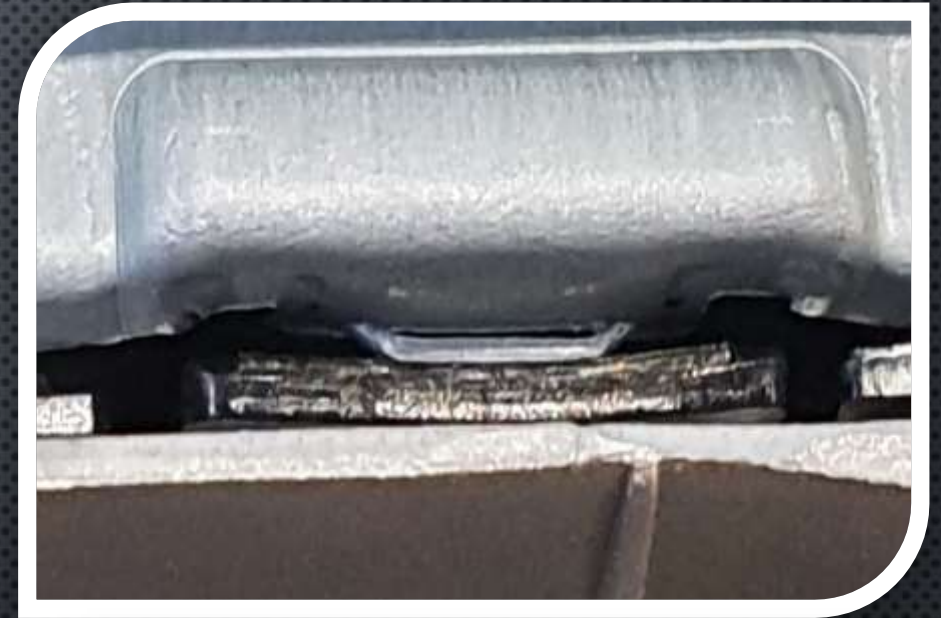
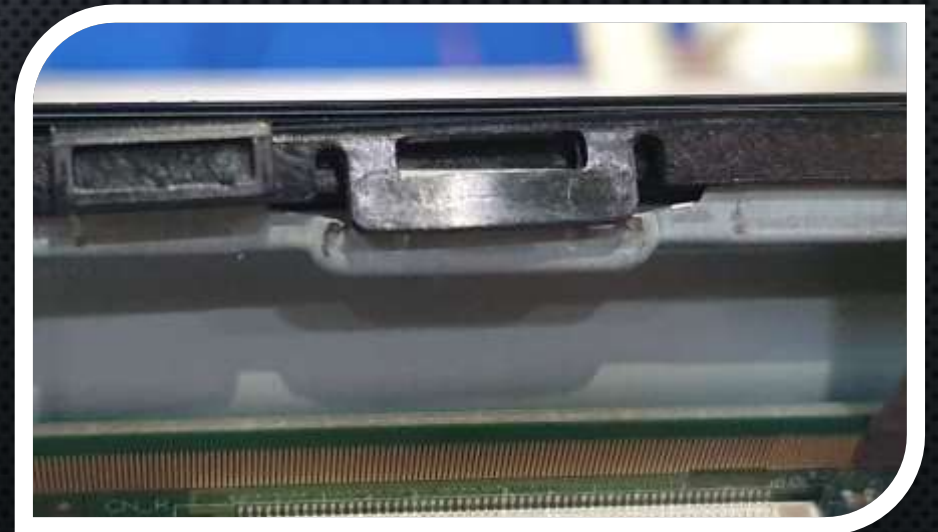
- Gasket stretches the OC too much.
- FC deformation
- Back light deformation
- Foreign body under FC, OC
- The rubber pad under the OC fell under the glass
- Middle frame incorrectly installed
- Backlight / Middle frame is deformed

- FC Gaps regulation
- Disassembly and assembly of FC + MiddleFrame
- Replacement of seals with new ones and even gluing of the glass.
- checking for foreign bodies under FC / OC
- BL deformation adjustment etc.
