TV Struck By Lightning Repaired

This Hisense 50” Smart TV had been a victim of a lightning strike. A friend of mine was asked by a customer of his to take it to landfill as he was cleaning the

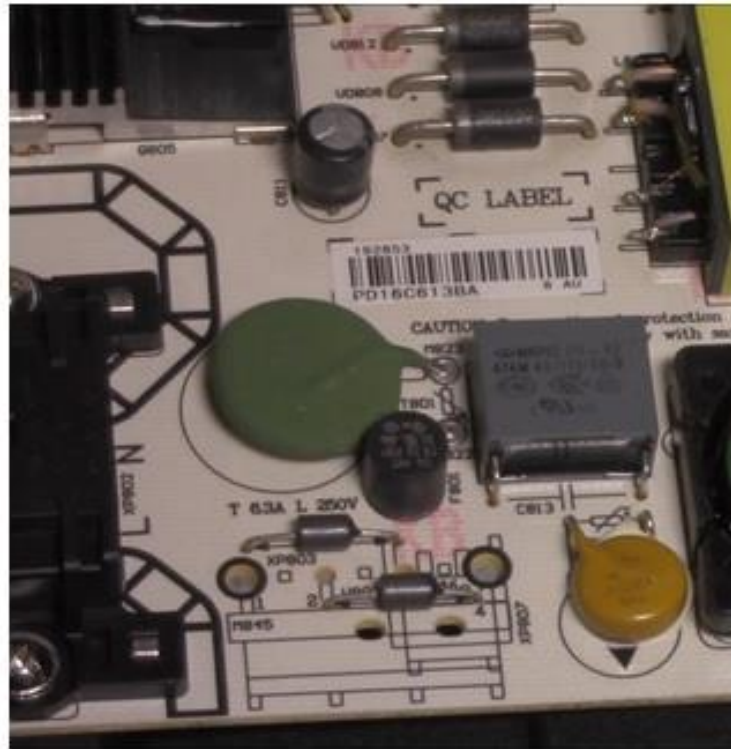
This TV had no standby light. Although I couldn't find a service manual, the voltages were written on the power board and testing proved that no voltages were being supplied to the mainboard. Considering this TV had a disagreement with a lightning bolt, I decided to check the protection circuit. Surely, with thousands, possibly millions of volts surging through the TV, I would naturally expect a blown fuse, varistor, thermistor, maybe some diodes and MOSFETS to be a little worse for wear.
