XIV International Conference on Building Pathology and Constructions Repair – CINPAR 2018

Evaluation of the infrared thermography technique for capillarity moisture detection in buildings

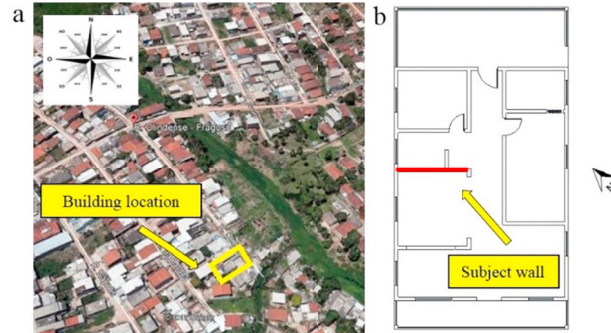
Subject building is a residence located at Olindense street, Jardim Fragoso, Olinda/PE (Fig. 1a). The main facade faces northeast; however, the subject wall is located in the inner area of the building and does not get any direct sunlight (Fig. 1b).

Fig. 1. (a) Building location and (b) scheme of subject wall. Source: Google Earth (2017).

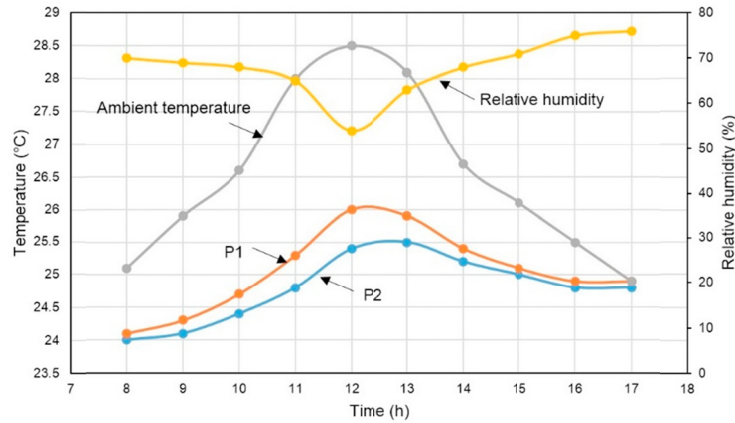
Fig. 5 shows a temperature evolution in points P1 and P2 during test time, in addition to ambient temperature and relative humidity recorded. It can be observed that during the first morning hours, high relative humidity and low values of ambient temperature are present, according to points P1 and P2; but as day progresses, temperatures of the subject points increase until they reach the maximum values at noon, contrary to relative humidity with the day's lowest value. However, this behavior is reversed in the afternoon, when temperatures of points P1 and P2, as well as that of the environment, decrease as the relative humidity increases.

Fig. 5. P1, P2 and ambient temperatures related to relative humidity.

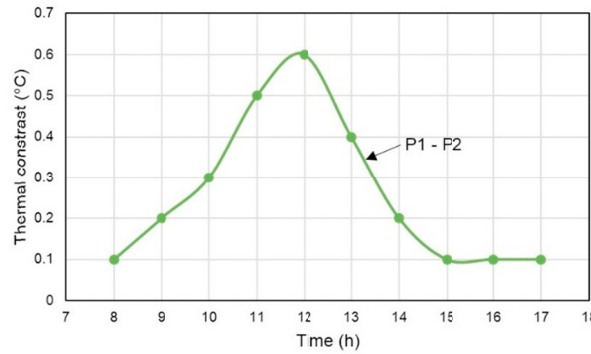
For a better observation of temperature difference between the dry area and the affected area, Fig. 6 shows a thermal contrast between points P1 and P2 during test time. It is observed that the highest values occur between 10:00 AM and 2:00 PM, when affected areas are clearly detected (Fig. 7a). However, values do not exceed 0,6 ° C. At 3:00 PM, as in the first morning hours (8:00 AM), small gradients, 0.1 ° C are present, which do not allow for efficient detection of these areas, as shown in Fig. 7b, thus representing inadequate periods of anomaly detection. In thermograms shown, purple areas correspond to low temperatures and yellow areas correspond to high temperatures.

Fig. 6. Thermal contrast between P1 and P2.

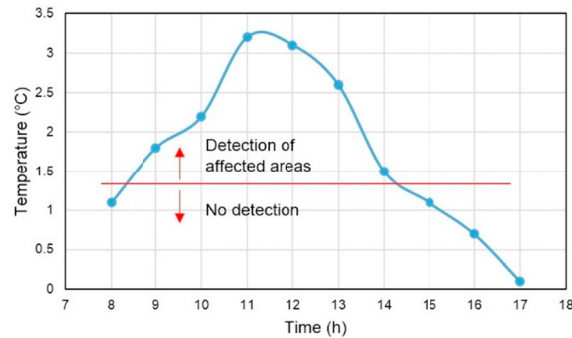
It is important to note that thermal gradients occur when there is a noticeable difference between ambient temperature and moist area (P2). In Fig. 8 this difference is observed during test time. This detection occurred only in a period between 9:00 AM and 2:00 PM, when the difference between ambient temperature and affected area was higher than 1 °C, whereas for smaller values, detection was limited and inaccurate. It can be concluded that detectable thermal gradients are produced when there is more than 1 °C difference between studied areas and the environment, which is also reported and recommended by Barreira and Freitas (2007).

Fig. 8. Thermograms taken at: (a) noon and (b) 5:00 PM.

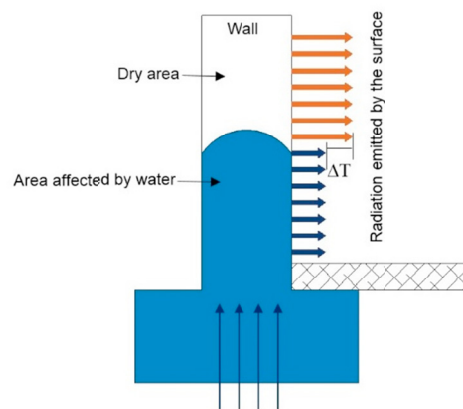
Melrinho et al. (2015) point out that areas affected by humidity have lower temperatures than dry areas because water modifies the thermal inertia for material, since water has high thermal inertia, requiring greater thermal energy for a change in temperature and, therefore, emitting less radiation than dry areas. Fig. 9 diagram demonstrates this situation for the case studied.

Fig. 9. Thermograms taken at: (a) noon and (b) 5:00 PM.
