## Return Evaluation Comments

Serial Num: 5C4-017-A

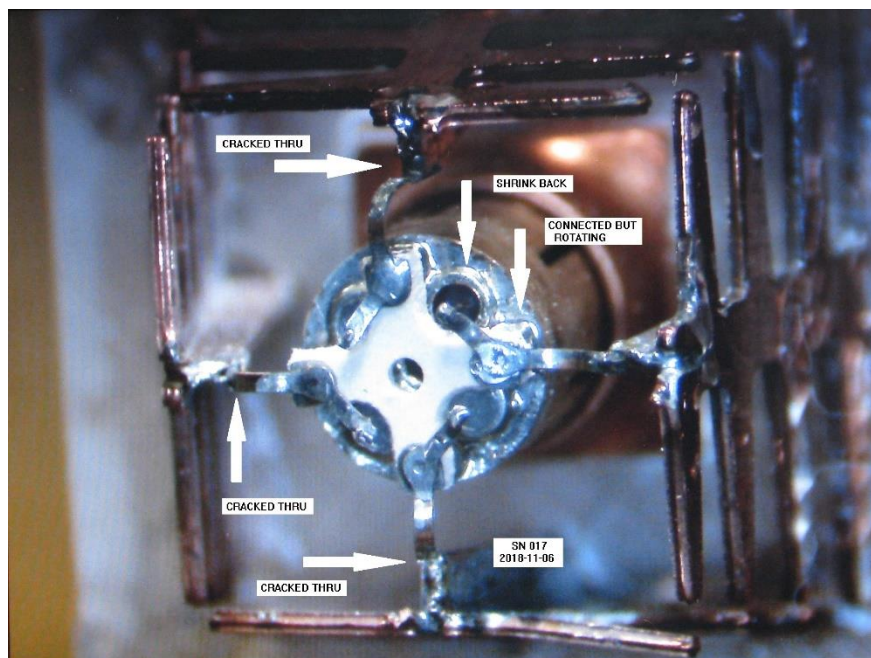
This unit operated at HCO for 1 year 5 months until returned for this evaluation. Vacuum system is good, and cryo system is good. Four tip links are broken and rexolite is abraded a little by vibration.

2018-11-06 Removed Glass to inspect Pyramid & Tip, signs of some vibration, some Rexolite dust (stand-offs), all 4 sides of the Tip have damage (data saved), no signs of moisture, inside of enclosure dusty.

Tip view, note gap to rexolite frame.
