Return Evaluation Comments

History from Data Sheet

Serial Num: 5C4-015-A

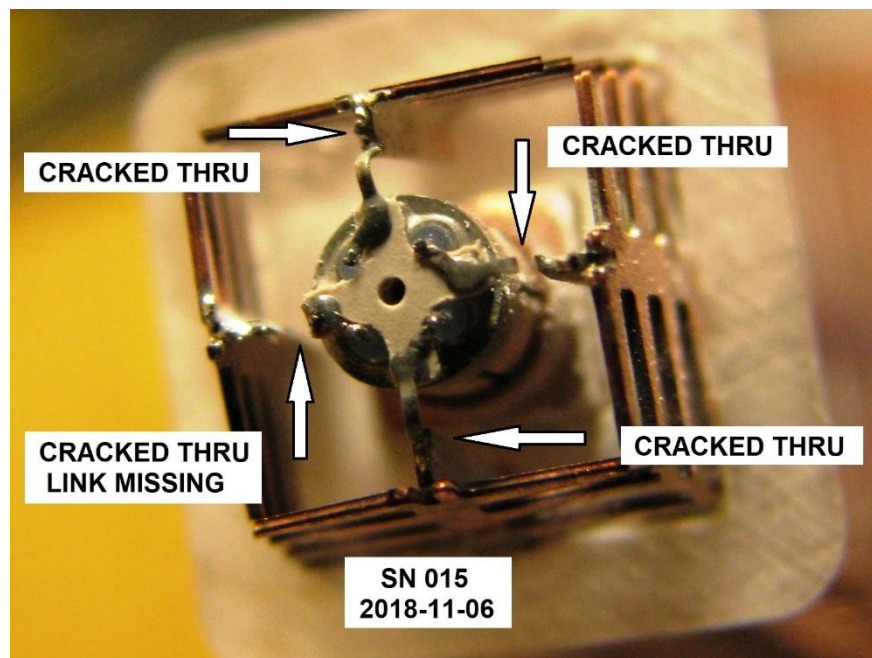
This unit was problematic during assembly with a defective bellows discovered during final testing. operated for 1 month then 1 tip link broke. It operated at HCO for 4 months and was then afflicted with another bellows failure. It was repaired on site and worked for another 1 year 5 months until returned for this evaluation. Vacuum system is good, but diaphragm pump is noisy, and cryo system is good. Four tip links are broken and rexolite is abraded by lots of vibration. This tip damage may have occurred prior to on site bellows repair.

2018-11-06 Removed Glass to inspect Pyramid & Tip, lots of vibration, lots of Rexolite dust (stand-offs), signs of moisture, all 4 sides of the Tip have damage (data saved), over heating damage to PAX case foam, air supply conduit to PAX case may have been disconnected, inside of enclosure dusty.

Tip view.
