Inspection Report

Property Address:
1018 23rd Ave. E
Seattle WA 98112

Coastline Home Inspections

Date: 3/11/2017	Time: 08:30 AM	Report ID: CHI8782
Property: 1018 23rd Ave. E Seattle WA 98112	Customer: Samuel Chien	Real Estate Professional:

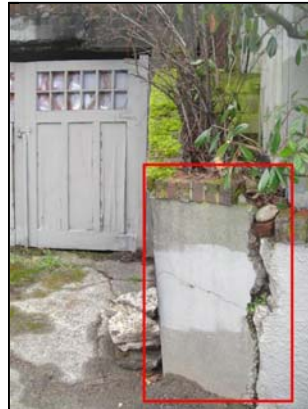
1.0 (2) Repair/Replace: Large cracks and evidence of movement were noted on the retaining wall adjacent to the vehicle door. Recommend further evaluation and repairs by a licensed contractor to prevent further movement and potential failure of the wall.

1.0 Item 4(Picture) Damaged retaining wall

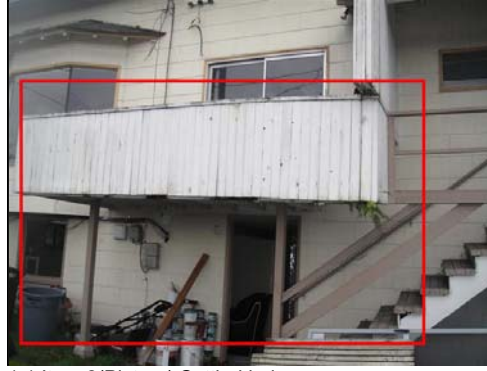
**1.1 (1) Safety: Repair/Replace:** The steps at the rear of the home are in need of replacing. Also, the balcony is leaning and wood rot was noted at several locations. The current condition of the steps and balcony is considered a safety hazard and new steps and balcony, constructed to current industry standards, should be installed to prevent potential failure or accidental injury.

1.1 Item 2(Picture) Settled balcony

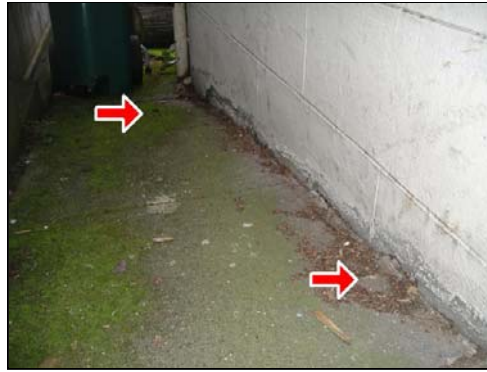
**1.1 (2) Repair/Replace:** Evidence of settling was noted on the sidewalk along the left side of the home. Recommend further evaluation and repairs by a licensed concrete contractor to prevent further settling and potential water intrusion into the basement.

1.1 Item 5(Picture) Evidence of settling

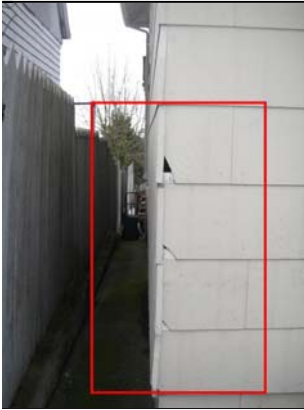
**2.0 (2) Repair/Replace:** What appeared to be asbestos tiles were installed on the exterior of the home. The asbestos in the siding poses no health danger as long as the siding is in place and not damaged. However, scraping the siding to clean prior to painting can release asbestos fibers. New siding can be installed over the existing, however removal would create a hazardous condition and proper removal and disposal would be required. At the time of inspection, considerable damage was noted to the wall cladding at many locations. It is recommended that a licensed siding contractor familiar with asbestos tiles be contacted to evaluate and make repairs as needed.

2.0 Item 1(Picture) Damaged siding

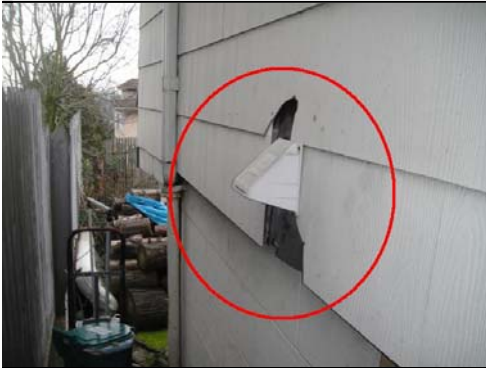
2.0 Item 10(Picture) Damaged siding

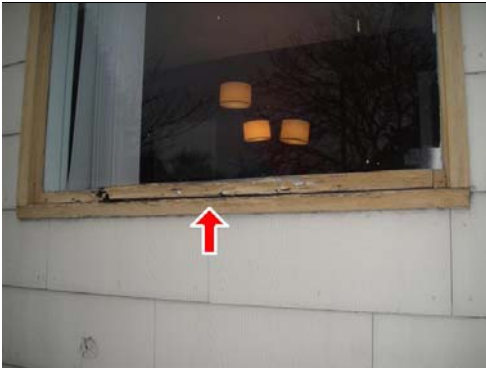
2.1 (1) Repair/Replace: Wood Destroying Organism (WDO): The paint on the windowsills was worn and wood rot was noted at several locations on the window trim/sills on the right side of the home. Recommend replacing all damaged window trim back to the point of sound lumber, prepping, priming and painting the trim to prevent future damage.

2.1 Item 3(Picture) Wood rot

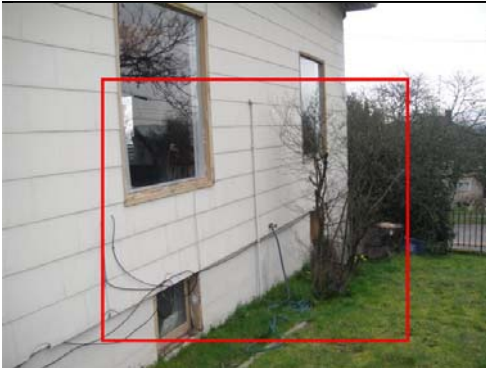
2.1 Item 5(Picture) Locations of worn paint/wood rot

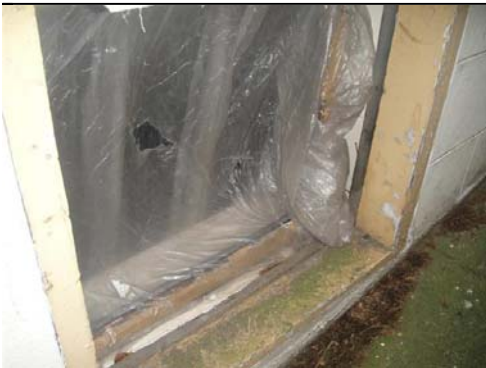
2.1 (2) Maintenance: The glass was missing on a basement window located at the front left corner of the home. Recommend installing a window at this location.

2.1 Item 6(Picture) Missing window

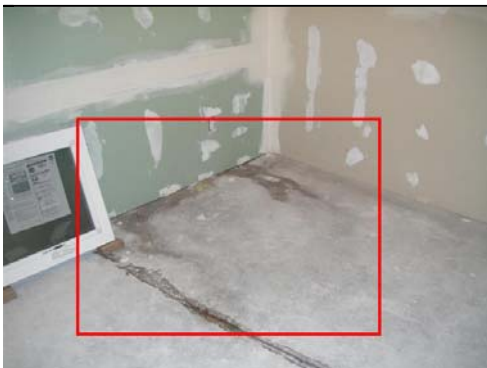
**3.0 (1) Repair/Replace:** Evidence of water intrusion was noted at several locations in the remodeled/under construction portion of the basement. Recommend contacting a licensed contractor familiar with water intrusion into crawlspaces to evaluate and make repairs as needed, potentially installing subsurface drainage around the exterior perimeter of the home to prevent future intrusion.

3.0 Item 1(Picture) Evidence of water intrusion

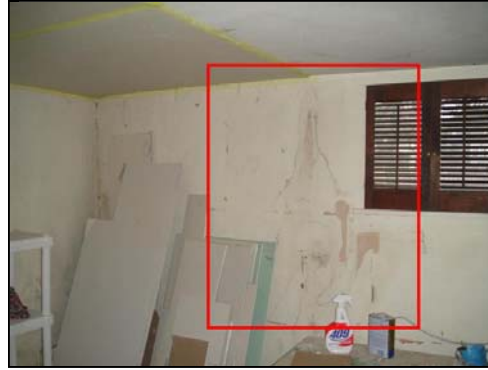
3.0 (2) Repair/Replace: Wood Destroying Organism (WDO): Evidence of water intrusion was noted into the basement along the right rear corner of the home. Water stains and what appeared to be mold growth was noted on drywall at many locations and water stains were noted on the floor. When inspected from the exterior, water is overshooting/infiltrating behind the gutters at this location and is likely contributing to the water intrusion. It is recommended that a licensed contractor familiar with water intrusion be contacted to evaluate and make repairs as needed, remediation or removing all soiled drywall to prevent future growth.

3.0 Item 4(Picture) Evidence of water intrusion

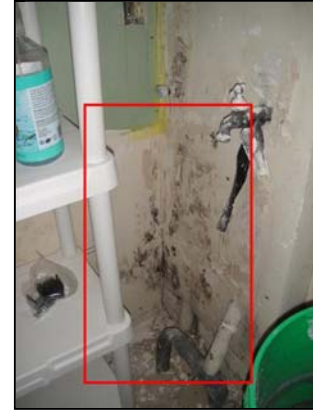
3.0 Item 5(Picture) Potential mold growth

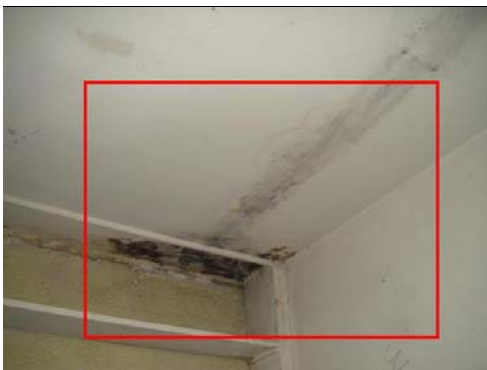
3.0 Item 6(Picture) Potential mold growth

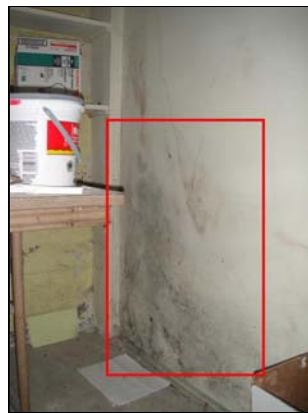
3.0 Item 7(Picture) Potential mold growth

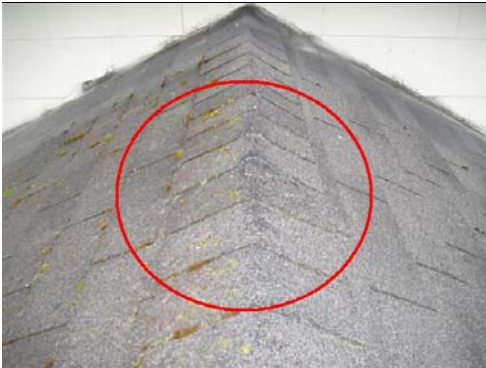
**4.0 (2) Repair/Replace:** The asphalt composition roofing material is at the end of its useful life. Missing granules, damaged shingles and improper/no visible flashing insulation was noted at many locations. It is recommended that a licensed roofing contractor evaluate and installing new roof, making repairs to all flashings and penetrations as needed to prevent further damage and potential water intrusion.

4.0 Item 8(Picture) Damaged ridge shingles

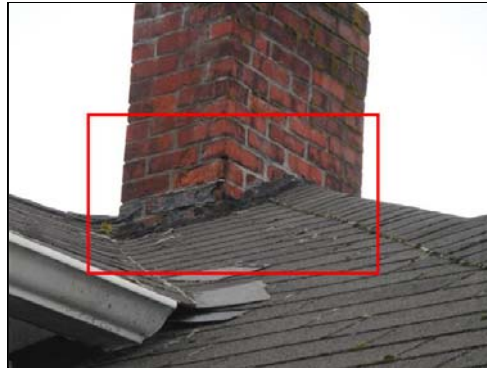
4.0 Item 9(Picture) Flashing needed

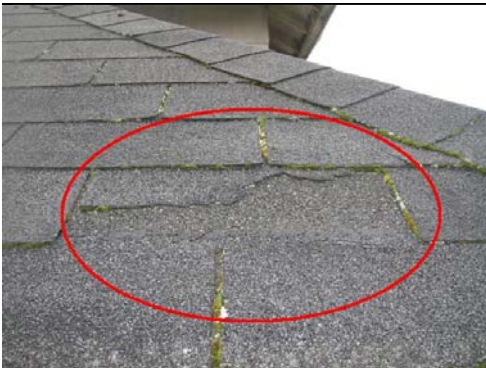
4.0 Item 10(Picture) Damaged shingle

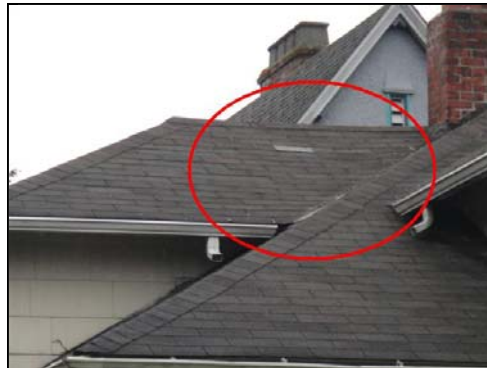
4.0 Item 11(Picture) Damaged shingles

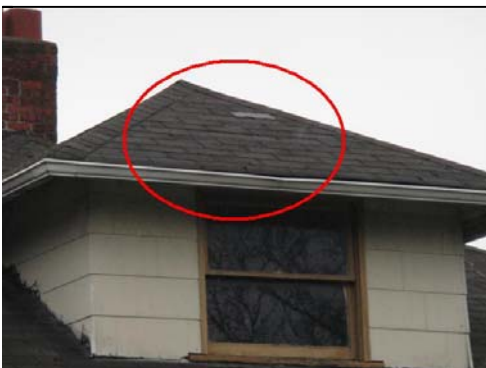
4.0 Item 12(Picture) Damaged shingles

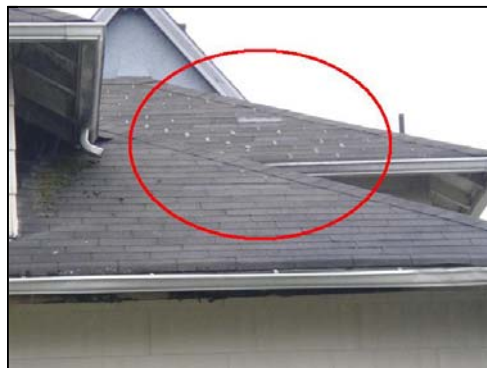
4.0 Item 13(Picture) Damaged shingles

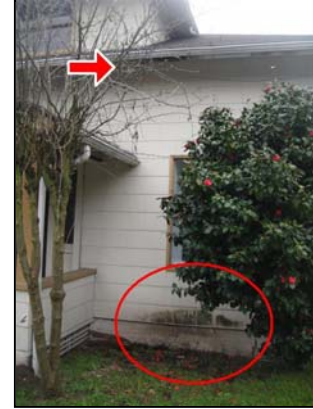
4.1 (1) Repair/Replace: Wood Destroying Organism (WDO): Overall, the gutters and downspouts are in need of replacing. Gutters were sagging, full of debris, allowing water intrusion behind the gutters and damaged at many locations. Recommend contacting a licensed gutter installation contractor to install new gutters and downspouts as needed to prevent further damage and water intrusion into the basement.

4.1 Item 3(Picture) Evidence of water splashing against home

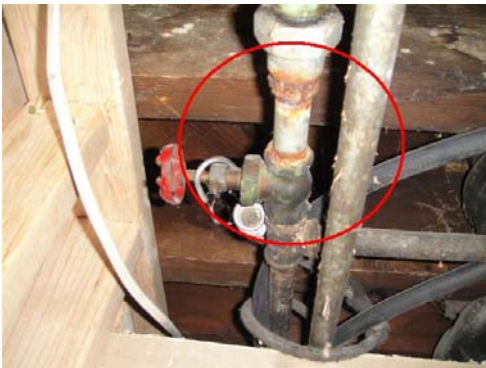
5.1 (2) Repair/Replace: Corrosion was noted between a shut off valve and galvanized pipe at the left rear corner of the basement. Recommend replacing the damaged pipe at this location to prevent potential leaks.

5.1 Item 1(Picture) Corrosion on galvanized pipe

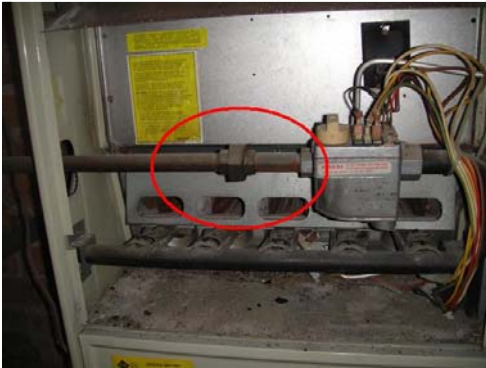
6.0 (2) Safety: A gas leak was noted on a the union located inside the furnace. Recommend repairs by a licensed HVAC technician to prevent further leaks.

6.0 Item 1(Picture) Gas leak noted

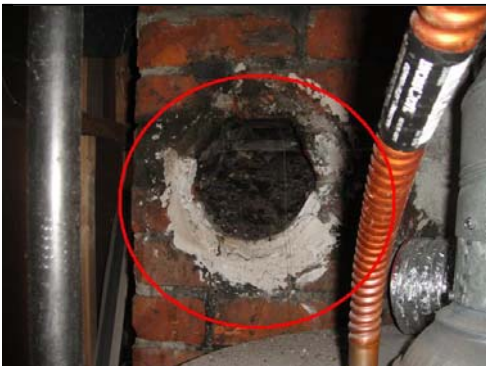
6.3 (1) Repair/Replace: An opening was noted in the chimney bricks behind the water heater. Recommend repairs to the chimney to prevent noxious gases from spilling into the basement.

6.3 Item 1(Picture) Opening in chimney

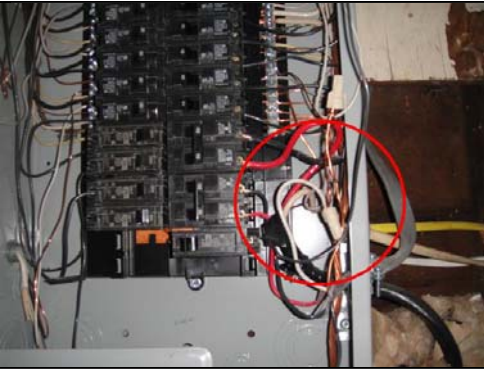
7.2 (2) **Repair/Replace:** Neutral wires of different gauges were wired nutted together and installed onto a 30 amp breaker in the electrical panel. One of the wires is not rated for 30 amps. Recommend further evaluation and repairs by a licensed electrician.

7.2 Item 2(Picture) Improper wire size

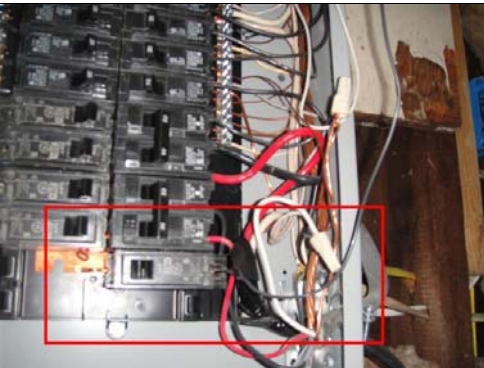
7.2 (3) **Repair/Replace:** A 14 gauge wire was installed on a 20 amp breaker in the main panel. A 20 amp breaker requires a minimum of a 12 gauge wire to prevent overheating of the wire. Recommend either replacement of the 20 amp breaker with a 15 amp, or replacement of the 14 gauge wire with a 12 gauge. Recommend evaluation and repairs by a licensed electrical contractor.

7.2 Item 3(Picture) Improper wire size

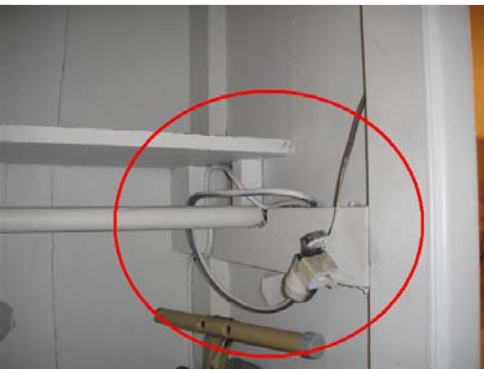
7.2 (4) **Safety:** Electrical cords and exposed wiring was noted in the entry closet. Recommend removal of the extension cord/wiring, installing electrical at this location according to current industry standards by a licensed electrician.

7.2 Item 4(Picture) Hanging electrical in entry closet

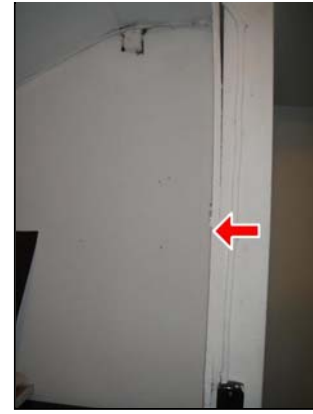
7.2 (5) Maintenance: Romex is installed subject to damage at many locations in the home. When electrical is installed beneath 8 feet, it should be in conduit to prevent accidental damage.

7.2 Item 7(Picture) Electrical subject to damage

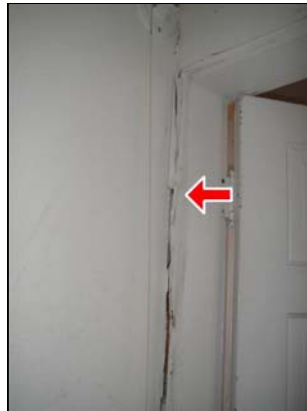
7.2 Item 9(Picture) Electrical subject to damage

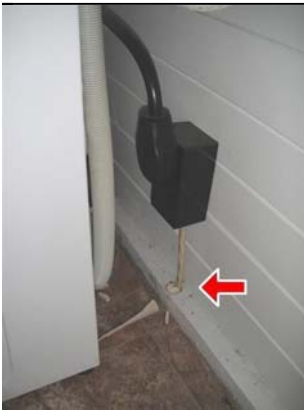
7.2 Item 11(Picture) Electrical subject to damage

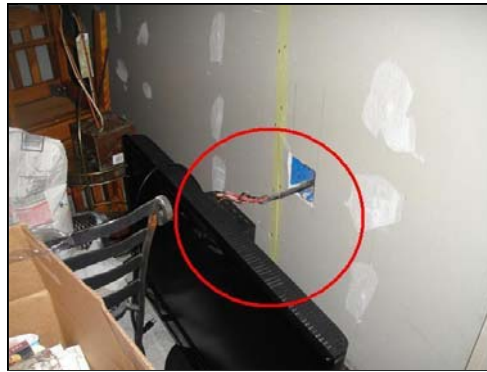
7.3 Item 2(Picture) Exposed electrical wires

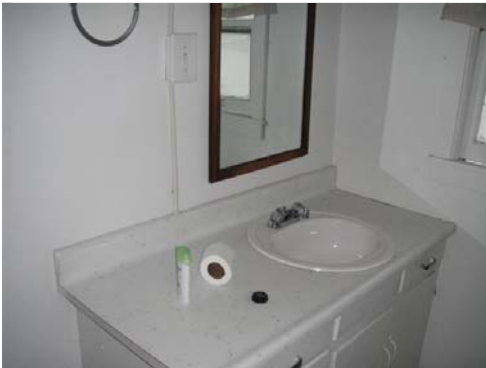
**7.3 (3) Repair/Replace:** Recommend the installation of a GFCI receptacle located in the upstairs bathroom adjacent to the sink by a licensed electrician.

7.3 Item 5(Picture) GFCI protected receptacle needed

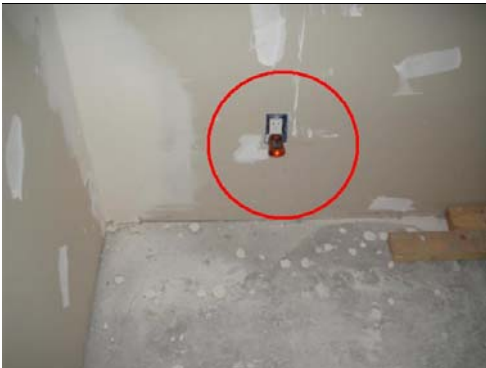
**7.4 (1) Safety:** When tested, the following outlets were not grounded: Several in the basement and home. It appears the original two pronged receptacles have been replaced with three pronged, however no ground wire was installed at this receptacles. Without grounded outlets, there is a potential for shock at these locations. Recommend replacing the three pronged outlets with a Ground Fault Circuit Interrupter (GFCI) outlets or installing a ground wire to the subject outlets. Recommend evaluation and repairs by a licensed electrical contractor.

7.4 Item 1(Picture) No ground protection

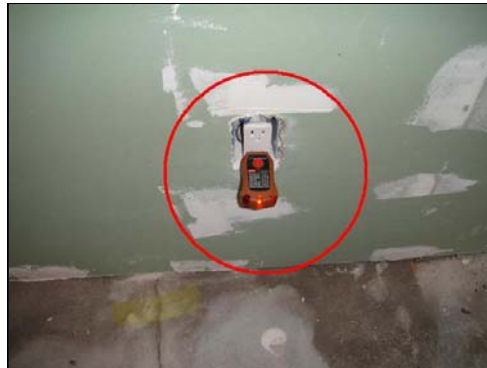
7.4 Item 2(Picture) No ground protection

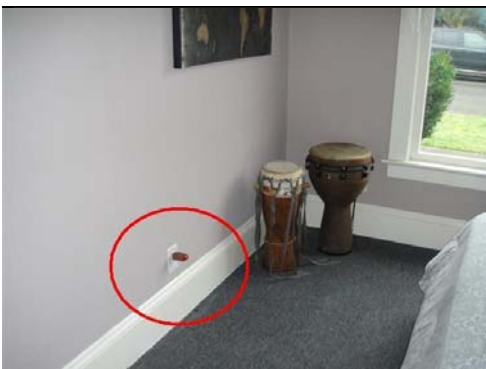
7.4 Item 3(Picture) No ground protection

**7.4 (2) Safety:** Two pronged receptacles were noted at many locations in the home. Two pronged receptacles are considered obsolete and do not offer ground protection. Recommend either installing GFCI (Ground Fault Circuit Interrupters) or installing three pronged receptacles and adding a ground wire to these locations.

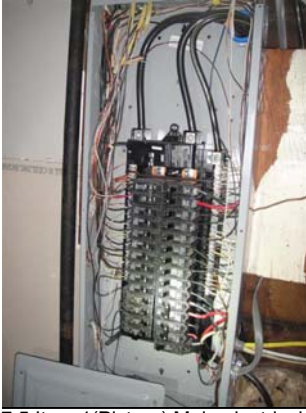
7.5 Item 1(Picture) Main electrical panel

7.5 The main electrical panel is located in the basement.

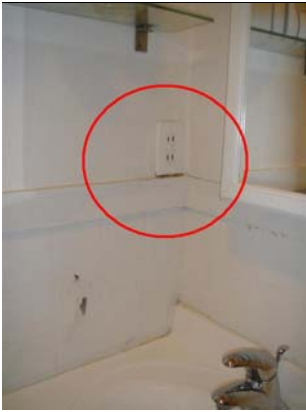
7.6 Item 1(Picture) No ground or GFCI protection

**7.6 (1) Safety/ Repair/Replace:** The following receptacles were not ground fault circuit interrupter (GFCI) protected: one in the main floor bathroom. GFCI's are currently required at all locations within 6' of a water source including the garage and exterior. GFCI's are intended to protect someone from electrical shock. This home was built prior to the requirement of GFCI outlets in some locations, however it is recommended that GFCI's be installed by a licensed electrical contractor as an upgrade.

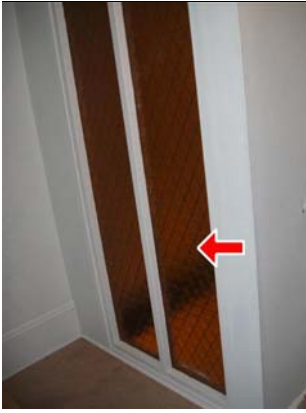
8.1 Item 2(Picture) Plexiglas wall

**8.1 (2) Safety:** Plexiglass of been installed from floor to ceiling at one location in an upstairs bedroom. The Plexiglass is installed above the stairwell creating a fall hazard. Recommend repairs by a licensed contractor to prevent potential injury should someone fall through the Plexiglass.

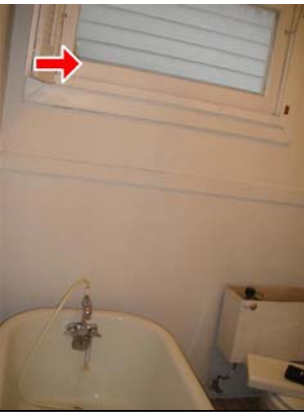
8.7 Item 2(Picture) Non-tempered glass

**8.7 (3) Safety:** The window located above the main floor bathroom tub was not tempered glass. Under current industry standards, when a window is located within 60" of the base of a tub it is required that the glass of the window be tempered to prevent injury in the event of breakage. Recommend replacing the glass with tempered glass as an upgrade.

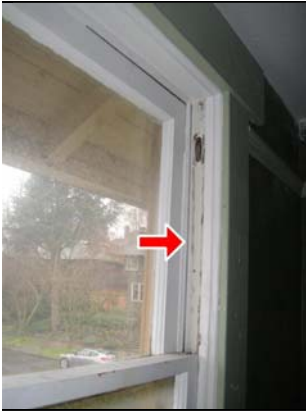
8.7 Item 4(Picture) Sash cord missing

8.7 (5) **Repair/Replace:** The sash cords were damaged/missing on windows located in bedrooms 2 and 3 upstairs. Recommend repairs to the windows by a qualified window installation company.

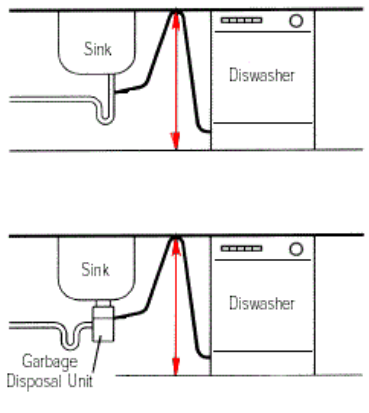
10.5 Item 2(Picture) No high loop installed

10.5 Maintenance: No air gap or high loop was noted on the dishwasher drain line. A high loop or air gap prevents a back flow into the dishwasher should the sink become clogged. Some dishwashers have a built in check valve to prevent back flow. Recommend rerouting the drain line above the bottom of the sink, and then into the garbage disposal, consulting the manufacturers' installation instructions to determine if a check valve is installed on the unit.

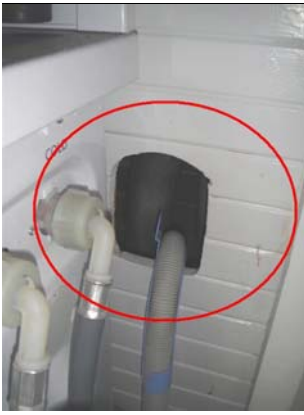
10.8 Item 2(Picture) No visible standpipe

**10.8 (2) Repair/Replace:** No standpipe was visible for the washing machine discharge pipe. Recommend the installation of a a standpipe is visible by a licensed plumbing contractor.

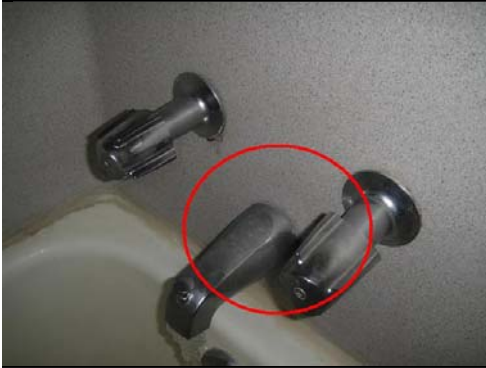
11.3.B Item 1(Picture) Silicone needed

11.3.B (1) Maintenance: Recommend installing silicone between the tub spout and the tub enclosure to prevent moisture intrusion.
