AR# 117422

Unplanned Shutdown due to High Distributor Plate DP

Oct 2024 case

Abnormality Report

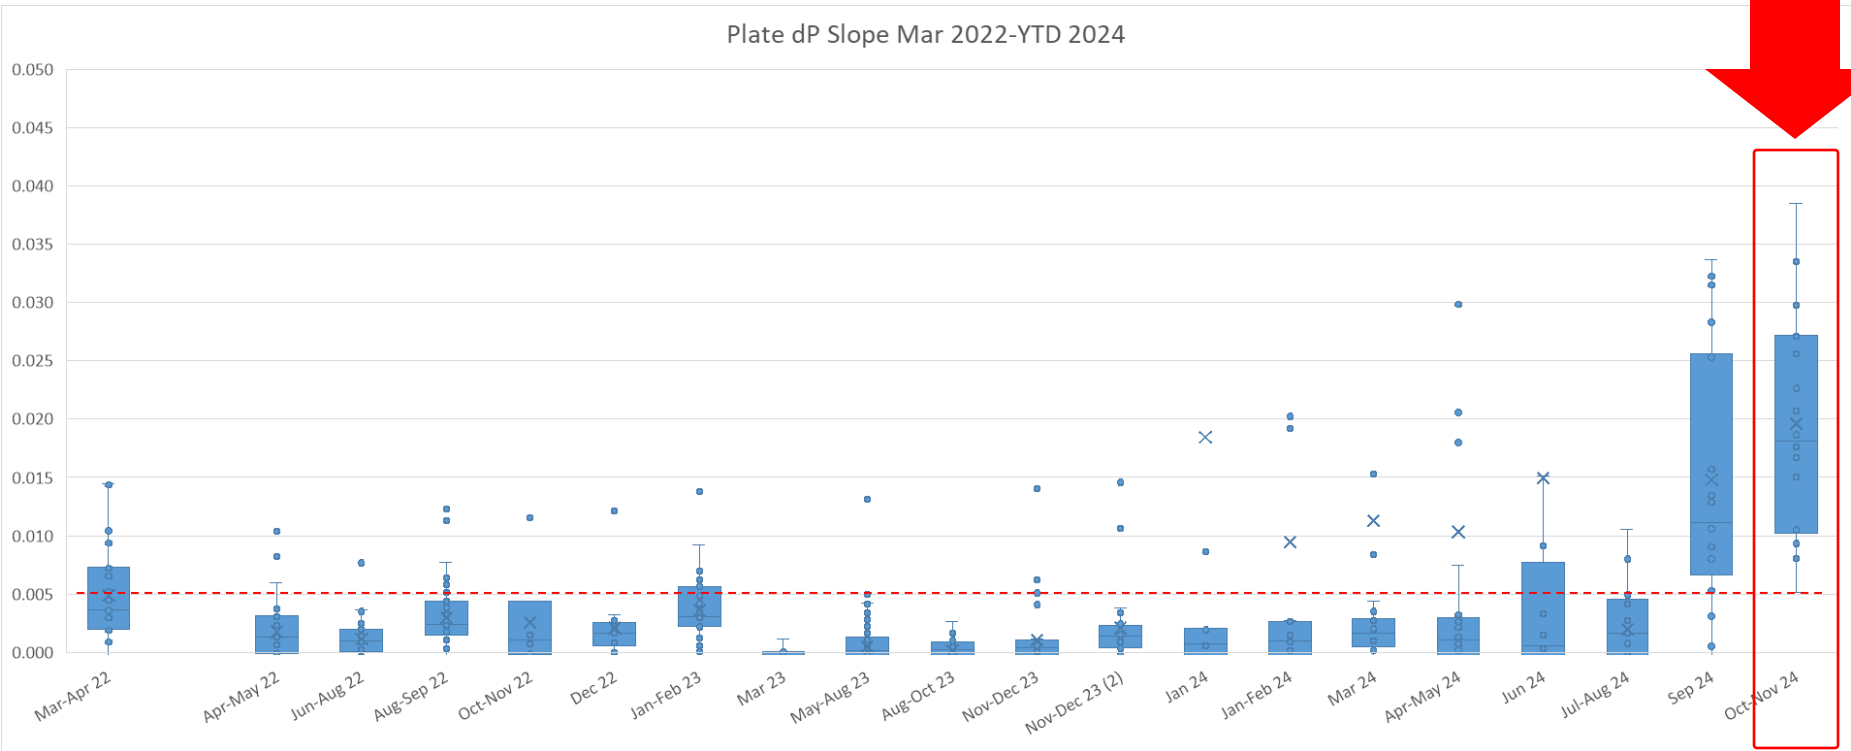
Past Performance Analysis (Data Historical, NC Evidence)

- 1st case in 2024 due to carryover refractory ball and unstable reactions due to catalyst feeder problems
- 2nd case in 2024 is suspected also due to unstable reactions impact of catalyst feeder problems and high initial dP

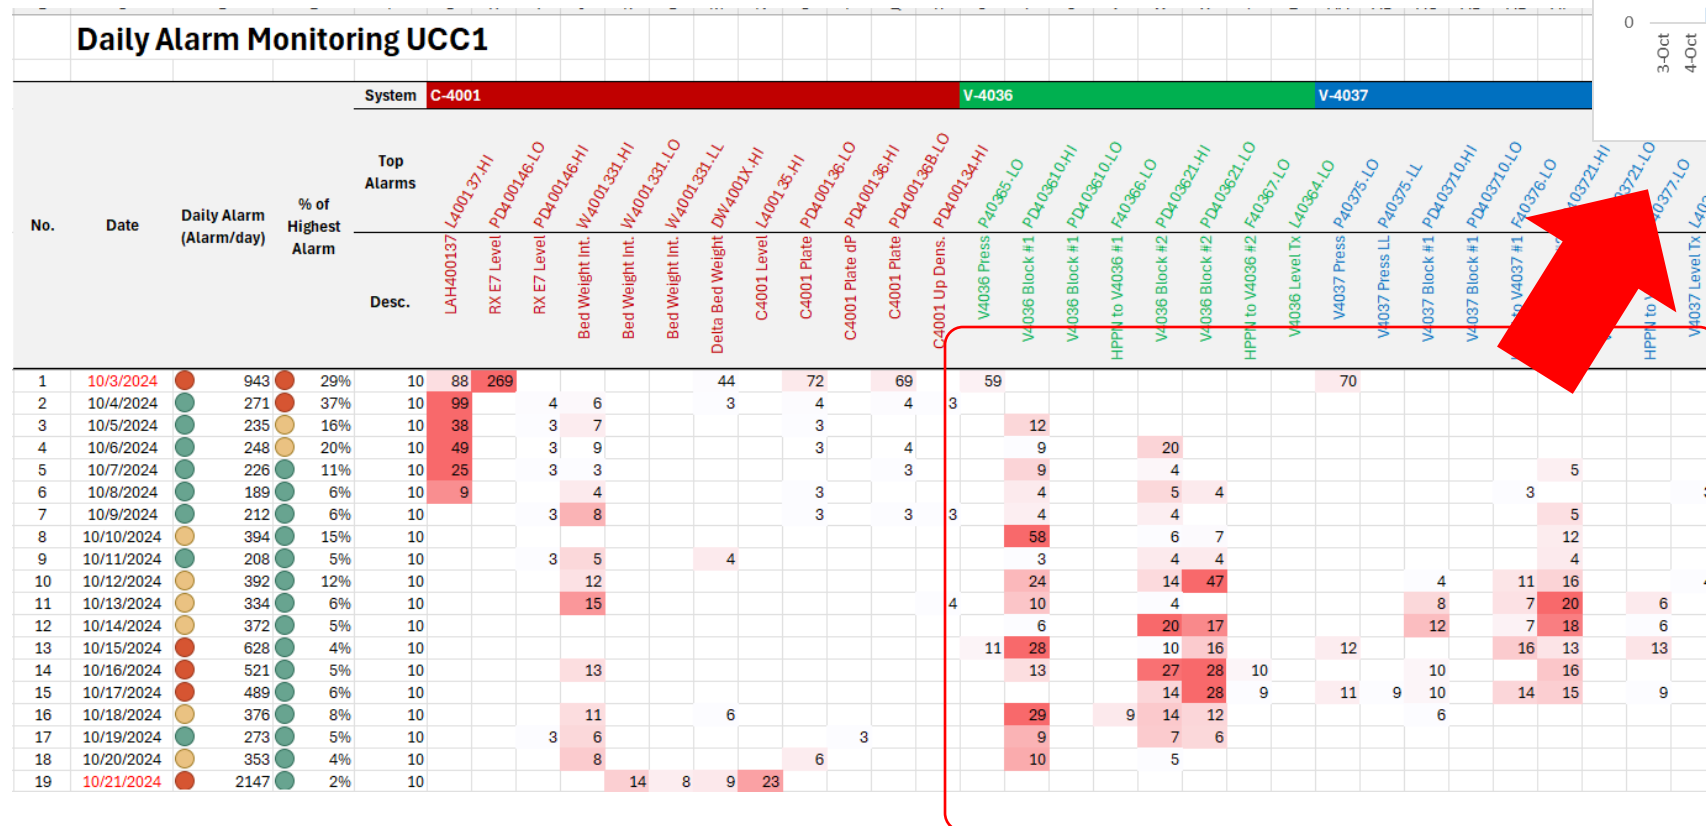
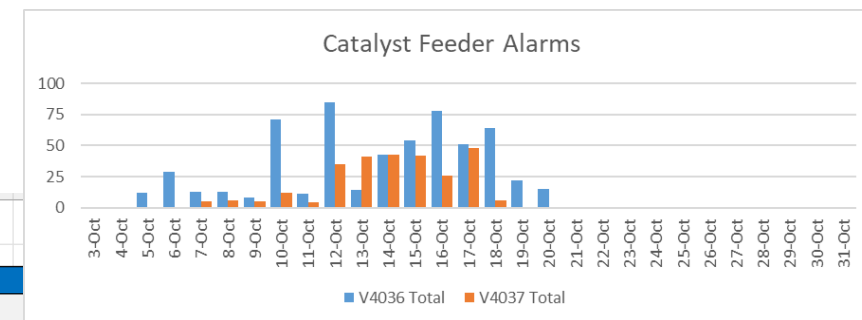
Historical Alarm from Catalyst Feeder

- Historical alarm records in Oct 2024 shows high frequency of catalyst feeder problems
- Below 25 alarm/day on first week
- 25-75 alarms/day afterwards

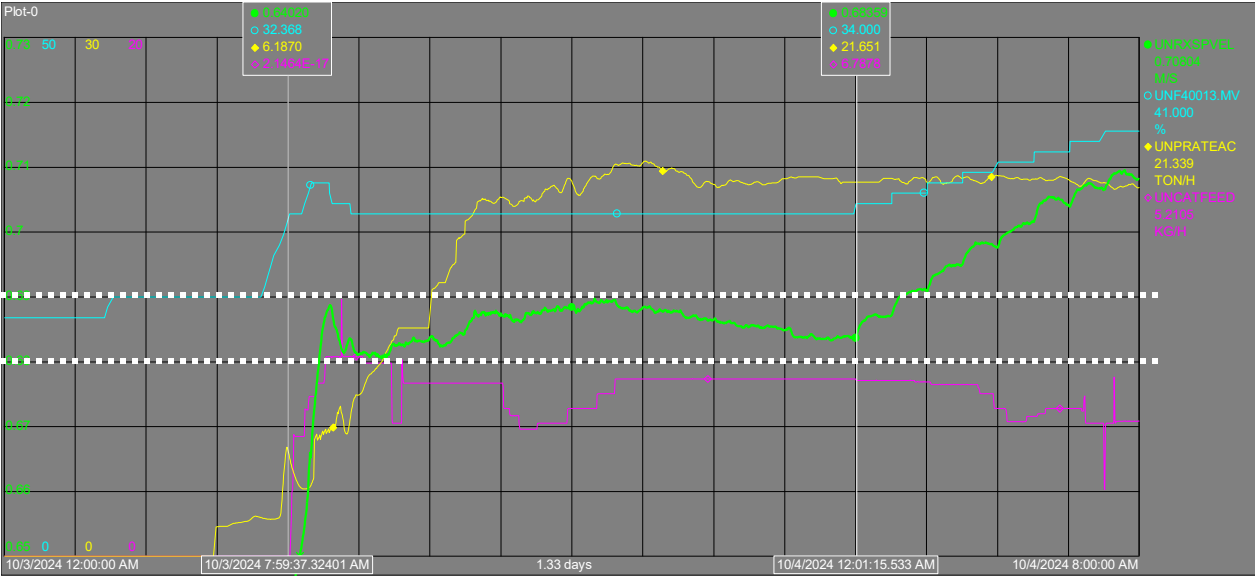
Cycle	Plate DP slope	SGV startup
27	0.0003	0.682
27B	0.0007	0.687
27C	0.0017	0.686
27D	0.0015	0.680
28	0.0001	0.678
28B	0.0015	0.686
28C	0.0032	0.679
28C(2)	0.0186	0.686
29	0.0195	0.684

- Too high SGV during startup period could lead to carryover startup fines to cycle gas and deposit at distributor plate
- SGV during startup was maintained **on range** 0.680-0.690 m/s.

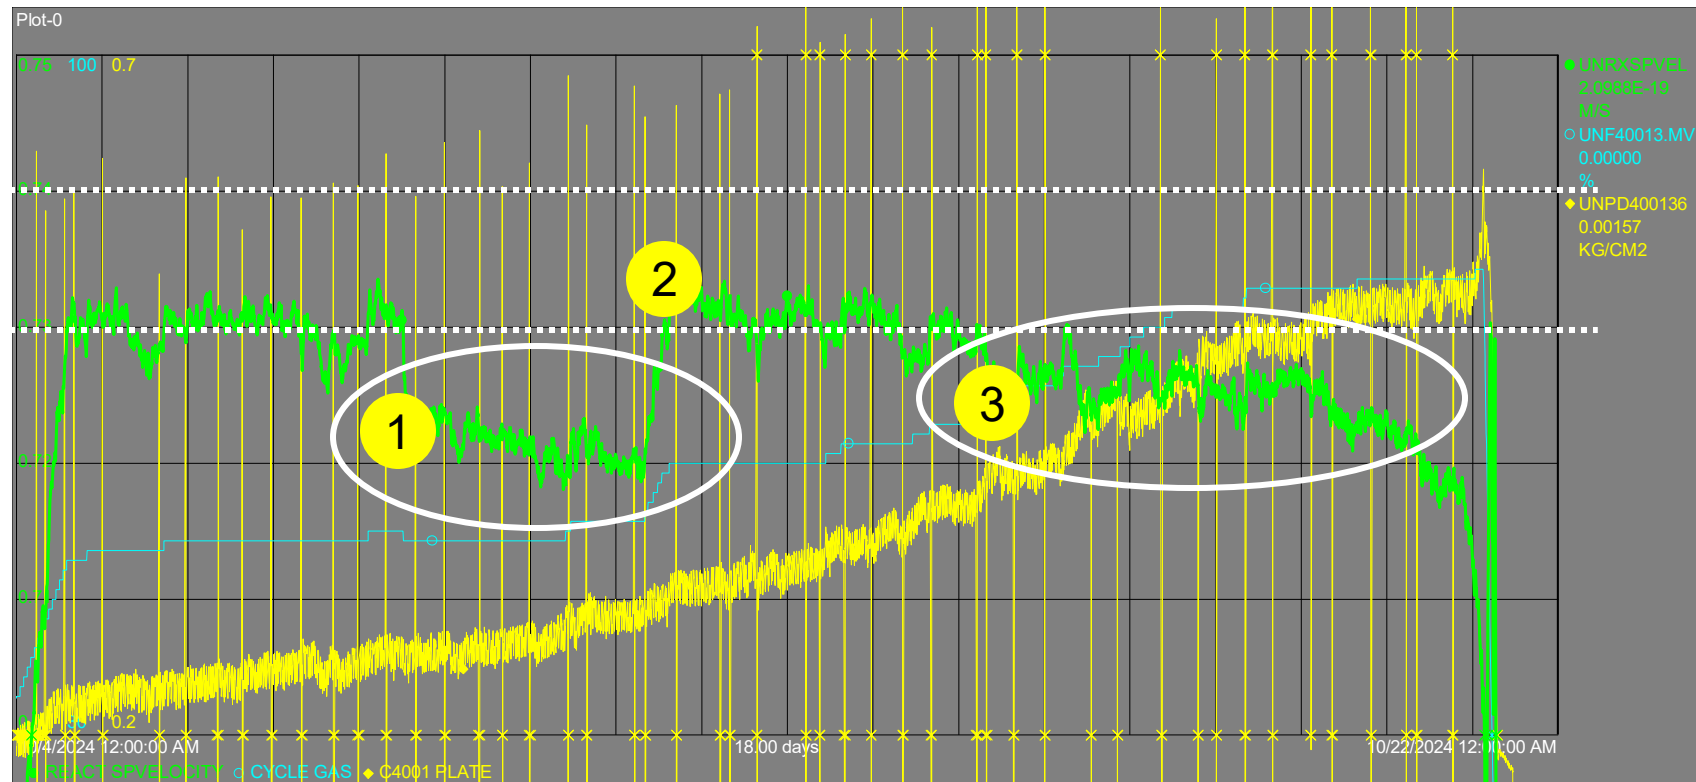
P4. SGV normal running out of range (>0.740 m/s or <0.730 m/s)

NG

- SGV is standardized at range 0.730-0.740 m/s
- Too high SGV increases potential resin/fines carryover
- Too low SGV reduces lifting force to allow carryover resin/fines re-enter the Reactor bed and doesn't attach/stick at dist. plate holes
- On 8/10 at 01 p.m. SGV was reduced to 0.720 m/s for troubleshoot high plate dP increment rate, but it didn't make significant result (1)
- On 11/10 at 3 p.m. SGV was increased back to 0.730 m/s (2)
- On 15/10, at plate dP 0.36 ksc, SGV started continuously decreased even though IGV continuously increased (3)
- This made plate dP increment rate became higher due to more polymer growing at dist. plate at low SGV

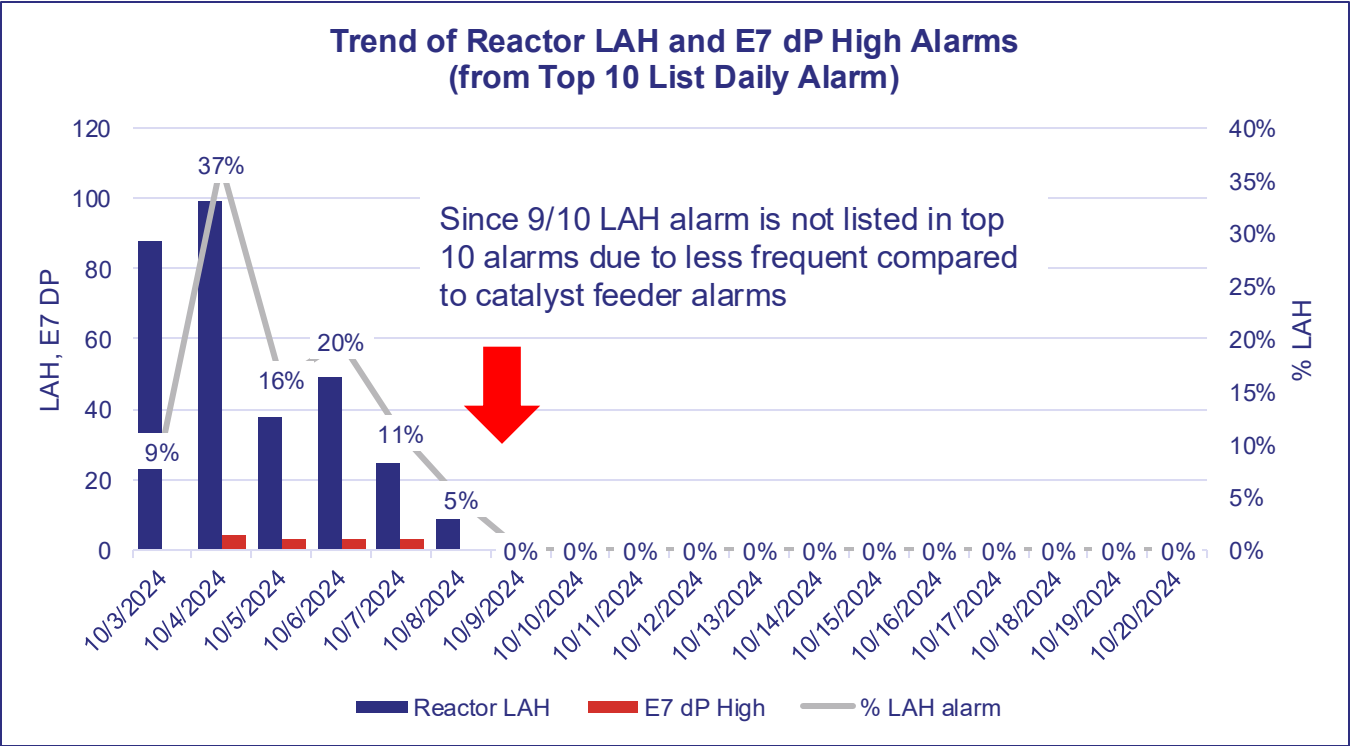
X.4.1.2.1. No clear information to deal with LAH alarm

NG

- Many alarms come from LAH400137 during startup until several days after startup up to 37% of total alarm on 4/10
- This impact to SGV adjustment on 8/10
- After SGV adjustment, LAH alarm disappeared from top 10 list alarm (top 10 list dominated by alarms from catalyst feeder problems)
- Even though LAH alarm disappeared from top 10, but plate dP increment rate still high
- OPR ask MTN to check LAH instrument on shutdown. Result: **LAH instrument is in good condition**
- So, the adjustment was caused by wrong interpretation of LAH alarm due to **no clear (limited) information to deal with LAH alarm**
- LAH alarm is not representative enough to represent actual condition in the reactor (see next slide)

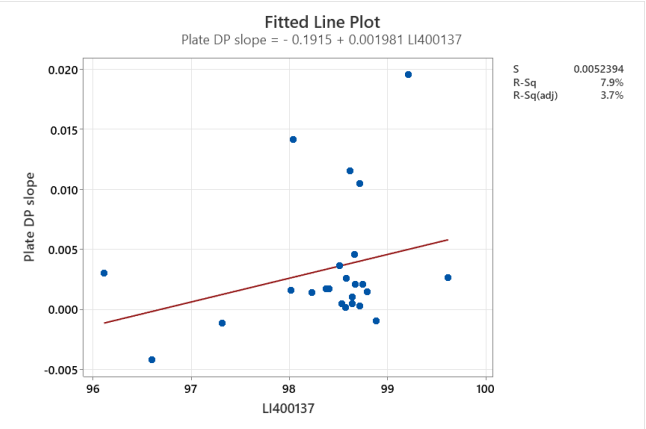
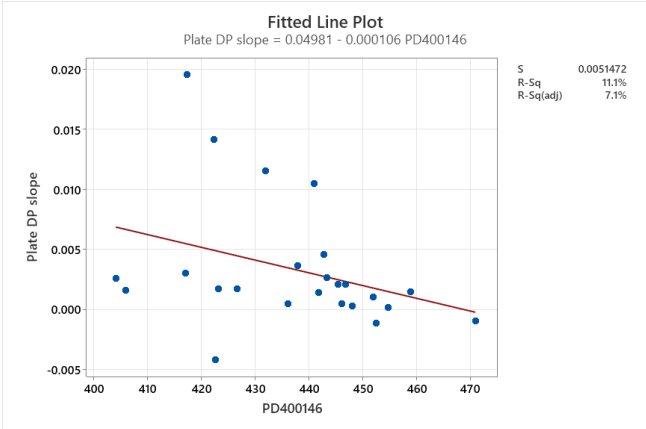
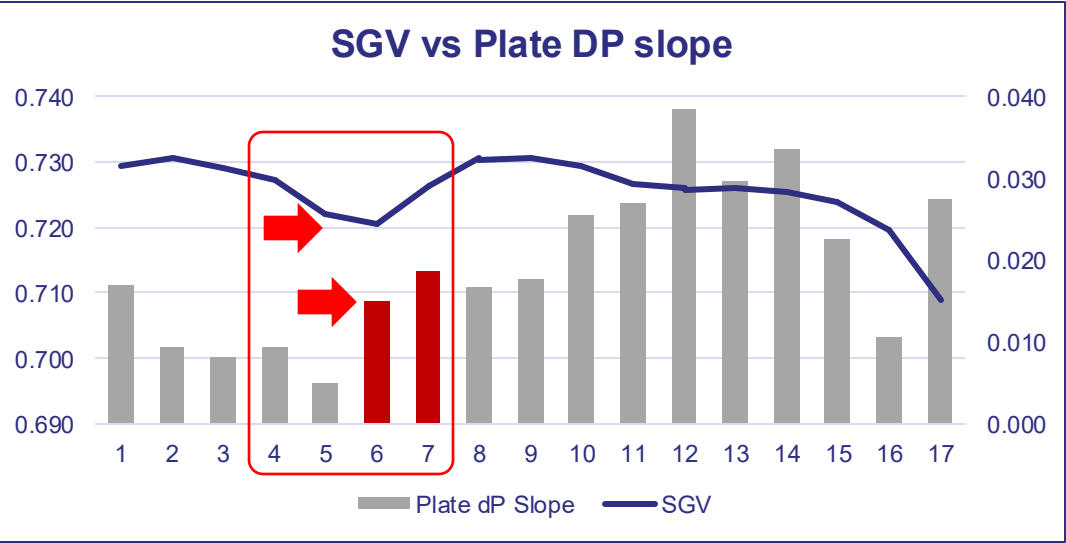
LI400137 vs PD400146: No one accurately indicating carryover that impact to plate DP increment rate

- Historical data from Oct 2021-Oct 2024 shows that LI400137 and PD400146 didn't represent as causes of high plate dP increment rate
- P-values of both fitted line plot show >0.05, means that the correlation aren't significant to plate dP increment rate
- So, it isn't always necessary to adjust the SGV when the LAH alarm occurs

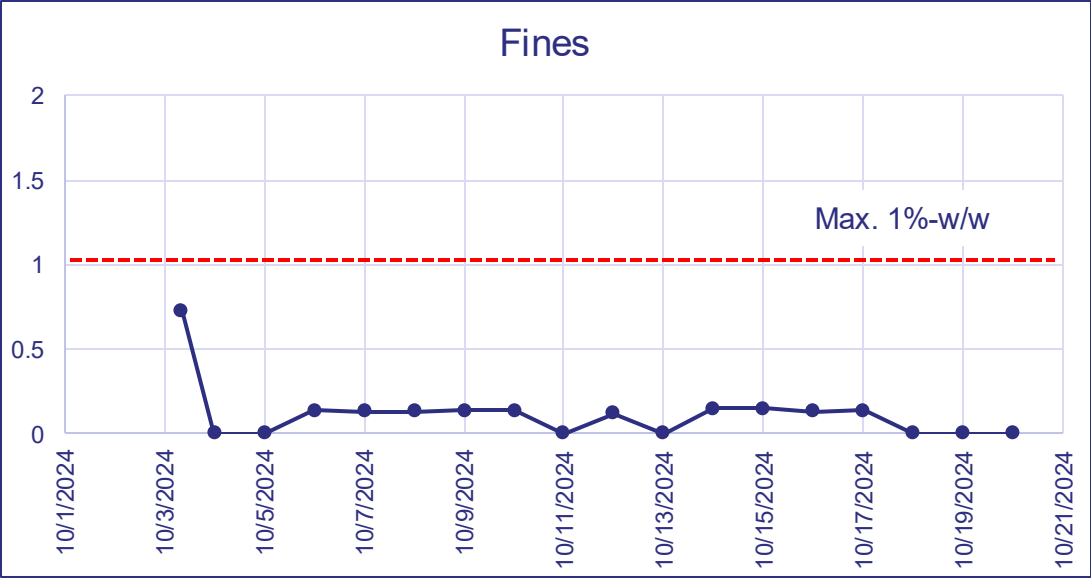
P5. Fines content too high (>1%)

G

- Fines content during Oct 3rd-21st, was normal below 1%
- In normal running, max. fines content 0.14%-w/w
- High dist. plate dP increment rate isn't caused by too high fines content

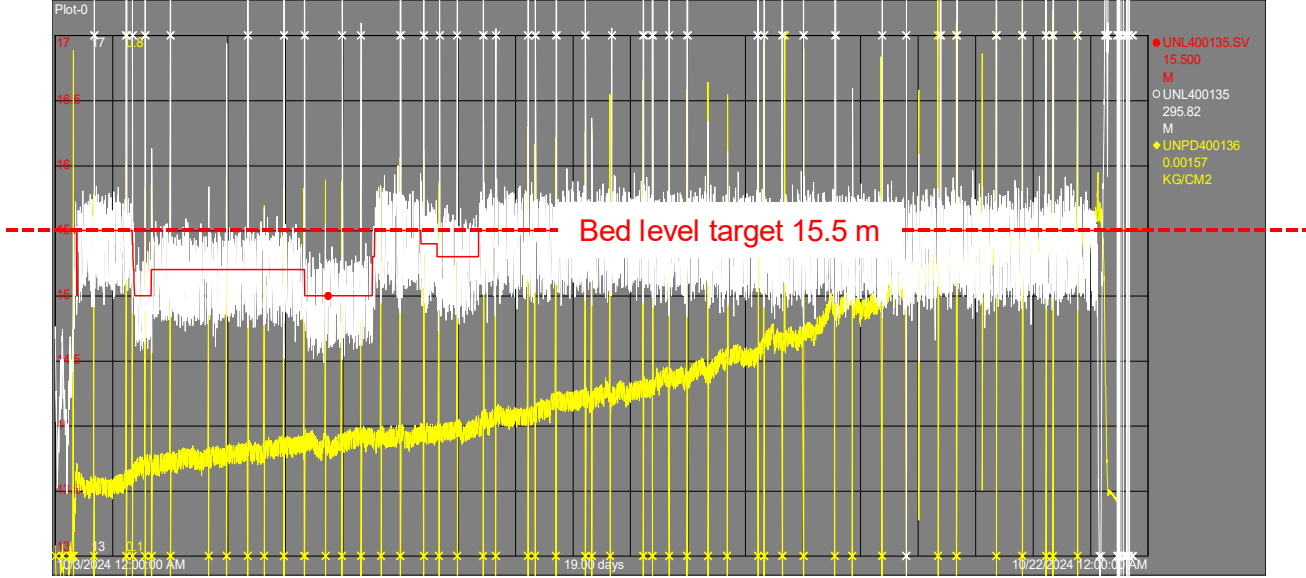
P6. Bed level too high (>15.5 m)

G

- Bed level during Oct 3rd-21st, was below 15.5 m (setting at 15.5 m)
- High dist. plate dP increment rate isn't caused by too high bed level

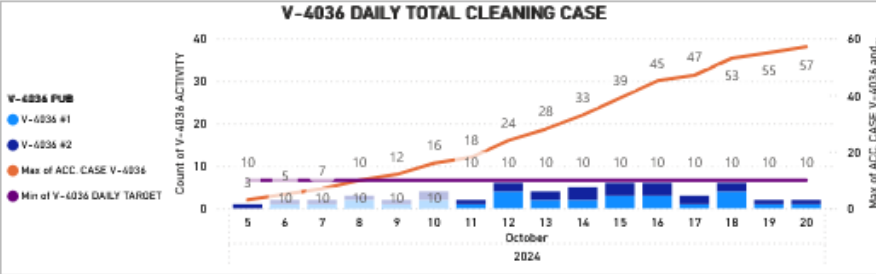
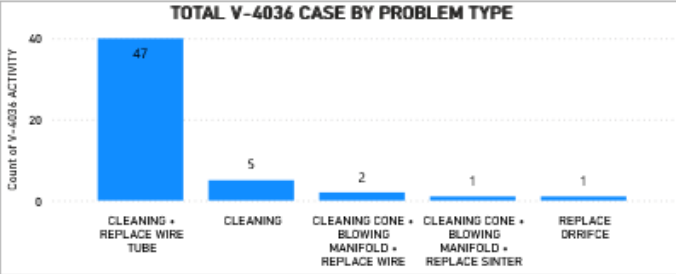
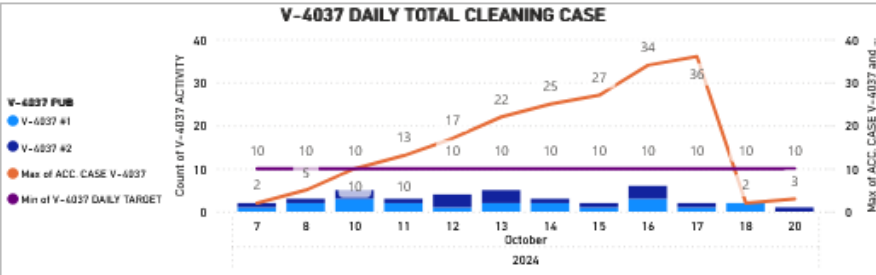
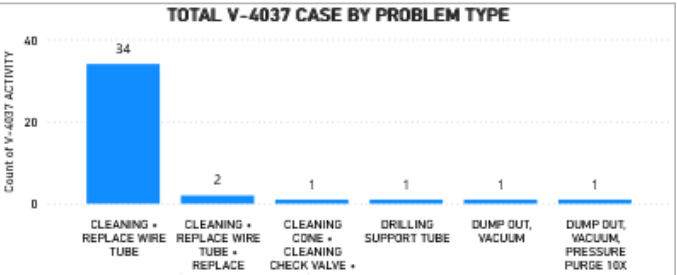
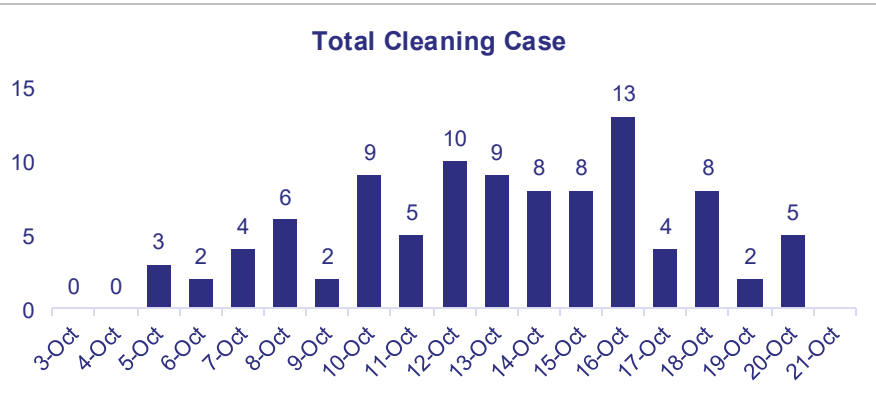
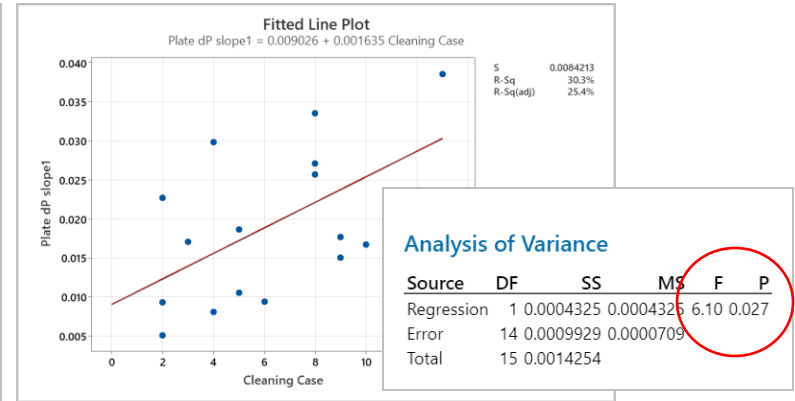
X7.1. Bad catalyst (from supply)

NG

- There were many cases of catalyst feeder unstable feeding in both V-4036 and V-4037 up to 13 cases per day
- The most activity done to tackle the unstable feeding issue is cleaning and replace wire tube (or catalyst tube)
- Correlation analysis using fitted line plot shows significant correlation between number of catalyst feeder cases with the dist. plate dP daily increment rate (p-value 0.027)
- Higher frequency of catalyst feeder cases leading to higher increment rate of distributor plate dP
- Currently it was suspected due to bad catalyst quality (from supply) → still under communication with licensor to check remaining unused catalyst cylinder

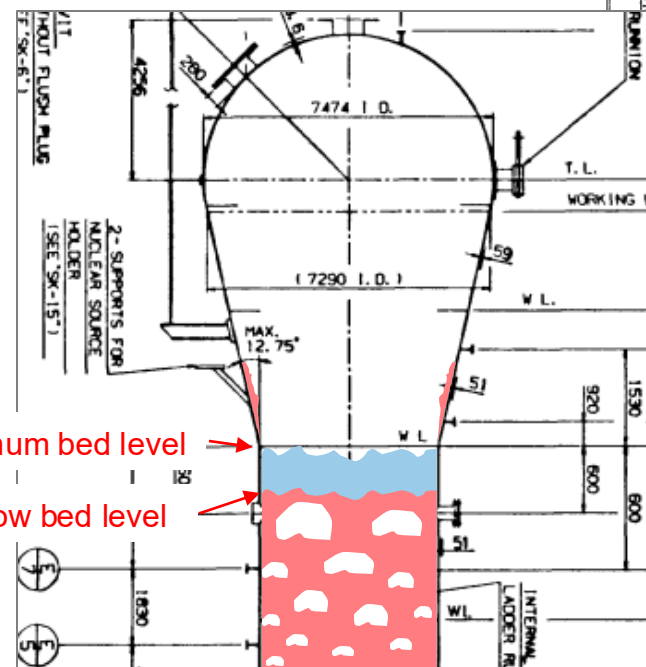
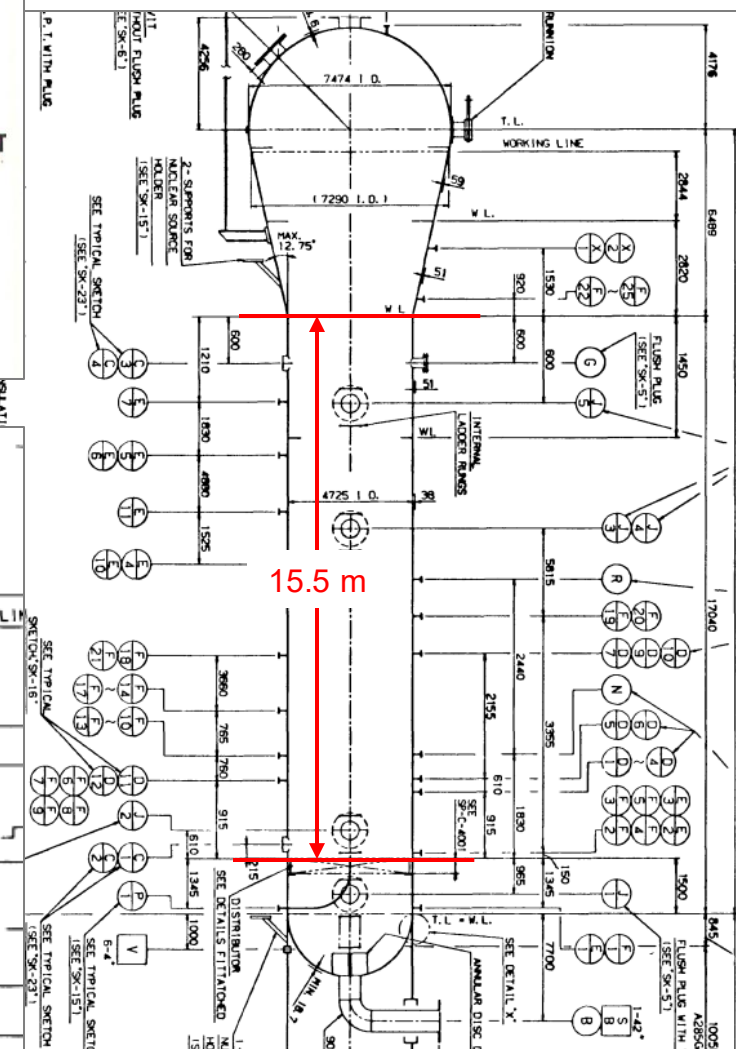
X9.1. Improper cleaning tools NG

X9.2. Improper inspection method NG

- Initial Plate dP data taken at similar SGV (0.730-0.735 m/s) and C2PP (14-16 ksca) shows that initial dP at startup October 2024 is relatively higher compared to previous
- High initial plate dP indicates there was remaining polymer layer in the holes which also impact to higher roughness of hole inner surface
- Higher roughness allows carryover fine particles to attach more easily during flowing through the holes
- Attached fine particles that contain TEAL will catalyze further polymerization during normal running and caused dist. plate dP increase faster (plug samples contains high Al content)
- This condition is due to **improper cleaning method** by MTN and **improper inspection method** by Operation (not thoroughly inspected)

4	Improper inspection method	Inspect thoroughly by more man powers	Oct 25, 2024	Mahadhika Habibi	CLOSED

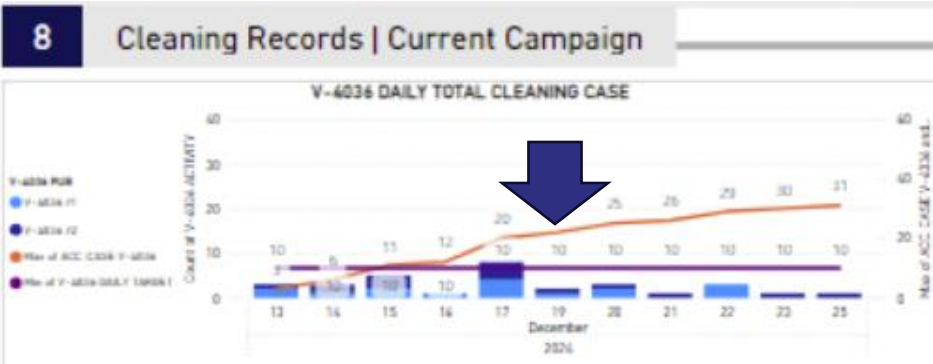
- After implementing new procedure, catalyst feeder problems/cleaning cases significantly reduced

Title	Guideline for Catalyst Feeder Operation after Overhaul		
SOR Request date:	SOR Start date:	SOR Finish date:	
26-Dec-24	26-Dec-24	W2 Jan 2025	
Description of Request:		Result of Hazard Identification (HIRAD):	
Follow this guideline as trial for Catalyst Feeder reliability improvement.		<div><input checked="" type="checkbox"/> Need to Conduct Process Hazard Analysis</div> <div><input type="checkbox"/> Need to Conduct Job Hazard Analysis (JOHAN) or HIRADC</div>	
Instruction of Request by including Caution, Risk and Troubleshooting Instruction			
<div>Latar Belakang</div> <p>The catalyst feeder has important role to maintain reaction stability in UCC1 Reactor. Since TAM 2024, UCC1 Operation team has struggled with many problems in the catalyst feeder, either in V-4036 or V-4037. Both feeders shows similar problems such as frequent plugging at catalyst tube, catalyst blocking the PUB cone, or even worse such as plugged PUB holes and plugged screen. Almost all problems lead to the most suspected cause which is poor quality of the catalyst.</p> <p>To mitigate this condition, lets do some new procedure to treat the Catalyst Feeder after overhaul (fresh) in order to make it has longer operation and more reliable.</p> <div>Procedure:</div> <div><div>1. Charge the catalyst to the fresh catalyst feeder as per normal procedure.</div><div>2. Still at low pressure, hold the catalyst in the feeder for 1 hour to dissipate static charge in the catalyst. Too high static charge is suspected cause the catalyst attach to the wall of reservoir or agglomerate and later will fall and packed the screen.</div><div>3. If before 1 hour, the running feeder has problem and need to be backed up, fresh feeder can be started after at least 15 minutes of holding time.</div><div>4. Start the new (fresh) catalyst feeder with speed of 200 rpm and keep for 4 hours, then increase to 300 rpm and keep for 4 hours, then increase to 400 rpm and keep for 4 hours. Another feeder speed will be adjusted to maintain the reaction at targetted rate (max. 1000 rpm). The fresh catalyst feeder speed can be adjusted as normal operation afterwards. For emergency condition as stated in point 3, duration for keep at 200, 300, or 400 rpm can be shorten to at least 15 minutes.</div><div>5. Close monitor performance and record abnormalities as usual.</div></div> <div>
