| | | AMSTED RAIL Reporte de Ingenieria de Servicio / Service Engineer Report | | Doc No. | |
| Folio: | 2022-04-12-GUN-CON-SIDE FRAME 528E-108 - NEGATIVE IND | | | | |
| Customer: | GUN-CONCARRIL-P2 | | Part Num: | 528E-108 | |
| Description: | INDICACION NEGATIVA - RETENEDOR DE RESORTE | | QTTY INSPECTED: | 1 | |

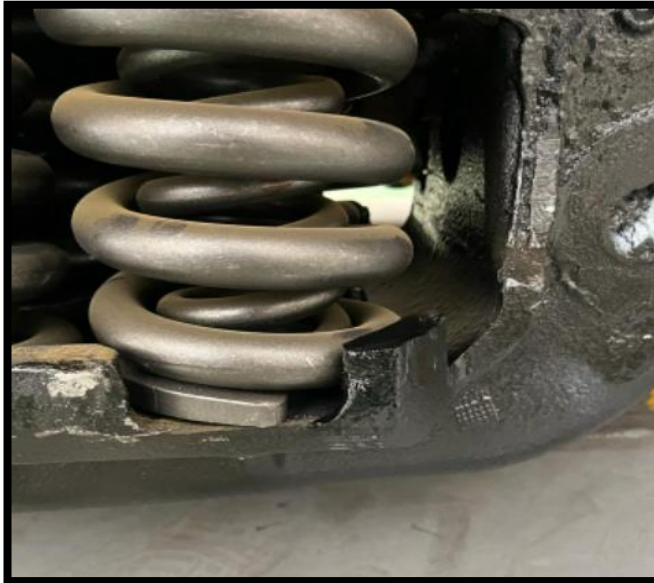
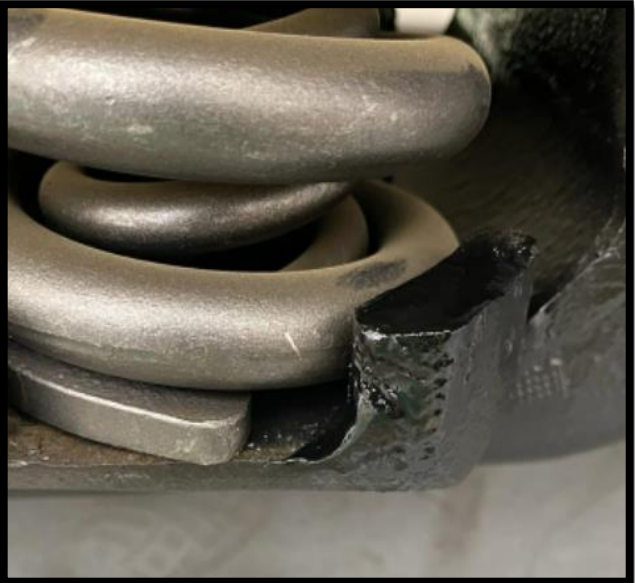
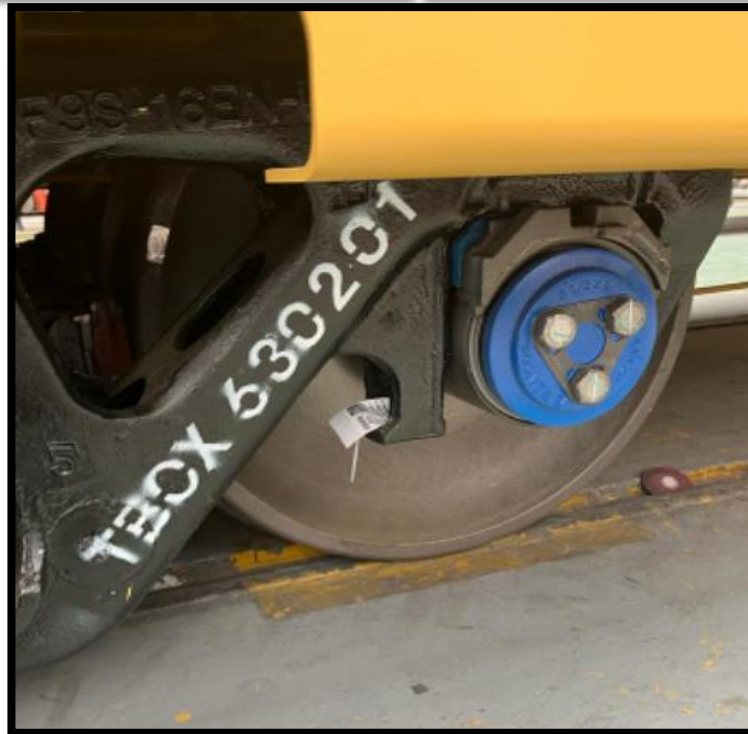
When inspecting the part, I realized that the indication was 1/4" deep and 1/8" in diameter.

I was able to rework the retainer (via grinding) to the contour of the surface.

For an aesthetic appearance the rework was covered with black paint (see video 3)

This side frame was reworked and Gunderson agreed, no more further assistance was needed
