Title: V GROUP SAFETY DIGEST (#4)

This Circular has been issued to share lessons learned from a lost time injury incident.

This Circular has been issued to share lessons learned from an overflow incident during bunkering operations

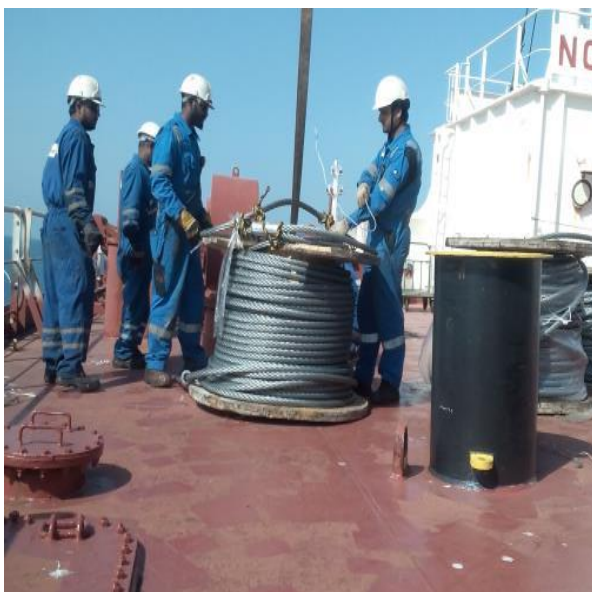
Photo 1/2 : (Above): Wire from reel through fairlead and back to winch drum. Note that photos show fitting of wires on foc's'le. Incident occurred on poop deck.

The wooden reel was suspended just above the deck using a provision crane.

The wire was to be fed over the side, back onboard through a deck fairlead and then onto the winch storage drum. (Photo 1 & 2 above show foc's'le arrangement).
