This Compendium contains the following Case Studies issued in year 2015:

CASE STUDY Nr. 1/ 2015 (17 Nov. 2014)
Main engine failure resulting in cruise cancellation

CASE STUDY Nr. 2/ 2015 (February 2015)

Pitting of fuel tank bulkhead leading to internal leakage of fuel into engine room.

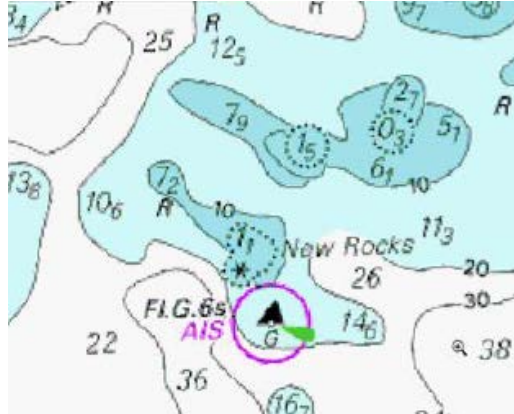
- **Voyage planning :**
 - a) a deviation from the voyage plan was done
 - b) the voyage plan was not re-assessed / not updated with all new elements
 - c) no new courses were laid
- **Bridge Management:**
 - a) music was played on the bridge
 - b) not all conversation was in English
 - c) communication between bridge team members was ineffective
 - d) the bridge team lost situational awareness
- **Navigation:**
 - a) the radars/ARPA were not adequately used to acquire all potentially hazardous targets
 - b) radar centres were offset preventing timely detection of targets

- c) ECDIS alarms were not adequately set up
- d) position fixing methods and intervals were ineffective and inadequately marked on the chart
- e) IALA - marking buoys were not adequately recognized and their meaning understood

- **COLREGs:**
 - a) Regulations were not followed
 - b) VHF was used to arrange avoidance of close quarters situations
- **Manning:**
 - a) Bridge was considered undermanned as the Quartermaster, OOW and the Captain were only on the Bridge in the above critical situation of arrival in heavy weather and intensive traffic
- **Watertight Doors:**
 - a) WTDs were not closed in a potentially hazardous situation / before the incident
- **Reporting:**
 - a) the shipboard command failed to report the incident and the vessel's hazardous condition to the relevant coastal authorities / MRCC
- **Recordkeeping:**
 - a) nothing was recorded in the bell/movement book
 - b) the incident checklists used after the grounding were incomplete

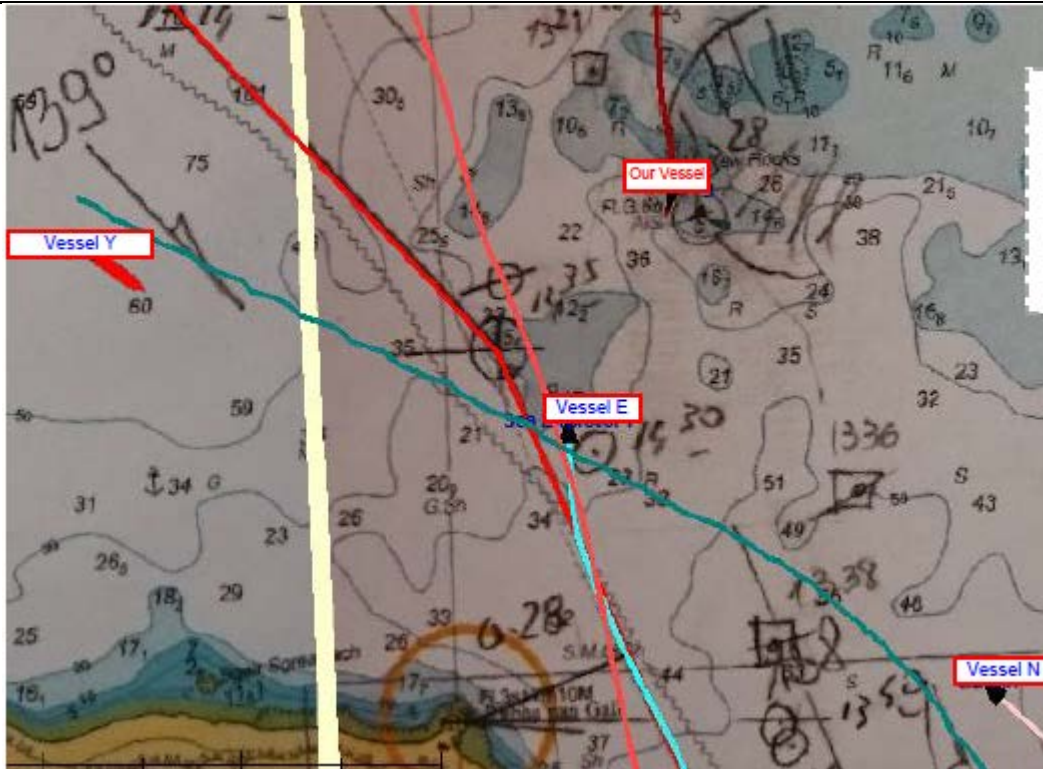
WHY IT HAPPENED - ROOT CAUSE / CONTRIBUTORY FACTORS

- EC.7 –External Conditions – Wind:
Wind of around 30kts gusting to 40/45kts
- EC.10 –External Conditions – Other:
Congested port and intense traffic
- HE.1 – Human Error – Communications – Difficulties in the transfer of information; failure to understand or comply:
The Bridge team failed to communicate critical information on navigational hazards and vessel's position

- HE.7 – Human Error – Inattention – Loss of attention, not paying attention, the failure to detect, attend to, or be aware of critical or significant information:
The Bridge Team lost situational awareness

- HE.11 – Human Error - Judgement - Incorrect assessment, estimation, interpretation or opinion:
Failure to follow COLREG and IALA rules and SMS requirements on voyage planning (deviation/update)

- OMF.1.2 – Organizational / Management Failure – Inadequate Procedure /Policy:
No procedure for minimum manning on bridge in arrival/departure or other critical situations

- The DPAs will draw a list of questions on the above findings and contributory factors and will engage the Bridge Teams in a discussion in the lines of:
 - *How do you ensure vessel's position with regards to navigational hazards and ship traffic is adequately monitored?*
 - *How do you make sure collision avoidance is as per COLREG and effective?*
 - *When and under what circumstances do you consider the Bridge Team is adequately manned?*
 - *What do you do to make sure there is always situational awareness amongst the Bridge Team Members?*
