The inspection of level crossing rails using guided waves

Mark Evans^{a,*}, Andrew Lucas^b, Ian Ingram^c

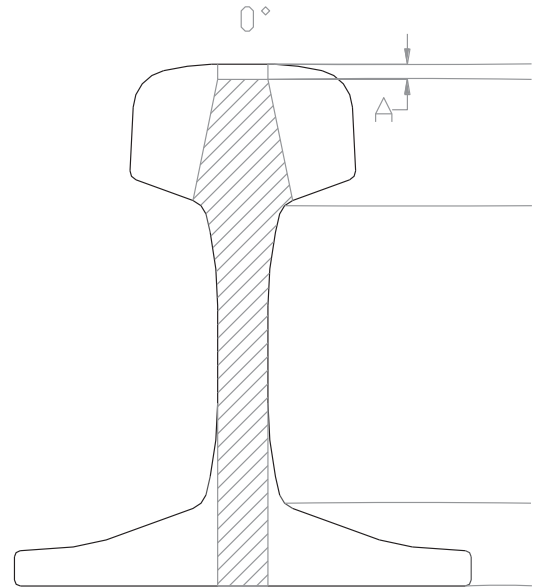
The main ultrasonic test method which is most applicable to level crossings is known as U15 in which the depth of the rail at the centre-line is measured using a vertically oriented (zero degree) transducer, as shown in Fig. 2 [2]. The corrosion found at level crossings typically does not affect the centreline but is concentrated at the toe sections of the rail as shown in Fig. 1, therefore, the result of the U15 inspection often does not correlate with the rail condition within the crossing and potentially catastrophic defects can go undetected. Additionally, some crossings cannot be ultrasonically inspected with the manual inspection trolley as

Fig. 2. The tested area of the rail using the zero degree ultrasonic rail depth measurement is limited to the centre-line only. The dead-zone (A) is typically between 3 and 8 mm.

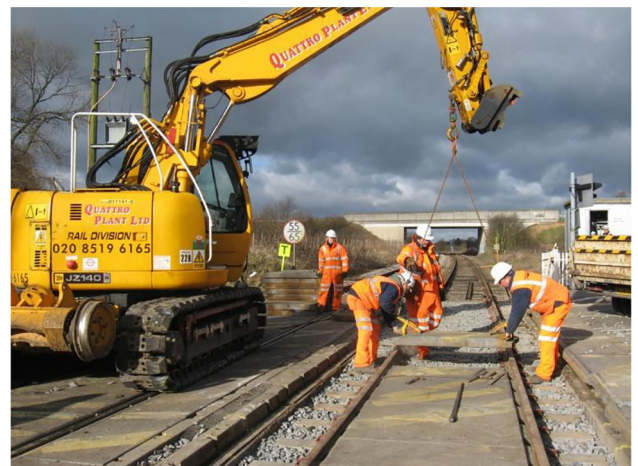
Once possession of the track is taken heavy machinery is used to remove each deck panel one by one, see Fig. 3. An average team of six men are required and the process of removing the panels which can take more than 2 h to complete. Replacement of the panels is the reverse process and requires a similar amount of time.

Fig. 3. Lifting the deck to allow visual inspection of the rail.

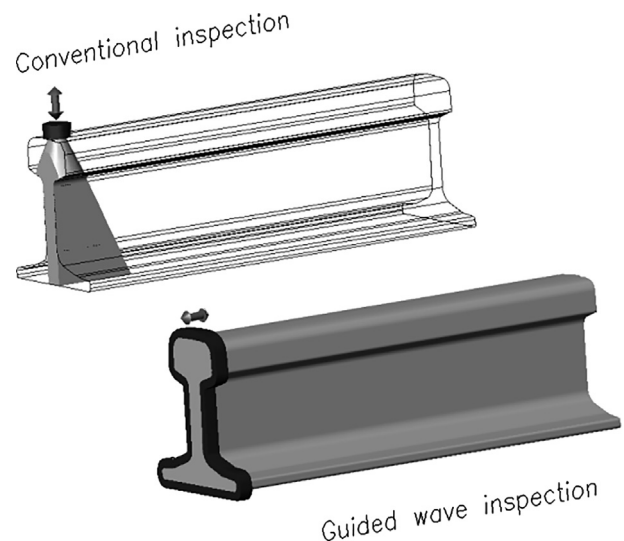
Guided wave testing (GWT) differs from conventional ultrasonic inspection (UT) primarily in terms of the area of the rail section which is inspected, as follows (see Fig. 4);

- The guided wave modes which are used are sensitive to defects at any position within the rail cross section. This includes the areas of the foot and toe of the rail which are normally un-inspected using UT methods but where corrosion defects are most common.
- The guided wave modes travel along the length of the rail and so the method is able to remotely test sections of rail. This is particularly advantageous in areas which are untestable by conventional UT due to minor rail head irregularities (such as corrugation) or where the rail is partially inaccessible for visual inspection such as level crossings (Fig. 5).

Fig. 4. The tested volume using conventional UT and Guided Wave testing.

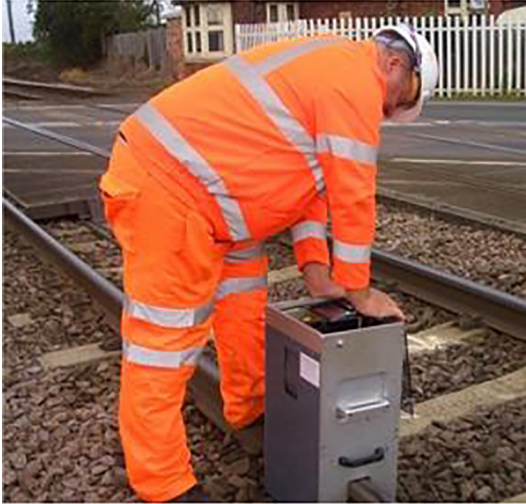
Fig. 5. G-Scan equipment being used to inspect a level crossing, the work is carried out in 'Red Zone' conditions with both road and rail open to traffic.
