# Feasibility of Cubesat Frames for Heat Dissipation Multi-view Onboard Computational Imager (MOCI)

**Michael Ely<sup>#1</sup>**, David L. Cotten<sup>^1,2</sup>, Deepak Mishra<sup>1,2</sup>  
<sup>#</sup>mje80254@uga.edu, <sup>^</sup>dcotte1@uga.edu,  
<sup>1</sup>Small Satellite Research Laboratory, University of Georgia,  
<sup>2</sup>Center for Geospatial Research, University of Georgia

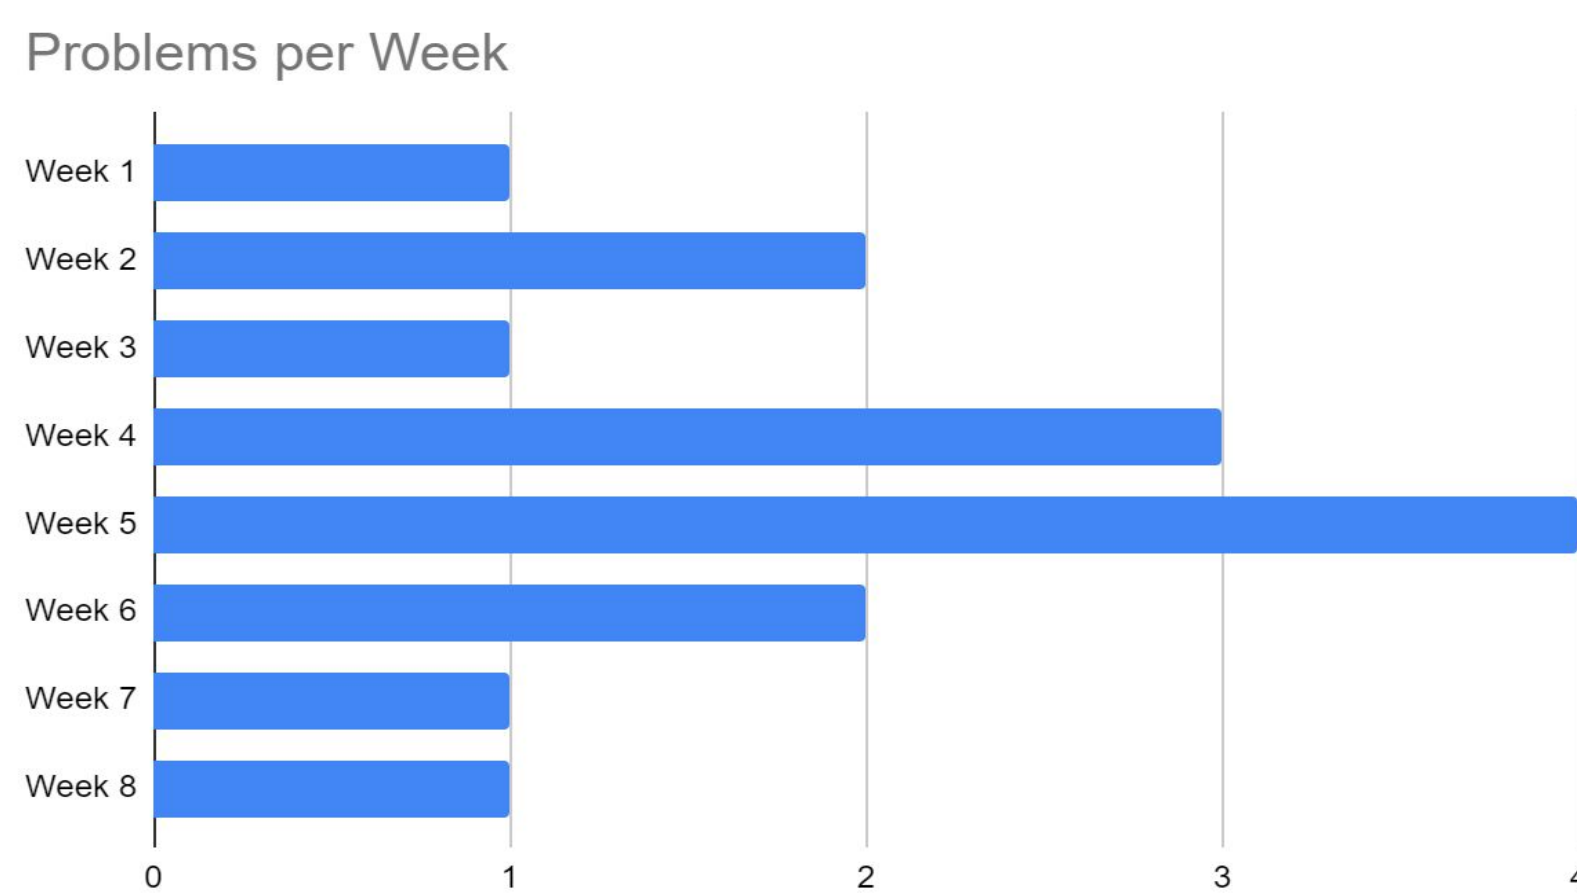
The graph below indicates the amount of problems that occurred per week over the course of this past summer. These were problems that stalled progress until they were fixed. This information provided a decent understanding of the timeline for future expected errors. Mid integration is when the most issues arose. This can be expected as large portions of the work were completed towards the center of the timeline.

Some issues are not listed in the graph below as they were on going issues that did not directly halt satellite integration, such as the development of wire harnesses.

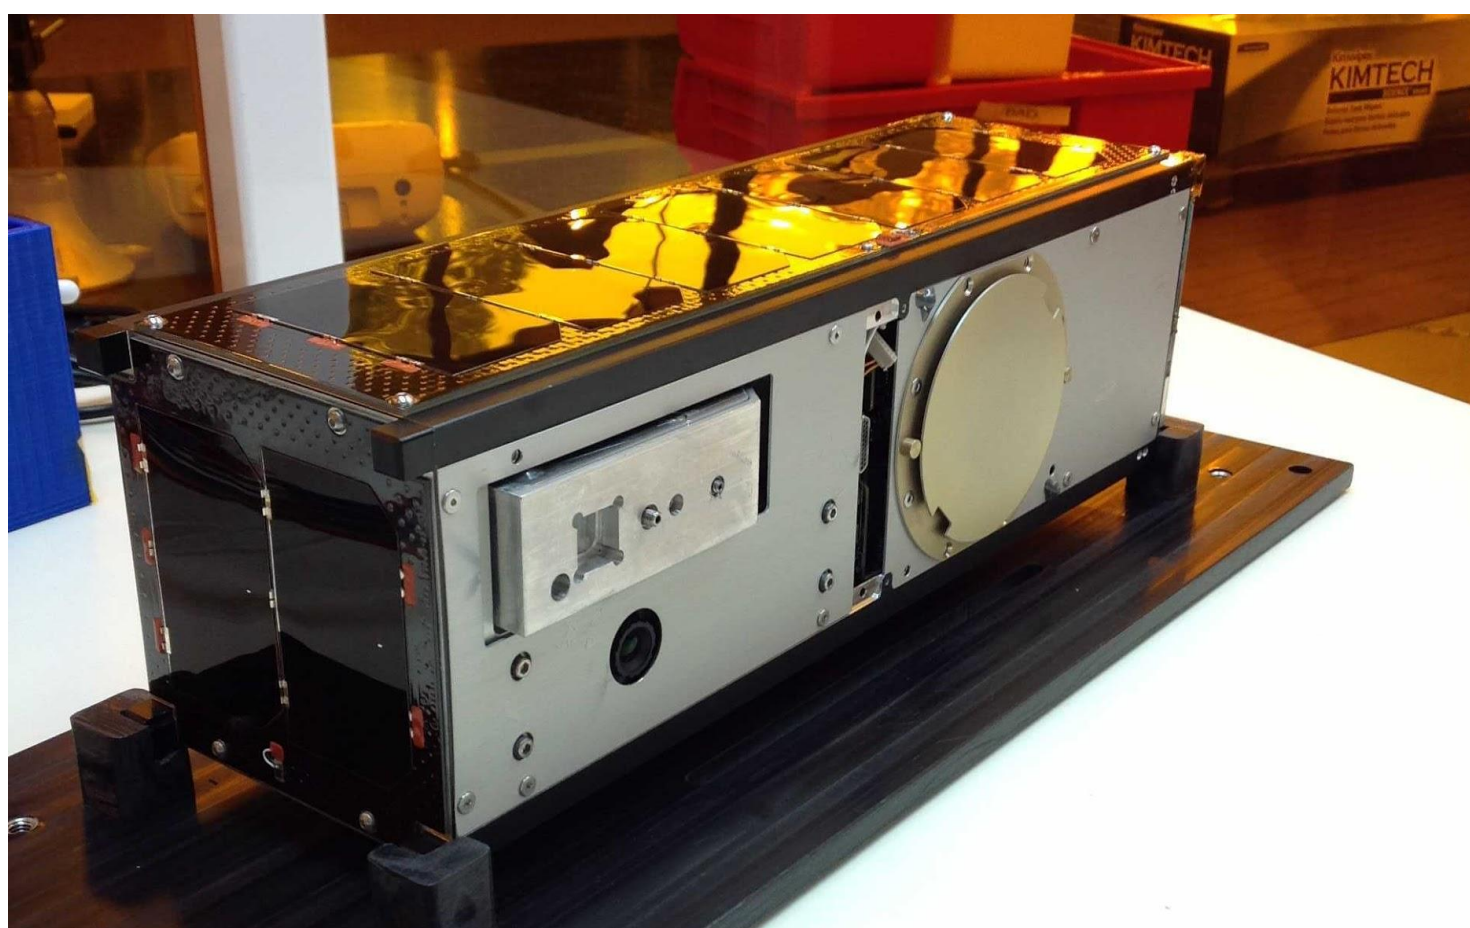
Figure 1: The flight ready SPOC satellite
