高速炉トラブル事例の着目項目(文献から抽出したい情報)

文献調査のイメージ(DFRの冷却材漏えい)

Location and repair of a leak in the Dounreay Fast Reactor Primary Circuit*

Location and repair of the DFR leak

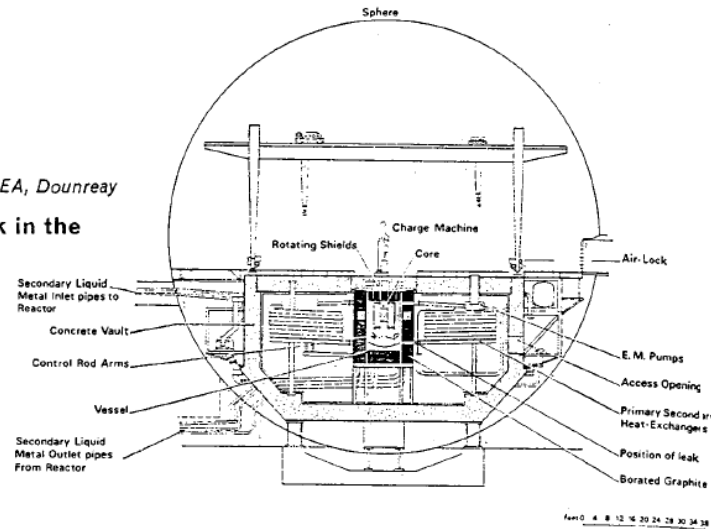
Fig.1 Section through the containment sphere and the primary circuit vault of the DFR

hacksaws. With this section removed it was possible to examine the suspect weld visually from a distance using an introscope and by ultrasonic techniques; evidence of irregularities in the weld bead but local leak tests proved negative. Meanwhile the 10 ft. section which contained some residual radioactive NaK, was decontaminated and pressure tested. This immediately revealed a crack about $1\frac{1}{4}$ in. long on the circumferential weld joining the 4 in. pipe to the thermocouple block, in line with and about an inch from a 1 in. diameter "tee" connection to the 4 in. pipe. The leak rate was measured and found to be of the same order as that measured during the circuit leak tests, but was still a large factor down on that needed to account for the leakage of about 200 litres of NaK per day during the last days of reactor operation.

The possibility of the leak rate being affected by temperature gradients and the resulting stresses was investigated. The 1 in. connection was provided to return coolant from one of the hot traps which were fitted at a late stage in the construction programme in order to reduce the oxide content of the NaK coolant to very low levels. In practice they have never been used, as a sufficiently low oxide content has always been obtained by using cold traps alone.* Under full power operating conditions there had been a 100°C temperature difference between the coolant in the 1 in. pipe and that in the main 4 in. pipe. A thermal stress of the same order was applied by cooling the tee junction to a temperature 100°C below that in the main pipe by immersing the former in liquid nitrogen. This resulted in an immediate and reversible increase in the leak rate by about a factor of 40. An adequate explanation had therefore been found for the differing behaviour of the leak between

1¼インチの周方向亀裂
