## **1. Introduction, failure background, aims of the investigation**

On November 25th/26th, 2005 strong south-west wind with storm force (8 Bft.  $\approx 18$  m/s) and heavy snowfall at a temperature of approx.  $0^{\circ}\text{C}$  were predominant in the region Münsterland, Germany. Due to these weather conditions wet snow rolls formed around the conductors of several overhead transmission lines. This led to excessive line loads of approx. 5 kg/m, [Fig. 1](#). Some of the covered conductors were sagging to the ground. Eighty-two tension and suspension towers of five different, 110 kV overhead electrical lines collapsed mostly by buckling, e.g. failed catastrophically, [Fig. 2](#). As a consequence nearly

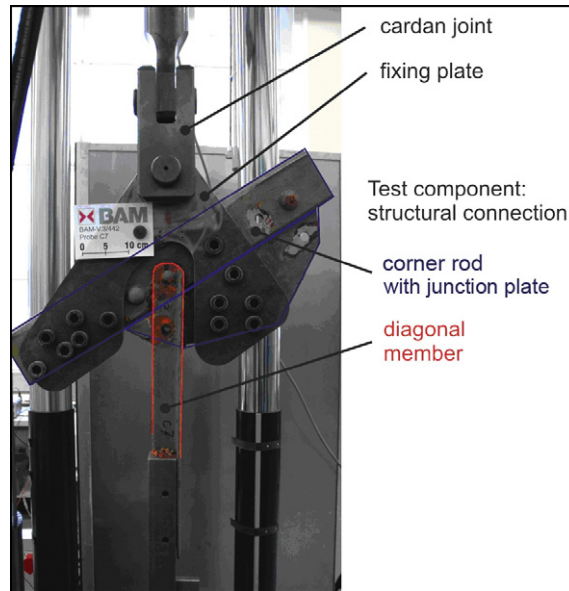
For estimating the effect of embrittlement on fracture forces, component type specimens containing the original riveted or bolted connection between corner rod and diagonal member were worked out of original parts of deviation tower M65 and tested, Fig. 10. The tests were performed at ambient temperature and at 0 °C and resulted in more or less brittle fractures, Fig. 11. The results were in perfect agreement with previous investigations [4].

**Fig. 10.** Test rig for tensile testing of components (corner rod/diagonal member connection).
