Failure analysis on collapsed towers of overhead electrical lines in the region Münsterland (Germany) 2005

BAM Federal Institute for Materials Research and Testing, Berlin D-12200, Germany

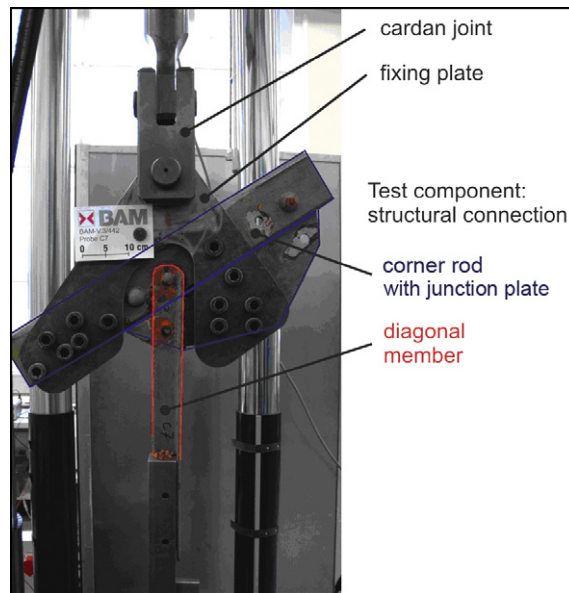
For estimating the effect of embrittlement on fracture forces, component type specimens containing the original riveted or bolted connection between corner rod and diagonal member were worked out of original parts of deviation tower M65 and tested, Fig. 10. The tests were performed at ambient temperature and at 0 °C and resulted in more or less brittle fractures, Fig. 11. The results were in perfect agreement with previous investigations [4].

Fig. 10. Test rig for tensile testing of components (corner rod/diagonal member connection).
