1. Introduction

In this paper, the crankshaft is made of 42CrMo steel with forging, heat treatment and nitridation. The crankshaft occurred fracture failure after using a period of time. The fracture position and surface of the crankshaft is shown in Figs. 2 and 3. The region around the lubrication hole is rough by observing Fig. 3.

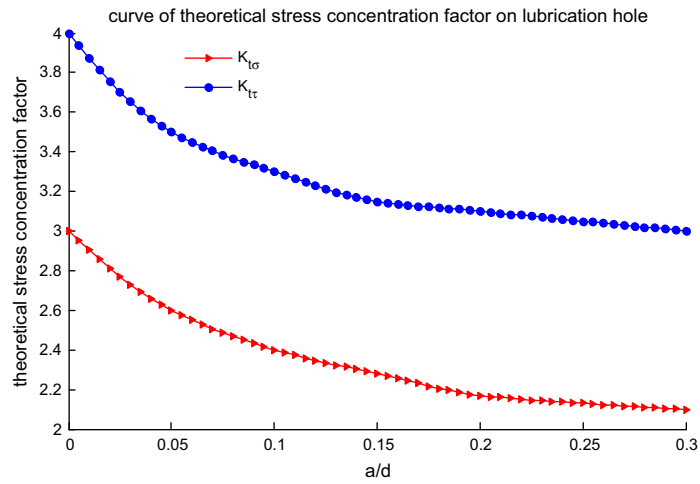
Fig. 7. Curve of theoretical stress concentration factor on lubrication hole.

We can get the following parameters, $K_{t\sigma}$, $K_{t\tau}$, η and η_{τ} according to the Standard Hand book of Machine Design, and then obtain the curve of theoretical stress concentration factor and the curve of the relative stress strength factor on lubrication hole through MATLAB simulation which is shown in Figs. 7 and 8.

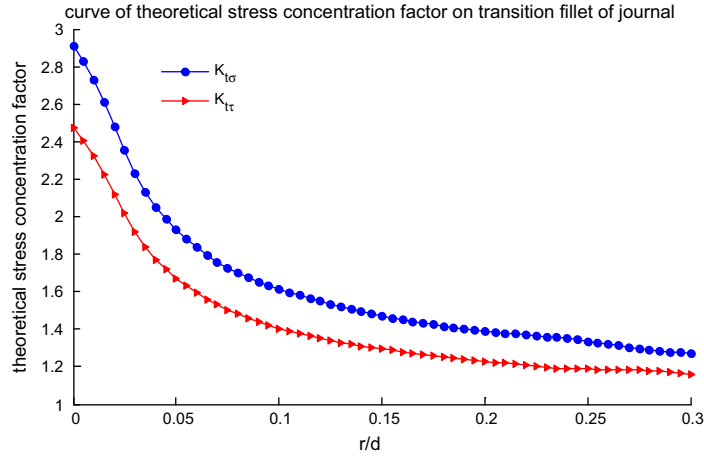
Fig. 10. Curve of theoretical stress concentration factor on transition fillet of journal.

At first, the curve of theoretical stress concentration factor on the transition fillet of the journal through MATLAB simulation has been got which is shown in Fig. 10. The parameter r represents transition fillet radius of journal in Fig. 10.
