Analysis of a crankshaft fatigue failure

Wei Li^{*}, Qing Yan, Jianhua Xue*School of Mechanical Engineering, University of Science and Technology Beijing, 30 Xueyuan Road, Haidian District, 100083 Beijing, China*

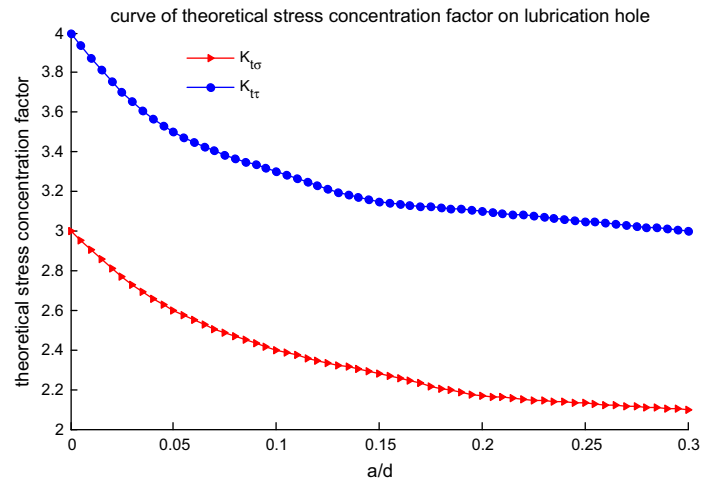
Fig. 7. Curve of theoretical stress concentration factor on lubrication hole.

We can get the following parameters, $K_{t\sigma}$, $K_{t\tau}$, η and η_{τ} according to the Standard Hand book of Machine Design, and then obtain the curve of theoretical stress concentration factor and the curve of the relative stress strength factor on lubrication hole through MATLAB simulation which is shown in Figs. 7 and 8.

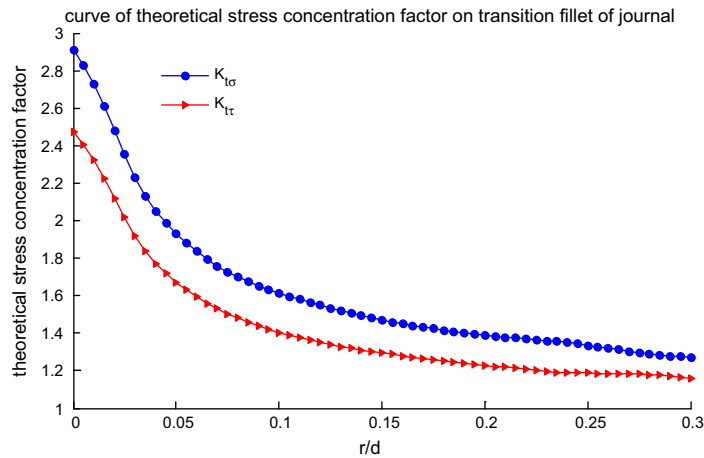
Fig. 10. Curve of theoretical stress concentration factor on transition fillet of journal.

At first, the curve of theoretical stress concentration factor on the transition fillet of the journal through MATLAB simulation has been got which is shown in Fig. 10. The parameter r represents transition fillet radius of journal in Fig. 10.
