This paper presents the causes and a diagnosis of the corrosion types in a tank used to store warm water in a brewery house. Corrosion of the installation made of austenitic stainless steel in conditions of hot water containing chloride ions can be considered as a very common problem [5]. Detailed researches had been performed in order to solve this problem after it was found that corrosion phenomenon also concerns cold water installations in nuclear power plants [6,7]. It was recognised that it would be demanded to perform a very detailed selection of construction materials on the basis of chemical composition of water and its temperature [8,9]. Corrosion in hot water installations occurs mainly in the form of stress-corrosion cracking or pitting corrosion [10]. Nevertheless, the stress-corrosion cracking process can be initiated by the pitting corrosion, precisely by the increase in stresses in the pits' bottom [11,12]. Data available in scientific literature indicate that appearance of localised corrosion processes in hot water installations (static stresses) does not demand high concentration of chloride ions. Studies carried out by Turnbull et al. [11] point out the critical c

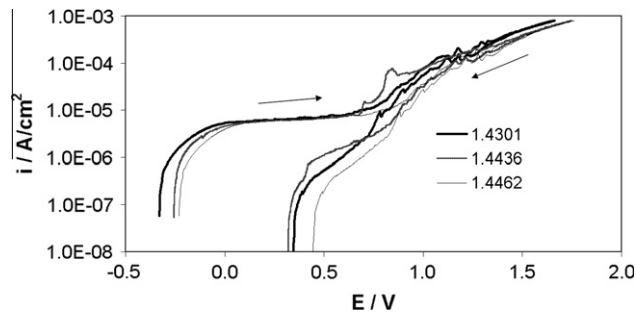
Tests of susceptibility to pitting corrosion in water before treatment were performed at 75 °C. This is a typical temperature of the water stored in the tank. Fig. 8 shows example curves of the cyclic polarisation of stainless steels in water.

The studied steels remained in the passive state in these conditions. The increase of the current in the polarisation curves occurs at a potential of about 0.9 V and it is linked to the emission of gaseous oxygen on the surface of the working electrode. The polarisation curve after the reversal of polarisation clearly indicates the lack of pitting corrosion. Based on these results, it can be concluded that pre-treatment water is not aggressive. The probability of pitting corrosion occurring is nearing zero in all types of steel studied.

Fig. 8. Cyclic polarisation curves in raw water at a temperature of 75 °C for investigated steel.

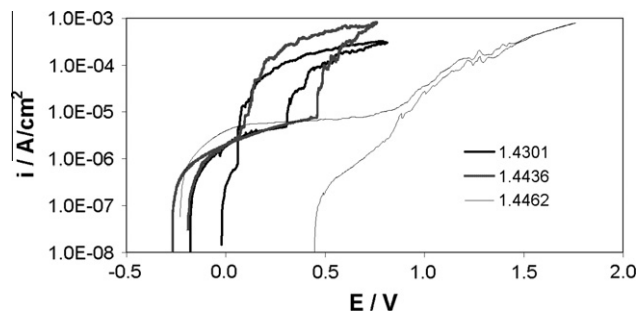
The cyclic polarisation measurements were also performed at 75 °C. Fig. 9 presents the results of these tests.

In a pH-adjusted water, only duplex 1.4462 steel does not show any susceptibility to pitting corrosion. Microscopic evaluation of the steel surface has also not shown the presence of pitting. Therefore, it can be concluded that the steel is resistant to corrosion in treated water within the whole temperature range. 1.4301 and 1.4436 steel types are subject to pitting corrosion. The pitting nucleation potentials are:

The pitting nucleation potential for 1.4436 steel is higher than that for 1.4301 steel, which indicates a higher resistance to pitting corrosion and a lower probability of occurrence of this type of corrosion in treated water at 75 °C, but does not exclude the occurrence of such destruction.

Fig. 9. Cyclic polarisation curves in treated water at a temperature of 75 °C.

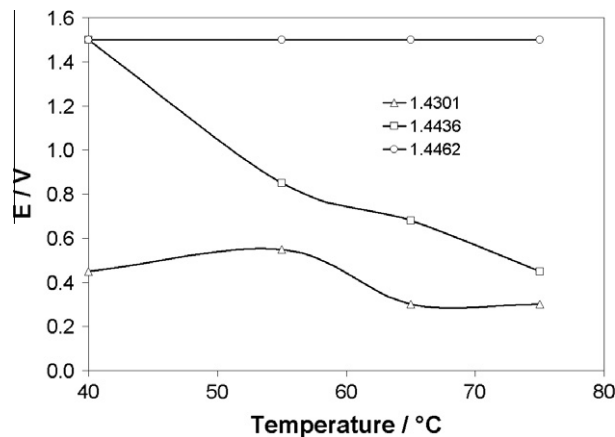
Fig. 11 shows a curve of pitting nucleation potentials as a function of the temperature of the treated water.

As shown in Fig. 11, the 1.4462 steel does not undergo pitting corrosion throughout the whole temperature range, and the probability of pitting corrosion occurring in 1.4436 steel is smaller than in 1.4301 steel.

Fig. 11. Changes of pitting nucleation potentials vs. the temperature of the treated water.
