## Service Bulletin

### Introduction of new Generator ATP Software v7R1b78

<b>Title:</b>	DX-D 100 - Service Bulletin No. 63 - Introduction of new Generator ATP Software v7R1b78
<b>Livelink ID:</b>	47923613
<b>Version#:</b>	6
<b>Version Date:</b>	2014-12-17 04:40 PM CET
<b>Status:</b>	Approved on 2015-02-10 12:32 PM CET
<b>Owner:</b>	Annette Peters (awtso)
<b>Created By:</b>	Annette Peters (awtso)
<b>Created Date:</b>	2014-12-04 04:09 PM CET
<b>PDF Creation Date:</b>	2015-02-10 12:32 PM CET

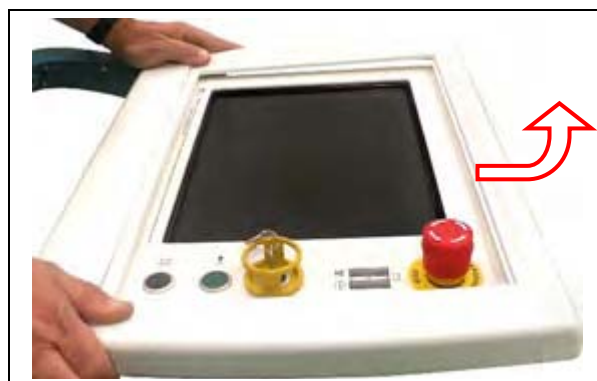
Figure 1

- (3) Open the pencil tray and remove the two screws that fasten the console frame to the unit.
- (4) Push the console frame towards the column.  
Do not lift up the console frame until its upper side is fully released.

- (8) Switch off the generator.
- (9) Set the switch SW7 in "OFF" position to enable Application Mode.
- (10) Close generator module front door and fasten the two Allen screws.
- (11) Mount the front cover.
- (12) Remount the console frame (see Figure 2 and Figure 1).

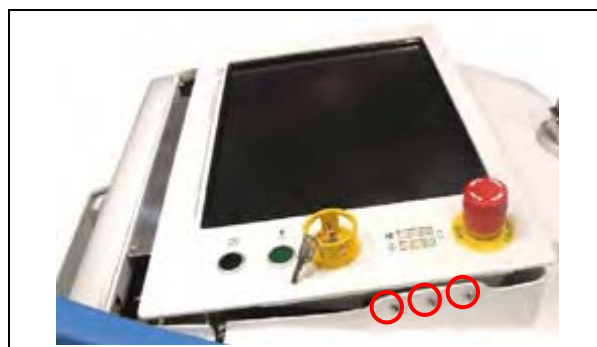
Figure 2

- (5) Remove the three lateral screws placed on the front cover, at the right side underneath the console frame, in order to facilitate an access between the console and the cover.

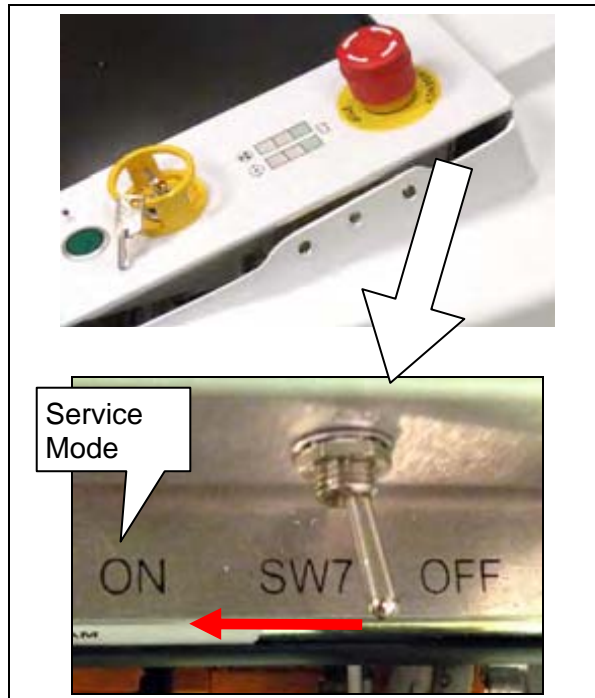
Figure 3

- (6) Set Switch SW7 "Calibration ON/OFF" in "ON" position to enable Service Mode.

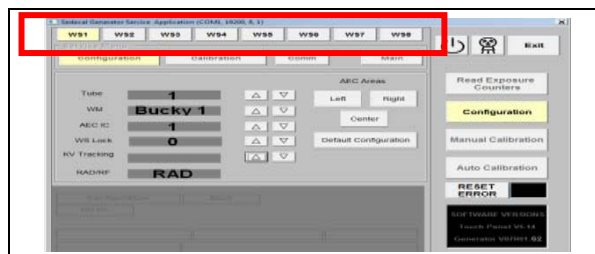
Figure 4

- (7) Switch on the generator.
- (8) On the NX, start the Techserv Software in the **Sedecal Generator Service Application** window.
- (9) Click the **Configuration** button.
- (10) Note down the configuration for all workstations WS1 – WS8.

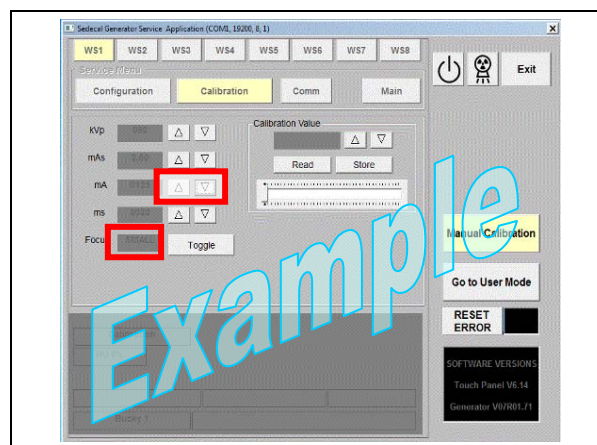
Figure 5

- (12) Click on **Manual Calibration**
- (13) Select WS1 and click **OK**
- (14) Use the arrow buttons to increase or decrease the mA value. Observe when the **Focus** field changes from LARGE to SMALL or vice versa.
- (15) Record the lowest mA version for the LARGE focus so the mA just before the focus switches to SMALL.
