Mandatory Service Bulletin

Mandatory upgrade to DMC board Rev. H with firmware V11R3b4

- DX-D 100, Type 5410, with SN < A5410000134
- DX-D 100 Wireless, Type 5411, with SN < A5411000408

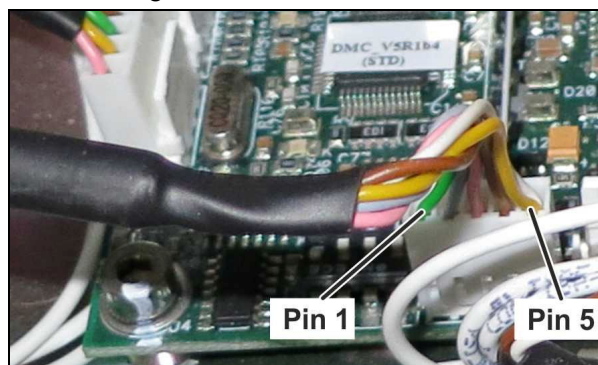
Figure 13

Normally these contacts should be open and with the button pressed the resistance should be close to 0.0 Ω .

- (1) Check the status of the drive batteries (Tray 6).
Make sure the drive batteries are fully charged before further testing. If they are not, then also check the condition of the fuses and charger boards.
- (2) Disconnect the cable from J2 on DMC board.
- (3) Measure resistance at each pin (1, 2, 3, 4) against pin 5 (Common).
