The crooked rod sign: a new radiological sign to detect deformed threads in the distraction mechanism of magnetically controlled growing rods and a mode of distraction failure

Study Design: Case report

Objective: To report a unique mechanical failure of magnetically controlled growing rods (MCGR) that is related to continuous rod slippage.

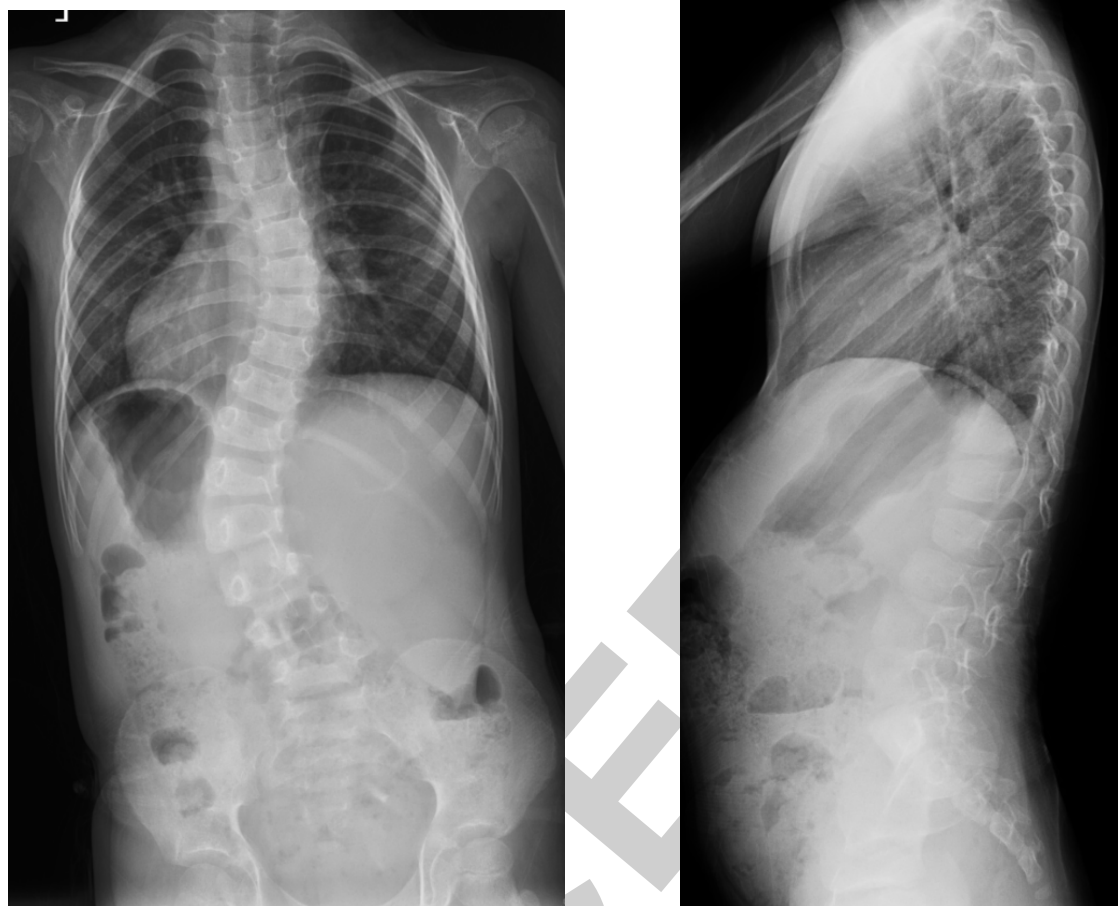
A girl diagnosed with Sotos syndrome presented at age of 3 years with a double major curve of 41° from T6-11 and 44° from T11-L4. MRI showed no intraspinal pathology. Despite good compliance to bracing, there was progression of the deformity to 54° at T11-L4 (**Figure 1AB**). Dual MCGRs in standard and offset configuration were implanted at T5-L4 (**Figure 2AB**) with claw construct at the proximal foundation (T5-T6) and pedicle screws at the distal foundation (L3-L4). Postoperatively she was given a corset with shoulder straps for 3 months before monthly outpatient distractions were performed.

Figure 1: Posteroanterior (A) and lateral (B) radiographs pre-MCGR implantation.

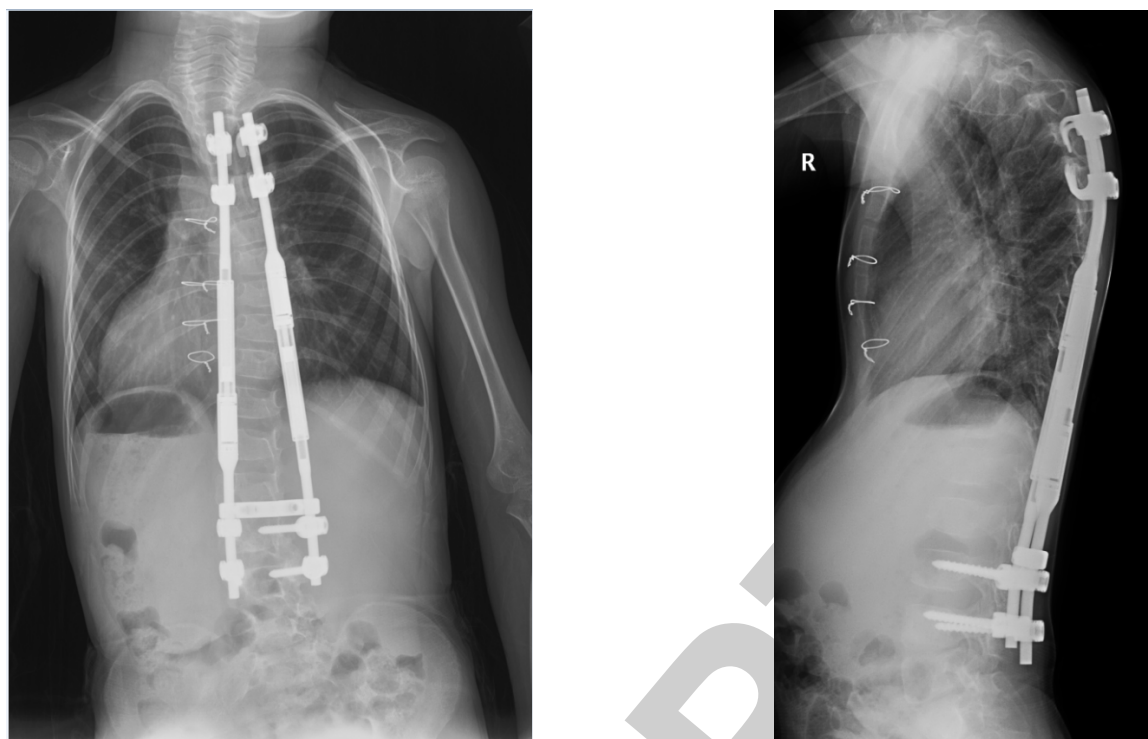
Figure 2: Posteroanterior (A) and lateral (B) radiographs post-MCGR implantation.
