Identification of Failing Septic Systems

Final Report

Huron River Watershed Council

10/2/12

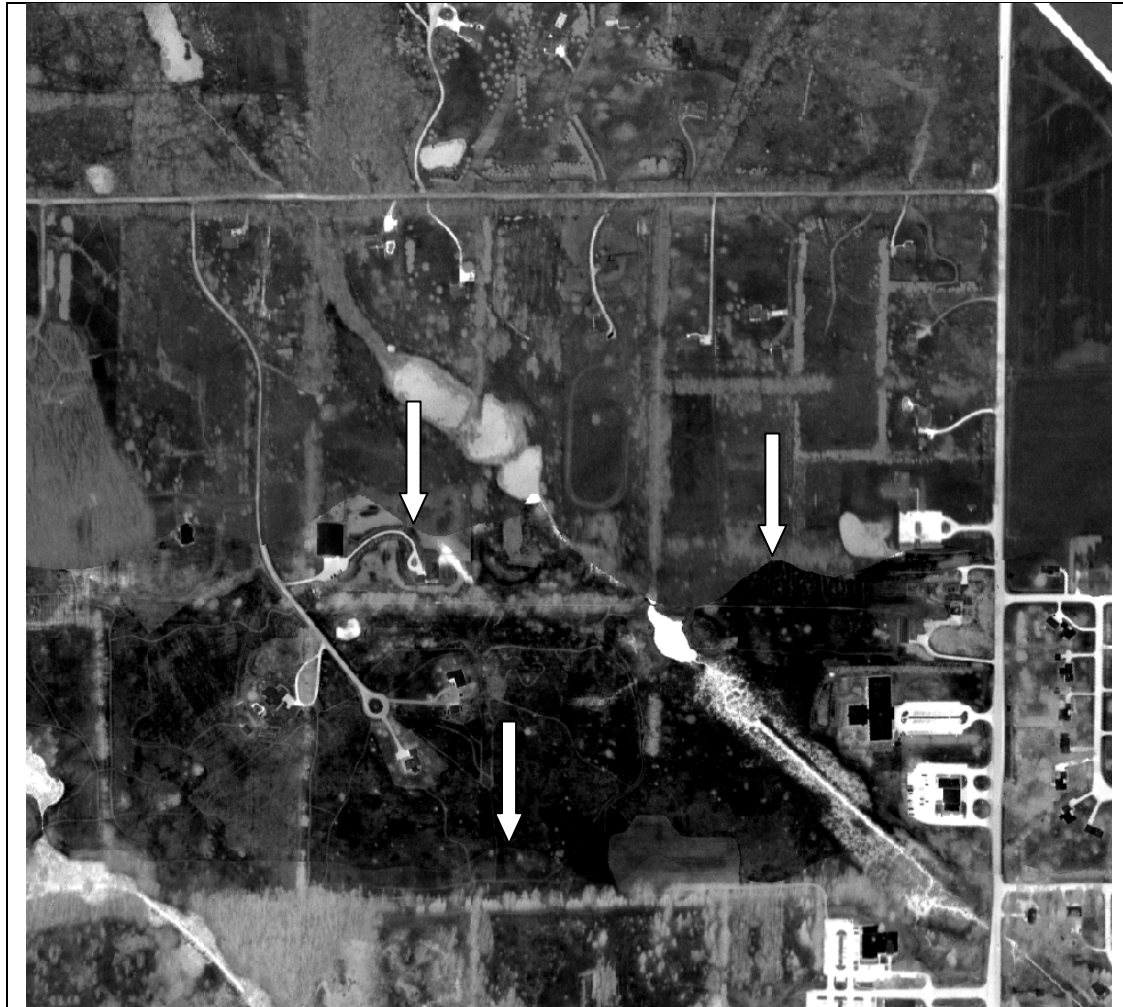
Figure 5: Differences in surface temperatures (white arrows) between flight lines resulting from different ambient surface temperatures.
