Device	XMC1300
Marking/Step	EES-AB, ES-AB, AB
Package	PG-TSSOP-16/38, PG-VQFN-24/40

Overview

This “Errata Sheet” describes product deviations with respect to the user documentation listed below.

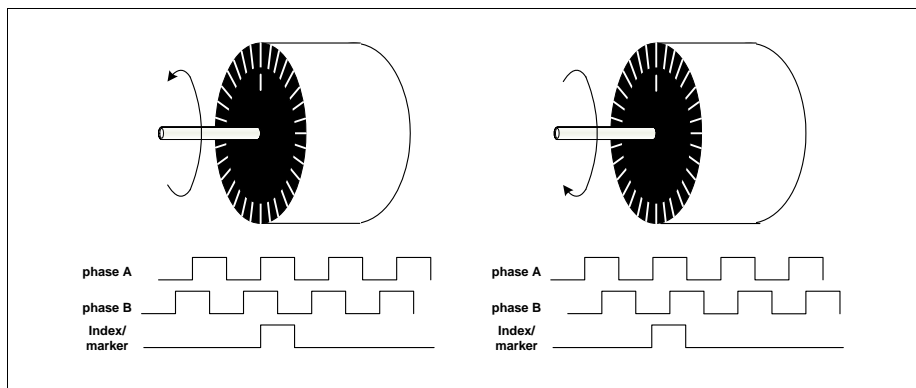
Figure 3 Rotary Encoder outputs - Phase A, Phase B and Index

A, Phase B (these two signals are 90° out of phase) and Index. The index signal is normally understood as the marker for the zero position of the motor Figure 1.

To make usage of the Index signal, when the length of this signal is less than $\frac{1}{2}$ of the tick period, one should connect it directly to the specific counter/timer. This connection should be done at port level of the device (e.g. connecting the device port to the specific Timer/Counter(s)), Figure 3.
