MECHANICAL ENGINEERING 224

United Airlines Flight 232: The Impossible Landing

December 6, 2018

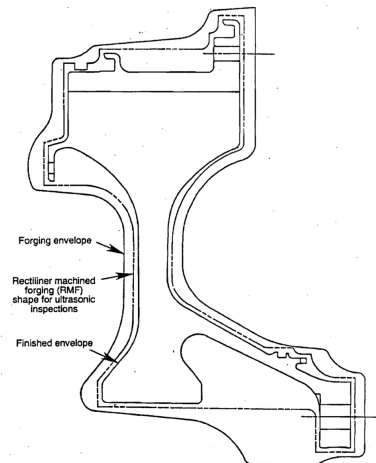
Processing a stage-1 fan disk generally consists of three major steps [1]: (1) material processing, where raw materials (alloy source compositions, Table 2) are combined as a heat and melted into a titanium alloy ingot, then are mechanically elongated into a billet; (2) forging, where a billet is cut into multiple forging blanks and forged into forging shapes; and (3) final machining, where a forging shape is machined into the final configuration, followed by a shot peening process that creates local compressive stress fields on fatigue-critical areas (Figure 6).

Fig. 6: Stage 1 fan disc cutaway view [1]

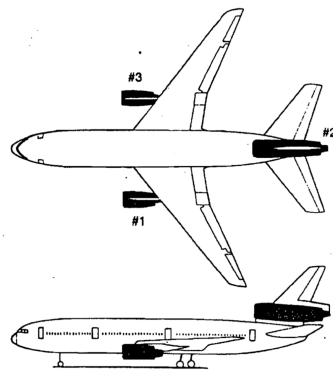
The engine was first installed in June 1972 in the number 3 engine position in United Airlines DC-10 airplane (N1814U). In September 1988, the engine was removed and installed in UAL airplane N1819U number 1 engine position. Eight weeks later, the engine was moved to the number 2 position in the same aircraft (Figure 7). By the time of the accident, the engine had accumulated 42,436 hours and 16,899 cycles.

Fig. 7: DC-10 airplane top/side view with engine arrangement[1]

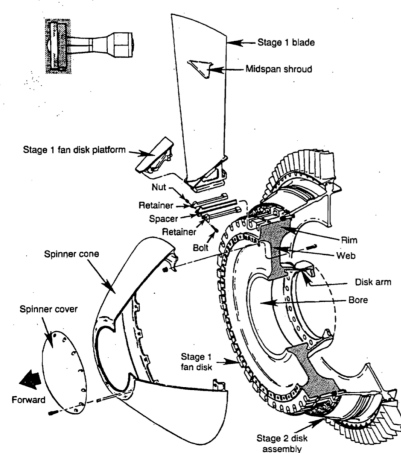
The fan disk of the CF6-6 engine is shown in Figure 1. The assembly consists of the large stage-1 fan disk and the attached fan blades (Figure 8). The analysis will focus only on the fan disk as it was the component that initially failed. The fan disk weighed 370 pounds, consisting of the rim, the bore, the web and the disk arm as labeled in Figure 2. The primary loads imposed on the fan disk were radially tensile loads. These loads were from the disk holding the fan blades against centrifugal forces during rotation of the assembly. The loads imposed by the fan blades caused radial stresses in the disk rim. These radial stresses decreased towards the bore, becoming zero at the bore since there was no material inboard of this location to resist the stress. Hoop stresses were greatest along the inside diameter of the bore, with the forward corner of the bore experiencing the maximum hoop stress (as shown in the finite element analysis (FEA), Figure 2).

Fig. 8: Fan rotor assembly [1]
