# Field Application of UAS-Based Bridge Inspection

Junwon Seo<sup>1</sup>, Luis Duque<sup>1</sup>, and James P. Wacker<sup>2</sup>

Transportation Research Record  
1–10

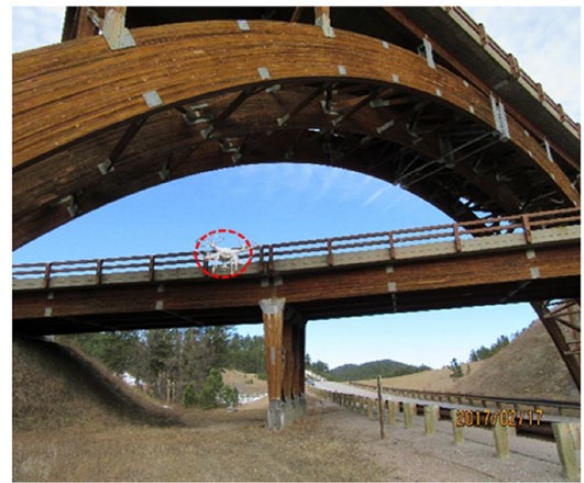
data acquisition to eliminate any unnecessary distractions from the picture-taking process while flying under such harsh weather conditions. Using the recorded videos, sample images were obtained to identify damage as seen in Figure 4a. Figure 4a shows concrete cracks and high moisture resulting from water leakage at the North Abutment of the bridge. It has been proved that the video-based inspection facilitated the acquisition of image information necessary for the damage identification. Figure 4b shows the UAS approaching components of the bridge.

**Figure 4.** Sample images obtained from the timber girder bridge inspection on February 17, 2017: (a) concrete cracking and water damage at abutment location and (b) UAS approaching the bridge (captured by Junwon Seo).
