Wood Destroying Insect Report

Inspection Performed by Stephen Lozano TPCL #888536 11/12/2024

2121 Bolsover St

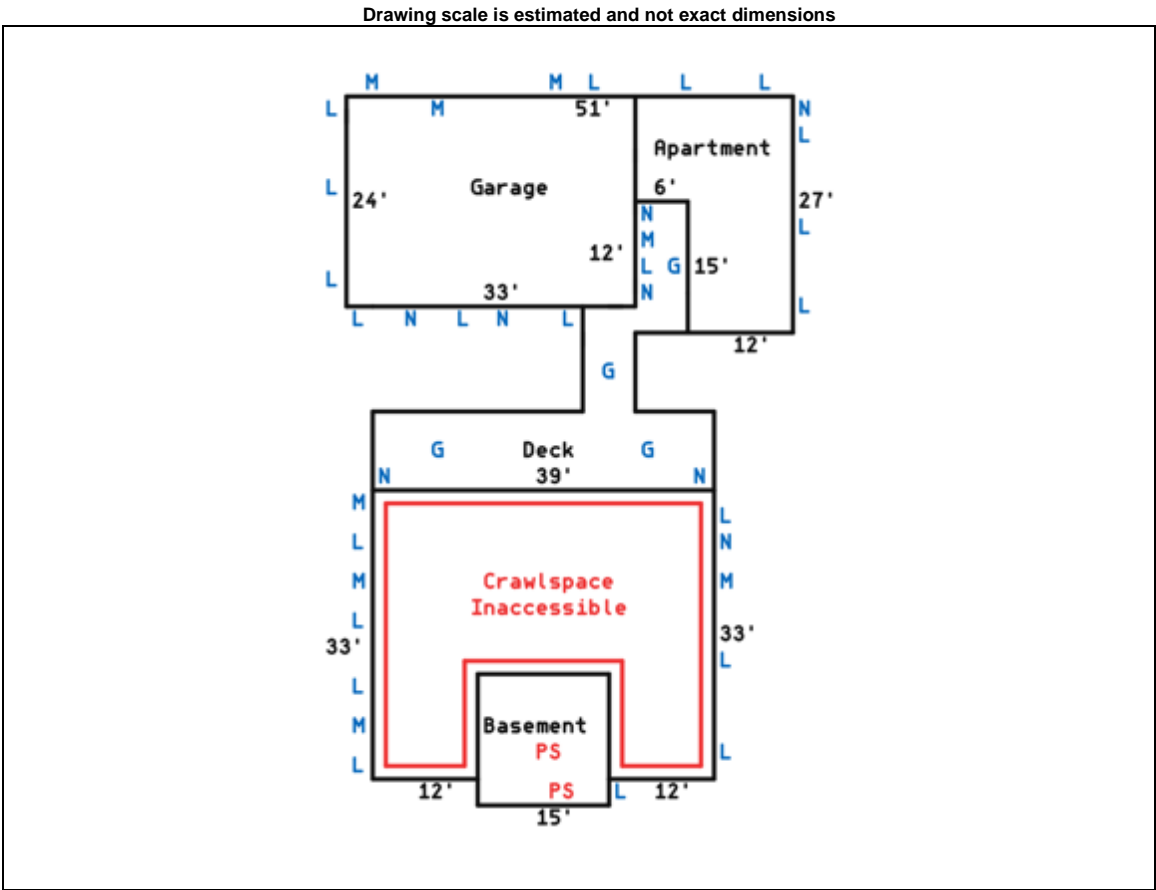
Additional Comments: **(L) High Soil – Soil should be lowered to below the top of the foundation.**

(N) Heavy Foliage – Foliage should be cut back to provide at least 3 inches of clearance to the structure.

(M) Wood Rot – All damaged or affected wood materials should be properly repaired or replaced.

(PS) Subterranean Termites - Evidence of previous infestation - evidence of previous treatment - No additional treatment recommended.
