Motorcoach Roadway Departure
and Overturn on Interstate 95
Near Doswell, Virginia
May 31, 2011

NTSB/HAR-12/02
PB2012-916202

Highway Accident Report

Motorcoach Roadway Departure and Overturn on Interstate 95
Near Doswell, Virginia
May 31, 2011

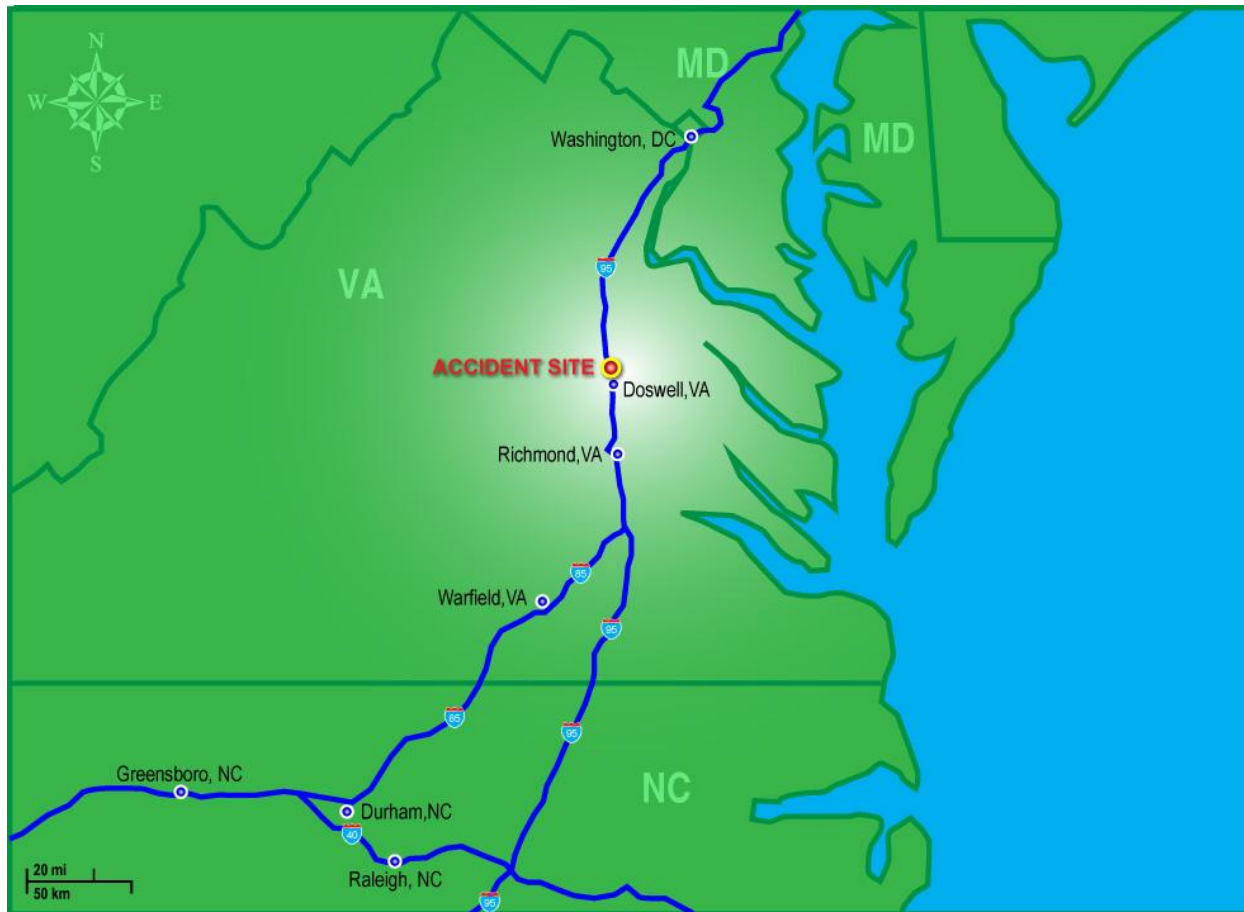
Figure 3. Map showing the motorcoach's travel area and the accident location.

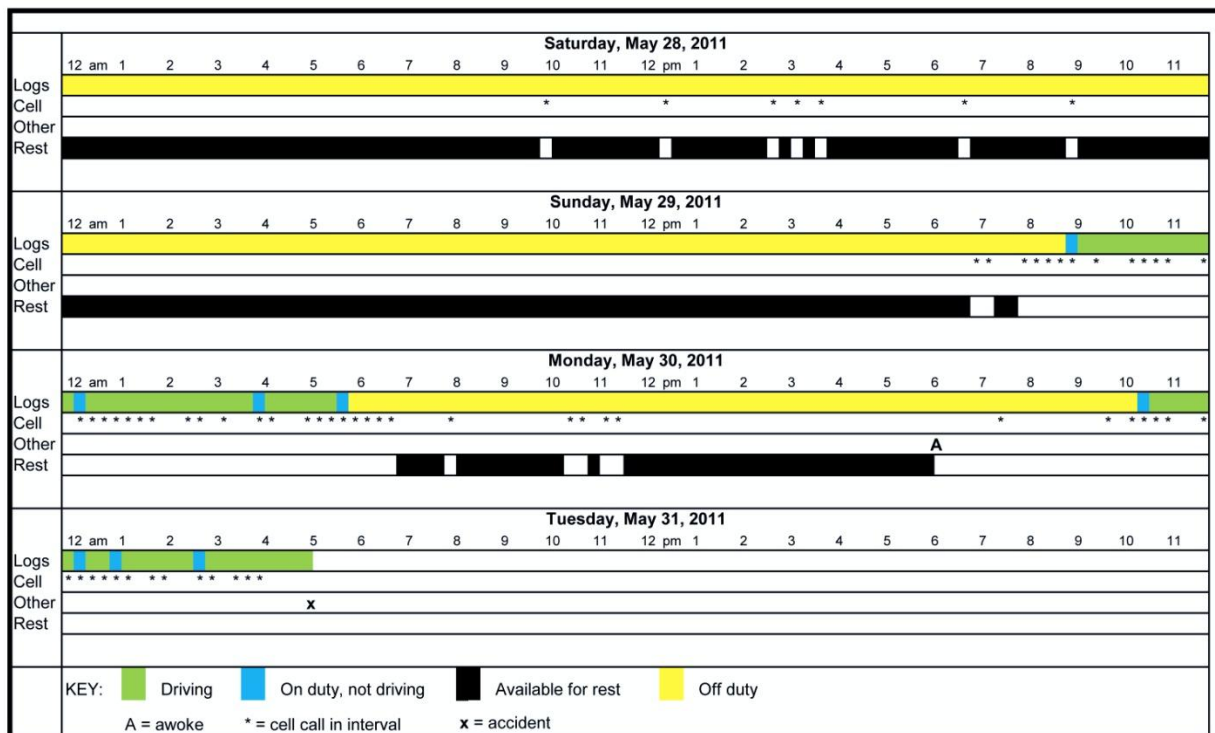
The driver's cell phone records showed that, from 10:15 p.m. on May 30 until the time of the accident, he made or received 21 calls. Eighteen calls occurred that night during the timeframe when the logbook recorded his duty status as "driving," with the last call occurring at 3:46 a.m., about 1 hour 11 minutes before the accident. (See figure 10 for more information on the driver's work/sleep/wake history. The figure indicates calls made or received in any 15-minute interval.)

Figure 10. Motorcoach driver's work/sleep/wake history. (Note: Investigators were unable to interview the driver or his wife. Activities preceding the accident were generated using the driver's logbook, his statements to FMCSA investigators and the VSP, and his cellular provider's records.)
