UAV-aided bridge inspection protocol through machine learning with improved visibility images

Euiseok Jeong^{a,2}, Junwon Seo^{b,1,*}, James P. Wacker^c

ABSTRACT

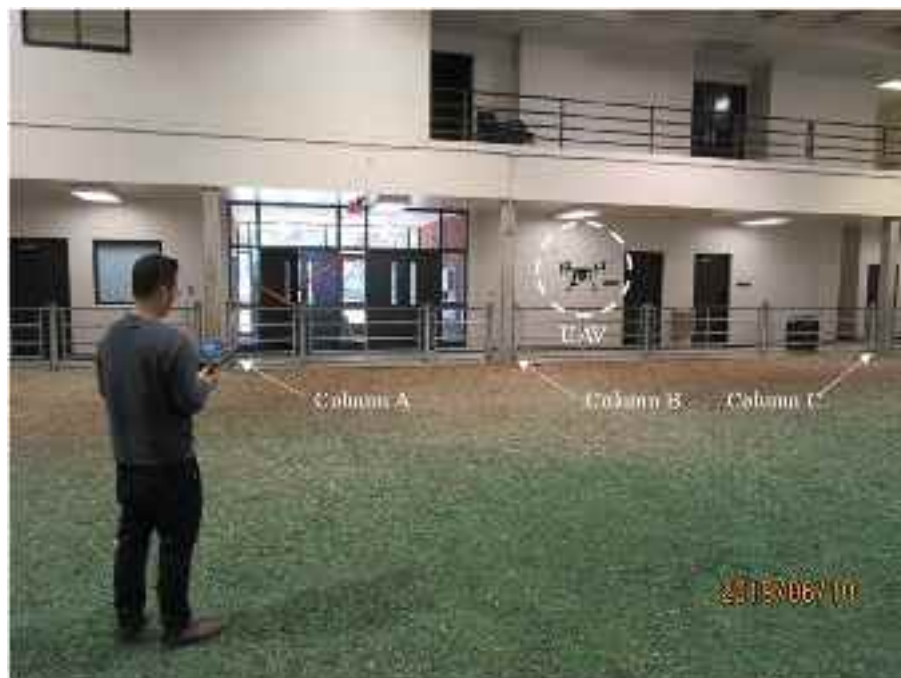
Fig. 3. Inspected concrete columns during indoor inspections.

In the first indoor inspection, UAVs captured 24,867 images of columns A through C in Animal Science Arena to identify any damage as displayed in Fig. 3. The images of the columns were examined in detail and a total of three noticeable cracks were visually observed on columns A through C. The damage classification using CNN-based machine learning coupled with the Residual Networks having 50 layers through MATLAB, 2020 was made as shown in Fig. 4 for three cracks on each of the columns.

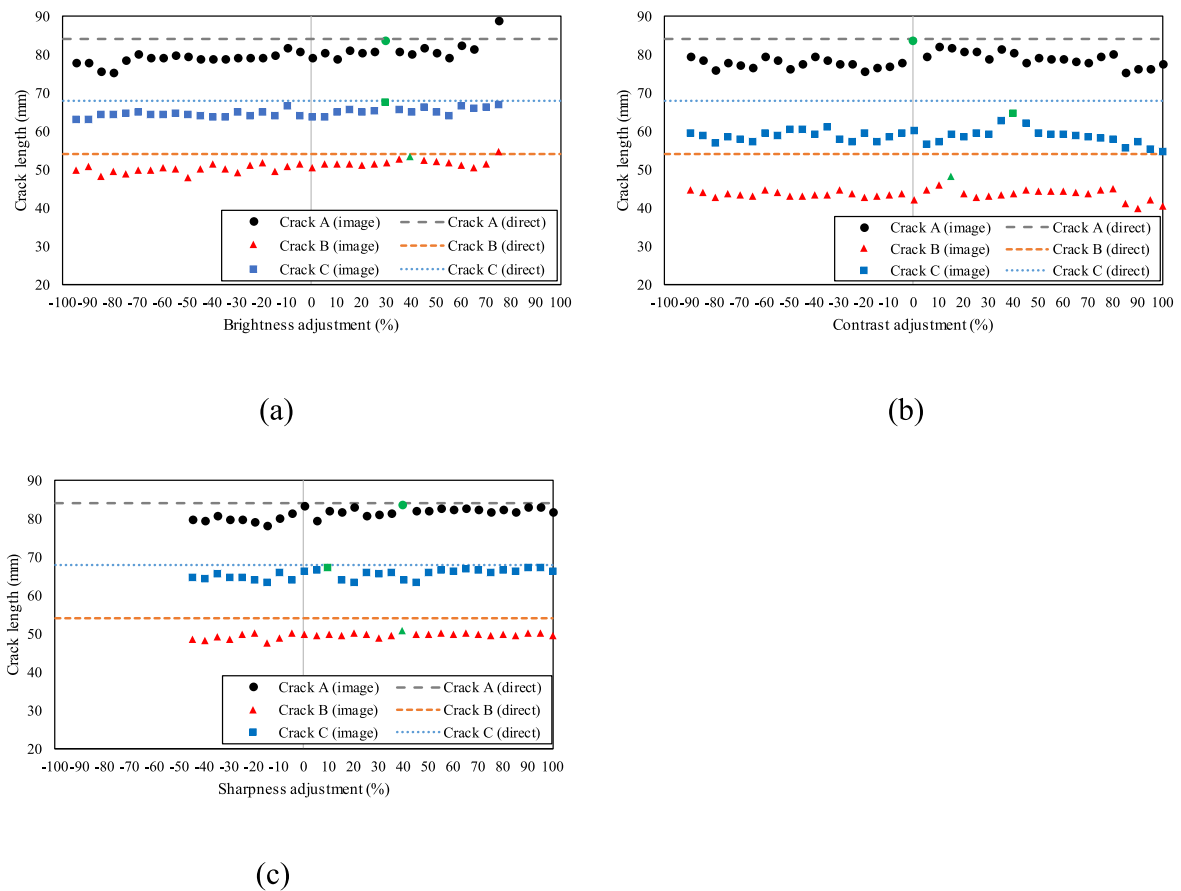
Fig. 5. Accuracy of the image analysis-based crack measurement with variation in brightness, contrast, and sharpness: (a) brightness adjustment for crack length; (b) contrast adjustment for crack length with the optimized brightness; and (c) sharpness adjustment for crack length with the optimized brightness and contrast.

Upon completion of UAV-aided inspections, the cracks on the columns were also measured directly using a measuring tape, and the direct measurements were compared to those obtained from image analysis of UAV inspection images to examine the accuracy of the UAV-aided inspection protocol. It should be noted that UAV inspection images filtered by adjusting their brightness, contrast, and sharpness were initially used for the image analysis-based crack quantification. Fig. 5 shows the accuracy of damage quantification through the image analysis with the filtered UAV images. The error percentages calculated between the direct measurements and corresponding values obtained from the image analysis with the filtered images with variance in brightness, contrast, and sharpness are illustrated in Fig. 5a through 5c, respectively. In Fig. 5a, dashed lines indicate the direct measurement of column A crack (gray line), B (orange line), and C (blue line), individually, and black circles for column A crack, red triangles for column B crack, and blue boxes for column C crack are defined as the results from the image analysis specific to brightness adjustment. The values having the lowest error against direct measurement are marked with green dots. Similar to Fig. 5a, b and c show the accuracy of contrast and sharpness adjustment,

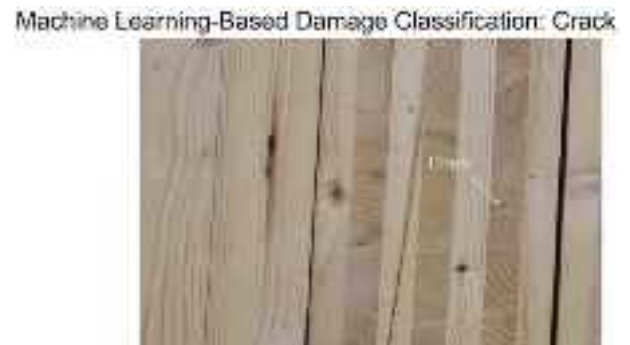
Fig. 8. Sample of damage classification using machine learning.

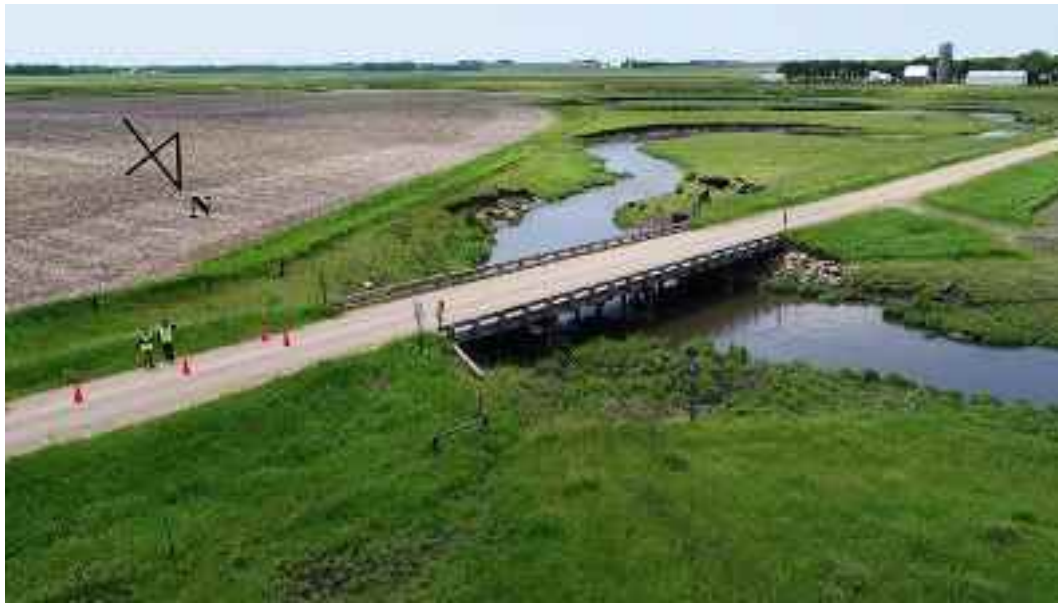
A field study of UAV-aided inspection for the bridge located in Pipestone, MN was conducted. This bridge, which was built in 1987, is a four-span timber bridge with a total structure length of 31.7 m, a maximum span length of 7.9 m, and a deck width of 9.1 m. According to the NBI condition rating scale (FHWA, 2018, 1995, 2012), the deck, superstructure, and substructure were recently evaluated in 2017 (FHWA, 2017) and assigned condition ratings of 6 (satisfactory), 6, and 5 (fair), respectively.

Fig. 10. Photograph of the inspected bridge taken by Matrice 210.

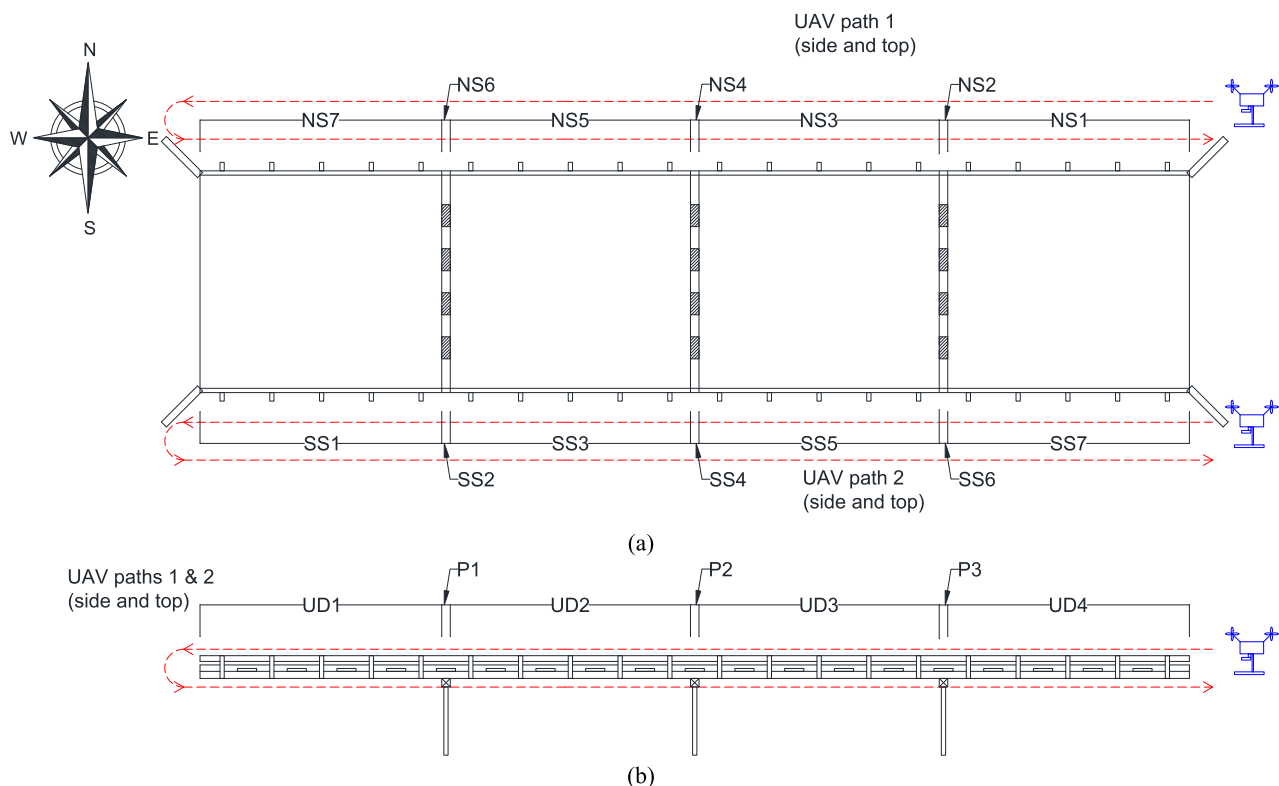
Fig. 11. Four-span timber girder bridge sketch with inspected sections: (a) plan view and (b) elevation view.

the plan view (Fig. 11a) and elevation view (Fig. 11b). Specifically, for effective damage identification, the superstructure of the bridge is divided into seven sections on each side as shown in Fig. 11a. In this figure, NS represents the north side of the bridge, and SS indicates the south side of the bridge. As shown in Fig. 11b, underneath the bridge deck is also divided into seven individual sections, including UD1 through UD4, and the bridge pier sections are denoted as P1 through P3. Note, UD indicates underneath deck and P is defined as a pier. The UAV-aided bridge inspection was conducted by following UAV paths 1 and 2 as depicted in Fig. 11. Each UAV path includes inspection of the side of the bridge and top of the railings.
