A Study of the Affected Layer and Stress Corrosion Crack of Ultra-high-strength Steel (300M) for Aircraft Parts

Jinwoo Ahn^{*,**}, Taehwan Kim^{*,**, #}

^{*}Defense Agency for Technology and Quality,

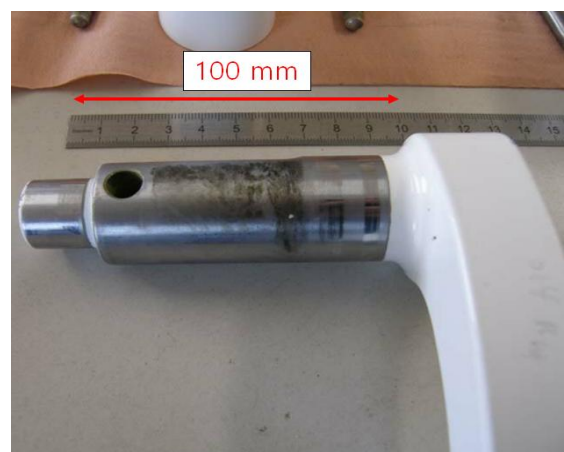
Fig. 1 Shapes of non-fractured part

The fractured is a part of the link assembly of the aircraft landing gear. The shape of original part is shown in Fig. 1. Fig. 2 show fracture surfaces. It can be seen that the fracture proceeded diagonally.

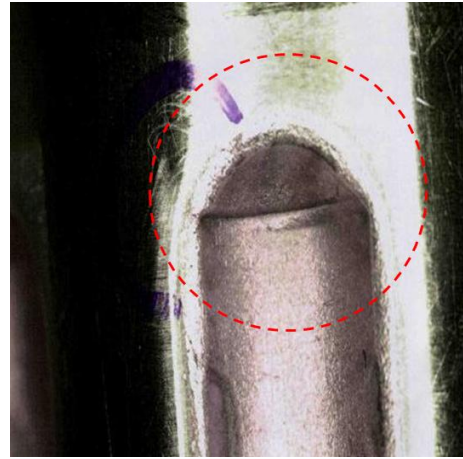
**Fig. 5 NDI point of the defected part**

Non-destructive inspection(NDI) was performed on the total quantity of defected products where the ridge edge was identified to check the defects that may exist inside the parts(Fig. 5).
