# **RESTORATION OF THE HISTORICAL ARCHBISHOP'S PALACE IN CAGLIARI (ITALY).**

G. Concu and F. Mistretta  
Department of Structural Engineering  
University of Cagliari, Italy  
Piazza D'Armi 2  
09123 Cagliari, ITALY  
[fmistret@unica.it](mailto:fmistret@unica.it)

## **ABSTRACT**

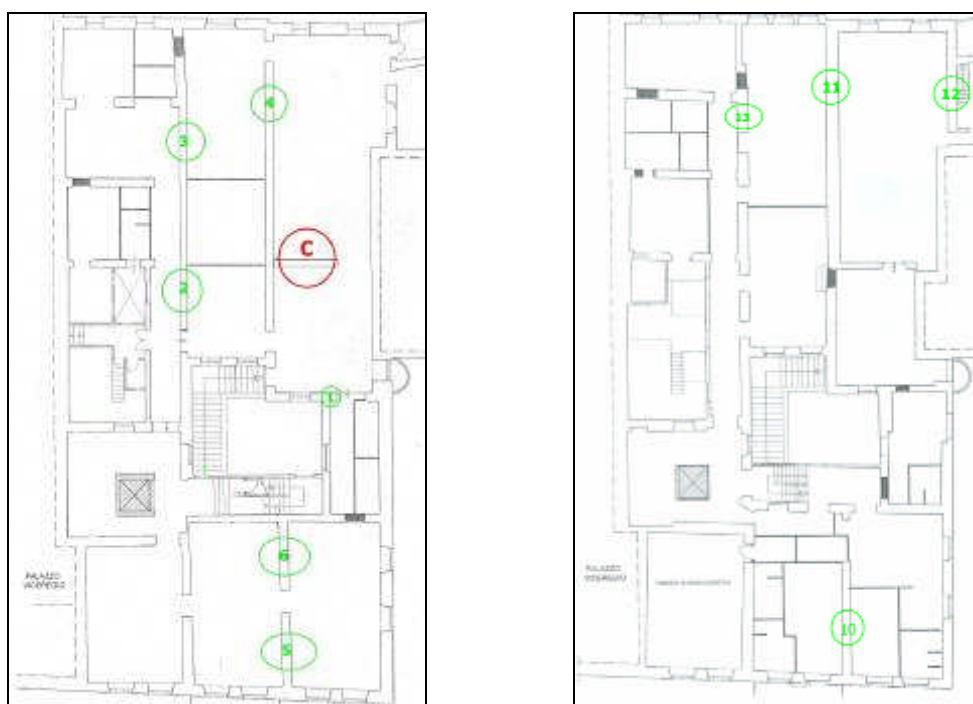
Fig. 3 Areas tested by sonic methods. First floor (left) and second floor (right)

SMs in Through Transmission mode have been carried out on the limestone masonries of the Archbishop's palace with the aim of qualitatively establishing the integrity of the materials and the static condition. The sonic surveys have been run extensively on the first and second floors' masonries. In the detail, the sonic tests have interested 7 wall's portions located on the first floor and 4 located on the second floor (Fig. 3). The characteristics of the tested areas are reported in Table 1. The sonic velocity  $V$  has been measured along paths crossing the thickness of the walls and located at the edges and in the centre of an ideal rectangle that identifies the tested area (Fig. 4).

- in the most of the tested areas V average value ranged between 900m/s and 1400m/s;
- areas 2, 3 and 12 showed V average value lower than 700m/s;
- area 1 showed a V average value higher than 2000m/s;
- V values scattering was extremely high in all the tested areas;
- the acquisition of the transmitted sonic signal in area 11 was impossible to perform.

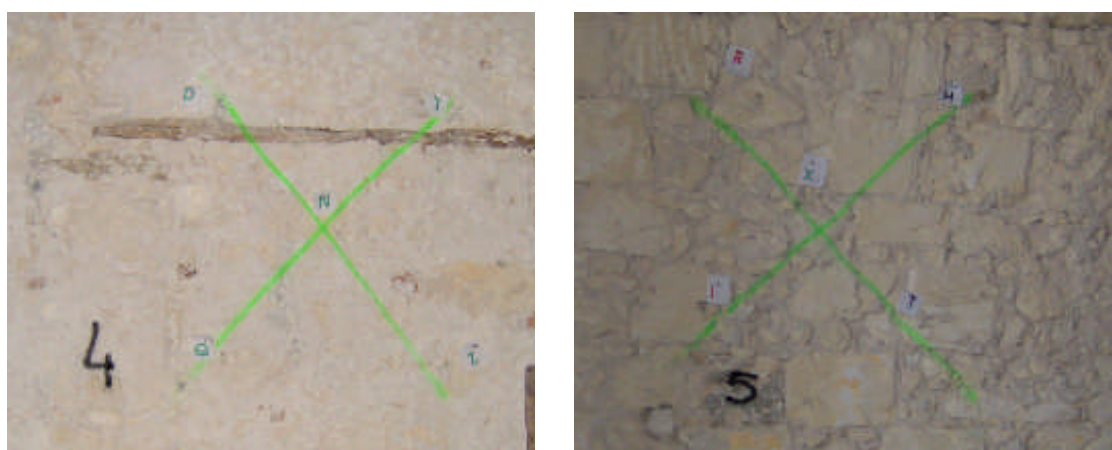
Fig. 4 Schema of measurements points

The velocity's values acquired on the crucial points (as shown in Fig. 4) have been processed and their histograms have been elaborated. As an example, the V histograms relative to two of the tested areas are shown in Fig. 5.

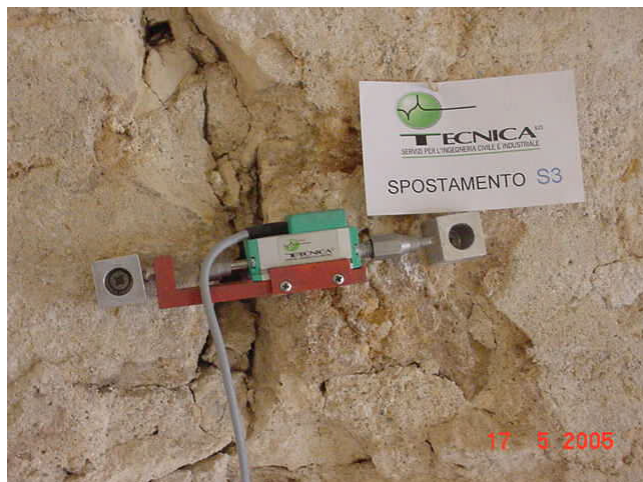
Fig. 7 Removable extensometer

Monitoring of cracks has been set up in order to assess possible risks and to understand the mechanical behaviour of the structures before planning the intervention. Aiming at evaluating the differential movement of the Archbishop, the most serious cracks have been monitored for 19 months. The displacements were measured by removable extensometer (Fig. 7) every month.
