980E Dump Body Bolster Corrosion

10/16/24

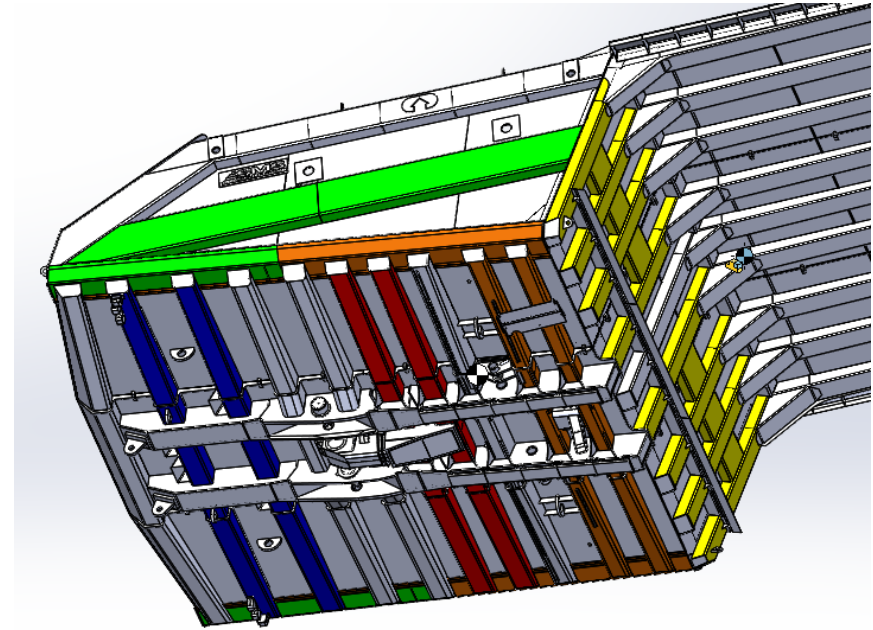
Arising Issue

- Heat and condensing gases from exhaust causing corrosion in bolster
- Leads to exhaust leaks thus insufficient heating of bed and decreased efficiency
- Causes preventable cracking and structural damage

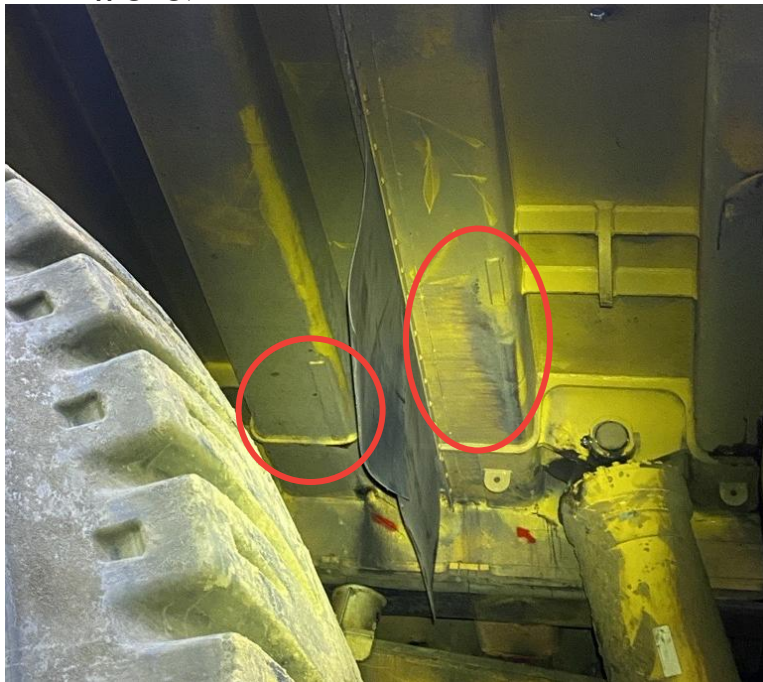
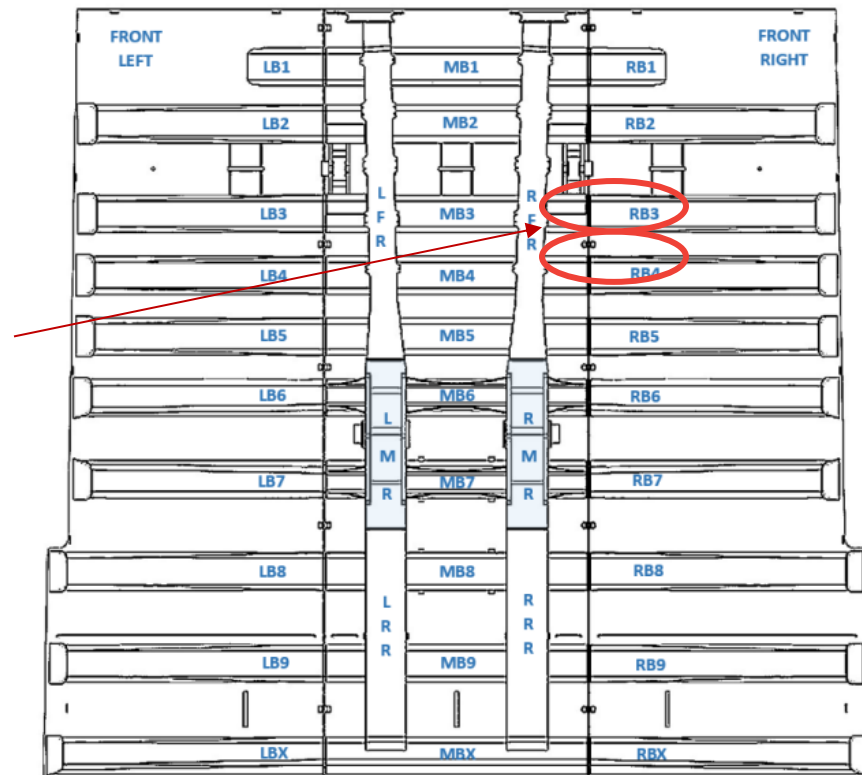
Critical Bolsters

- On 980E-4 Front Wall Bolsters see most corrosion due to exhaust heat – However they are not removed during rebuilds.
- Bolsters 3, 4, 5 subject to second most exhaust heat corrosion. Specifically first 3ft from the center of bed.
- Bolster 8 subject to greatest length of cracks – Suspected mechanical fatigue, not corrosion induced.

- Corrosion Mitigation: application of a thermal spray coating on **critical horizontal exhaust bolsters** most susceptible to corrosion.
- Use aluminum or Inconel based thermal spray coating
- Apply thermal spray coating to the inside of bolster 3,4 & 5 on 980E-4 due for rebuilds.
- Apply thermal spray coating to bolster 4 & 5 on 980E-5 dump bodies waiting to be in installed/assembled
- F347 is the -5 closest to a rebuild. Not economical to take -5 trucks out of operation to coat bolsters.
- Greatest results to be seen from coating first 3ft from the middle on bolsters 3,4,5 on 980E-4
- Contact Kymera International & SMS to discuss coating new bolsters before being welded to bed floor during rebuild.

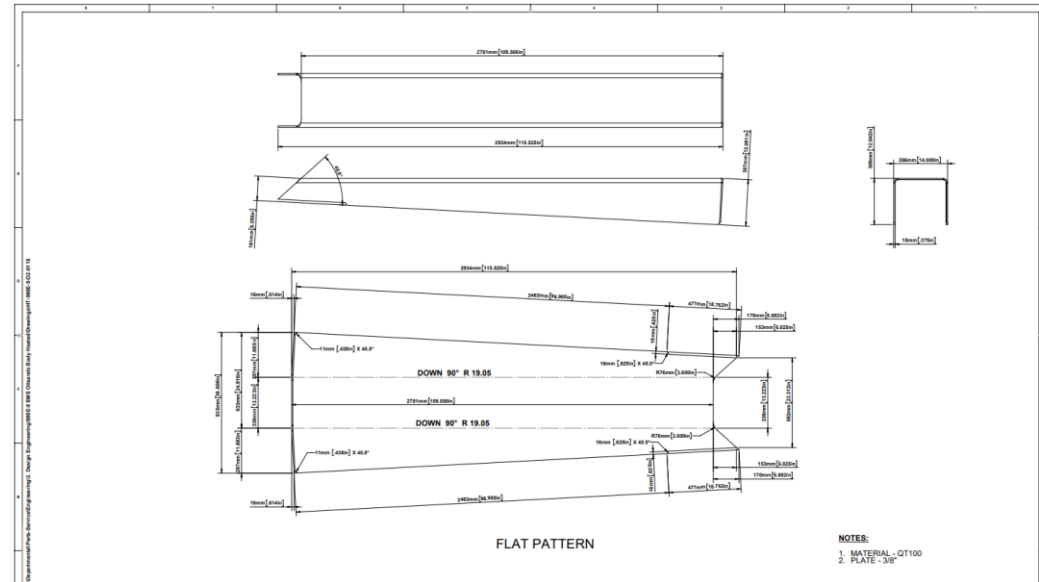
Bolster Drawing

- Bolsters are ~ 3m long and 1 wide/around
- ~ 18sq m of of coating required to cover bolster 4 ,5 & 6 on both side.
- Thickness TBD
