Reservoir Inspection Report

Lisvane Reservoir

This document has been prepared in good faith based on data collected by Abyss Solutions Pty. Ltd. during the inspection of Lisvane Reservoir on January 21-22, 2019. The information contained herein, is to the best knowledge of Abyss Solutions Pty. Ltd. complete and accurate.

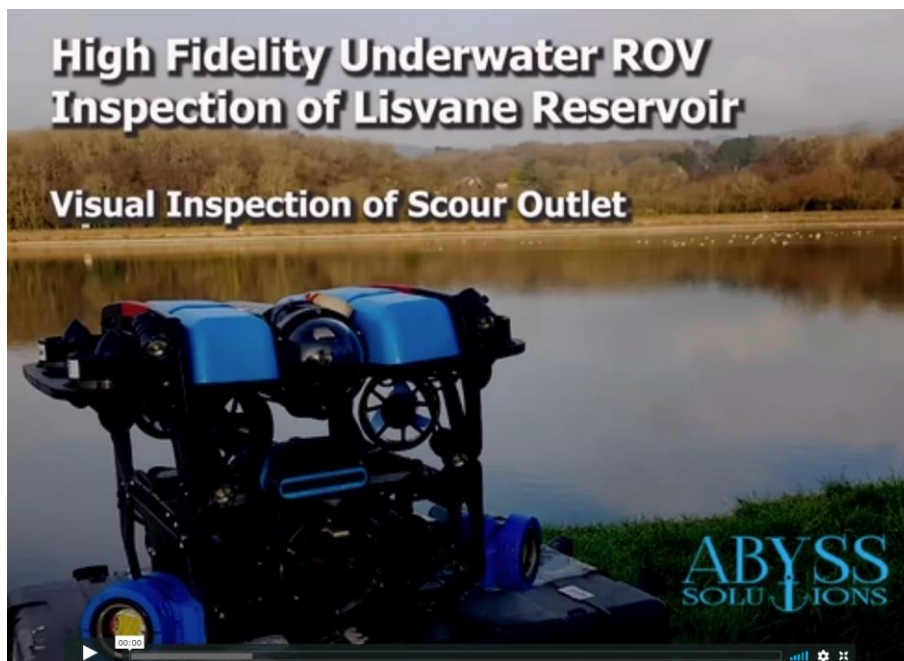
The scour outlet was judged to be in adequate condition based on the moderate deficiencies (fractured bar & debris) identified. Nevertheless, the outlet appeared to be functioning as designed. Imagery of the outlet screen is presented in Figures 2-06. Inspection video footage of the outlet and a visual 3D model are presented in Figure 7 and Figure 8, respectively.

Figure 7 - Inspection video of scour outlet screen ([click here](#) or on the image above to launch).

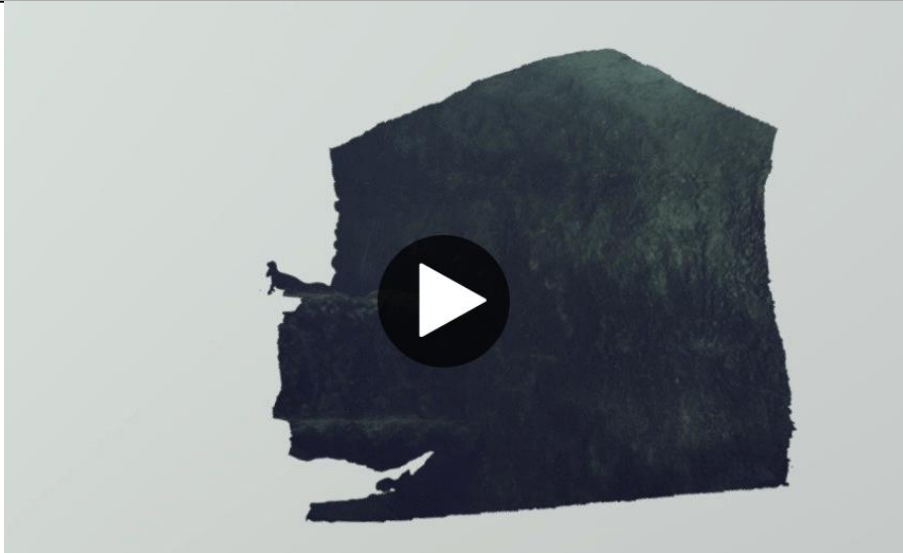
Figure 15 - Visual 3D model of embankment inlet headwall ([click here](#) or on the image above to launch).

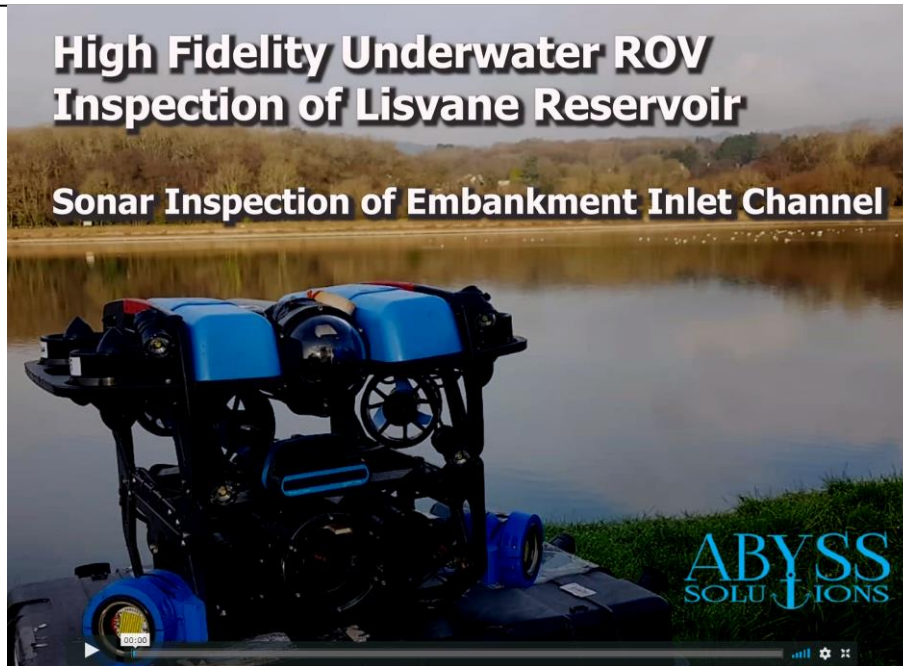
The channel appeared well defined in the sonar imagery indicating that it is largely intact and not completely silted. The channel was judged to be in good condition. A sonar image and video of the channel are presented in Figure 14 and Figure 15, respectively.

Figure 17 - Sonar inspection video of the embankment inlet channel ([click here](#) or on the image above to launch).
