# Reservoir Inspection Report

*Lisvane Reservoir*

Welsh Water  
Pentwyn Road  
Nelson, Treharris  
Mid Glamorgan CF46 6LY

Abyss Solutions Pty. Ltd.  
Unit 35 11-21 Underwood Rd  
Homebush NSW 2140  
Australia

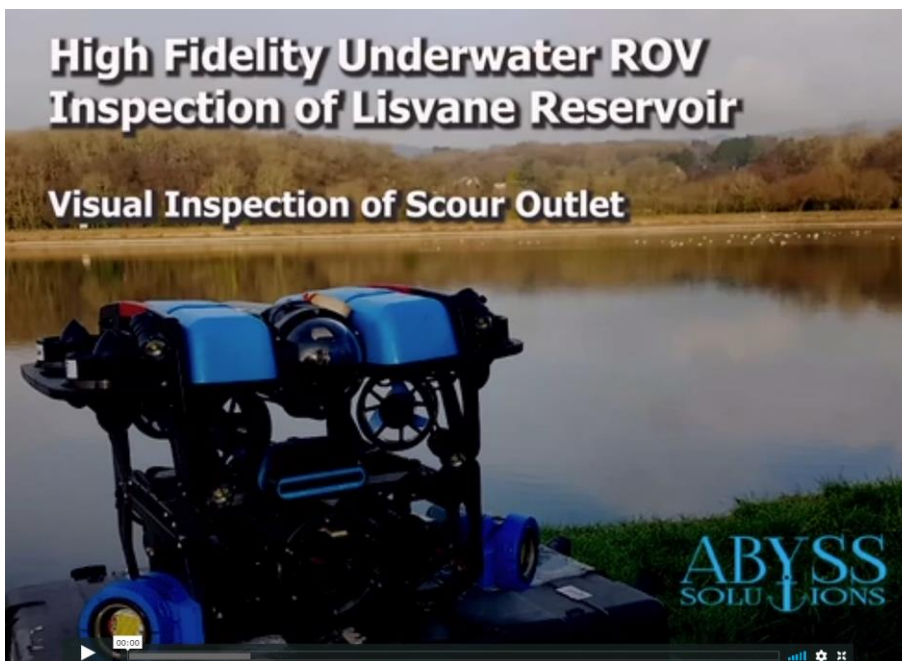
The scour outlet was judged to be in adequate condition based on the moderate deficiencies (fractured bar & debris) identified. Nevertheless, the outlet appeared to be functioning as designed. Imagery of the outlet screen is presented in Figures 2-06. Inspection video footage of the outlet and a visual 3D model are presented in Figure 7 and Figure 8, respectively.

Figure 7 - Inspection video of scour outlet screen ([click here](#) or on the image above to launch).

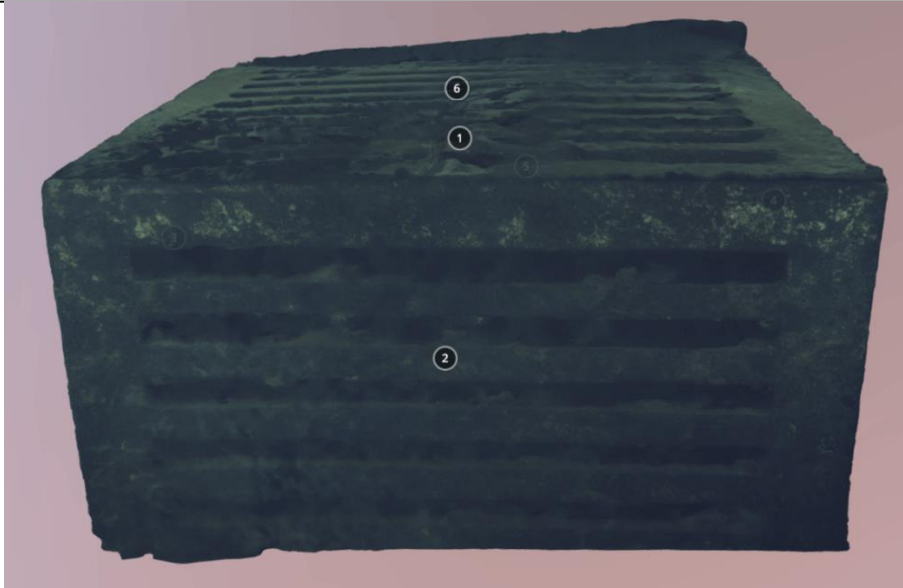
Figure 8 - Visual 3D model of scour outlet screen ([click here](#) or on the image above to launch).

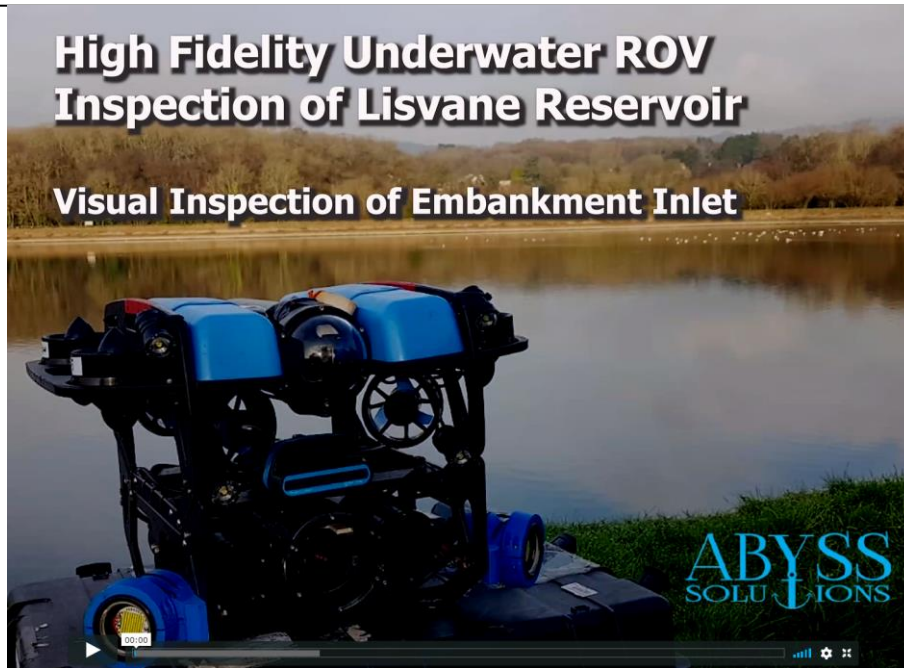
The inlet was judged to be in good condition based on the minor deterioration of the asset. The inlet appeared to be functioning as designed. Imagery of the inlet is presented in Figures 09-12. Inspection video footage of the inlet is presented in Figure 13. Visual 3D models of the concrete headwall and the interface between the I-beam brace and headwall are presented in Figure 14 and Figure 15, respectively.

Figure 13 - Inspection video of embankment inlet ([click here](#) or on the image above to launch).

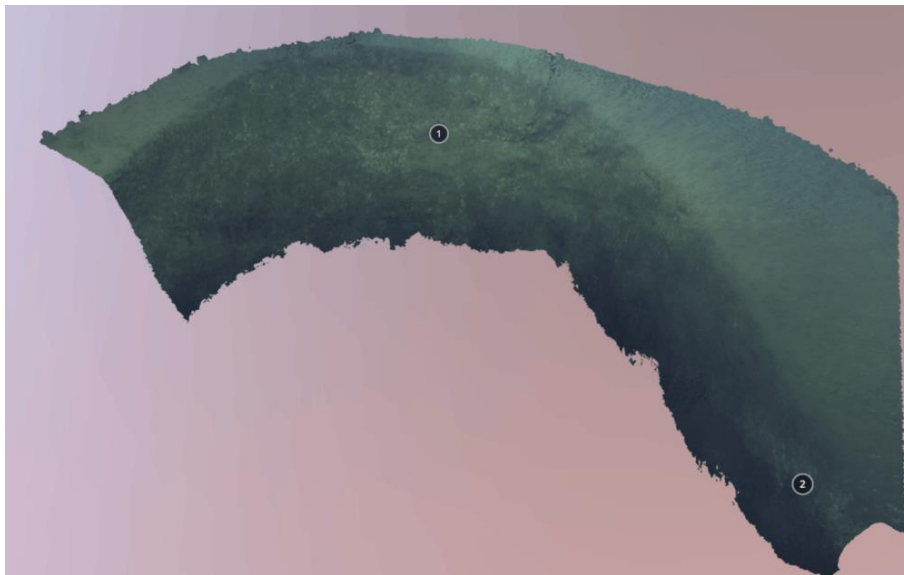
Figure 14 - Visual 3D model of embankment inlet headwall ([click here](#) or on the image above to launch).

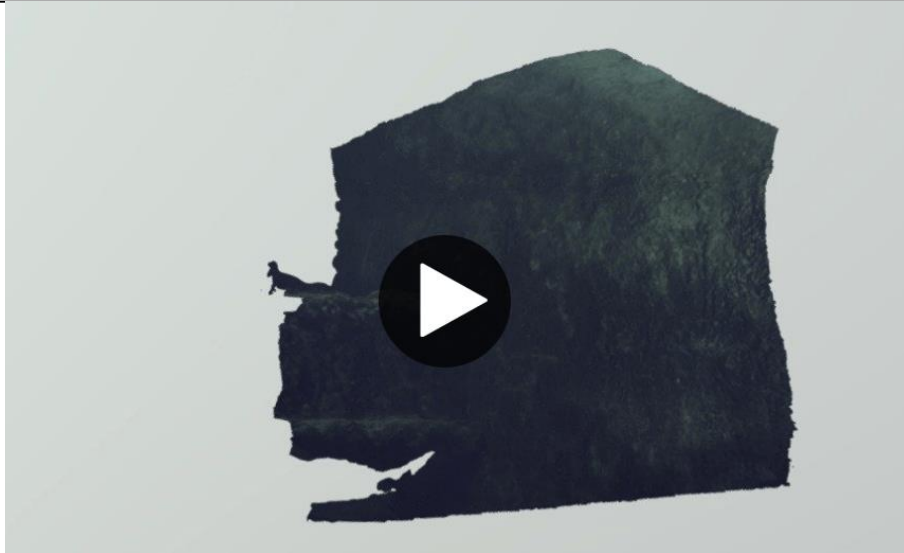
Figure 15 - Visual 3D model of embankment inlet headwall ([click here](#) or on the image above to launch).

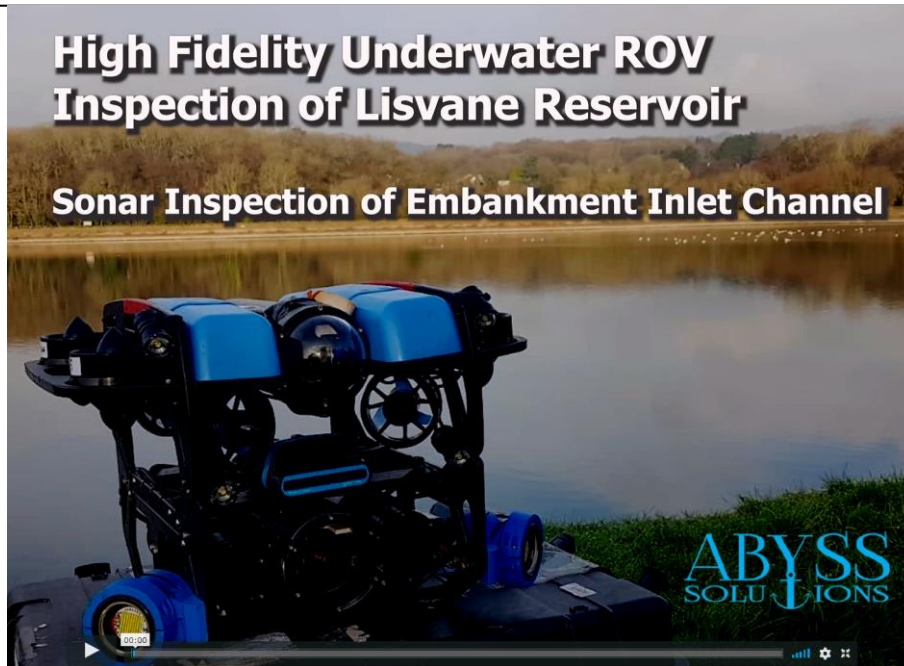
The channel appeared well defined in the sonar imagery indicating that it is largely intact and not completely silted. The channel was judged to be in good condition. A sonar image and video of the channel are presented in Figure 14 and Figure 15, respectively.

Figure 17 - Sonar inspection video of the embankment inlet channel ([click here](#) or on the image above to launch).
