Dam Inspection Report

Craig Goch Dam

Welsh Water
Pentwyn Road
Nelson, Treharris
Mid Glamorgan CF46 6LY

Abyss Solutions Pty. Ltd.
Unit 35 11-21 Underwood Rd
Homebush NSW 2140
Australia

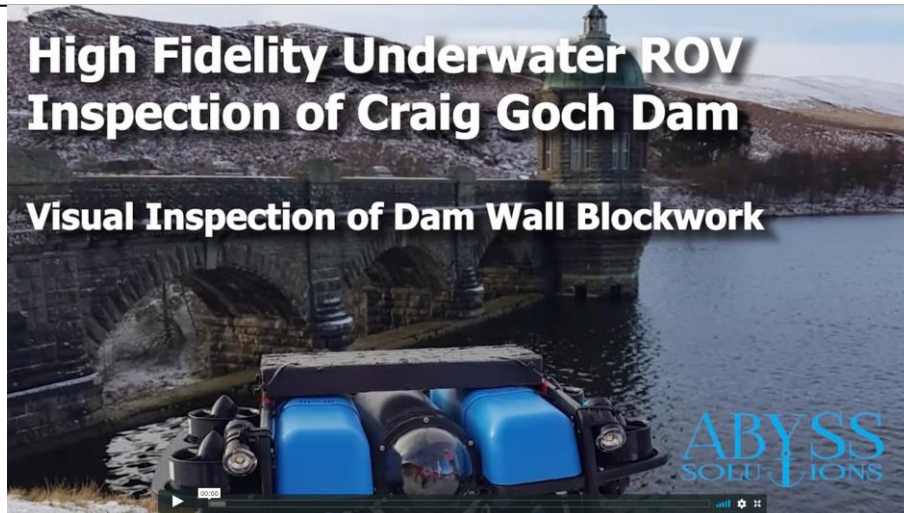
Figure 15 - Inspection video of dam wall blockwork ([click here](#) or on the image above to launch).

The exterior of the unreinforced concrete dam wall was found to be clad in stone blockwork. Blockwork junctions appeared to be grouted. The outlet tower was constructed with an octagonal profile, with 5 of the walls on the upstream face of the dam. The outlet tower was observed to be constructed of grouted stone blockwork. Condition - The blockwork was found to be intact with no signs of major cracking observed. Grouting appeared to be in place with no instances of missing grout identified. Stone lintels above trash screen grate penetrations appeared intact. The blockwork appeared to be in good condition.

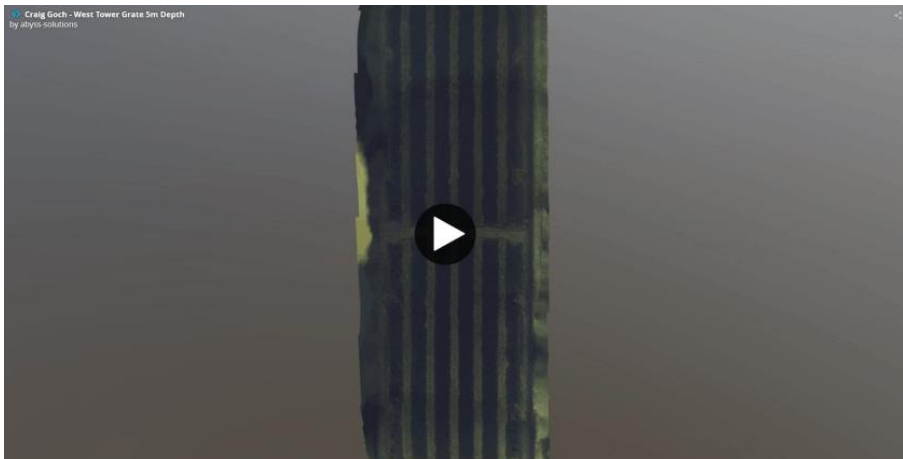
Figure 19 - Trash screen grate at 5m depth on the western wall of the outlet tower. The grate is heavily corroded with significant material loss.

Figure 20 - 3D model of trash screen grate at 5m depth on the western wall of the outlet tower ([click here](#) or on the figure above to launch).

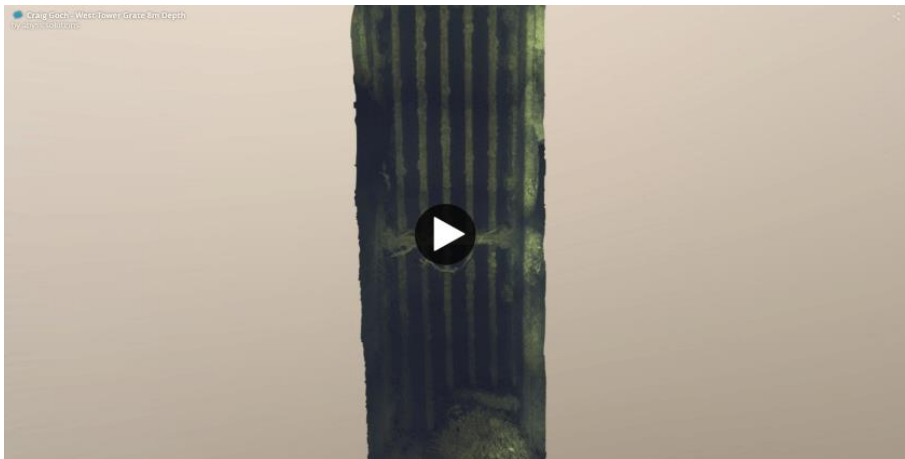
Figure 21 - Trash screen grate at 8m depth on the western wall of the outlet tower. The grate is heavily corroded with significant material loss. Material obstructing 10% of the grate was observed.

Figure 22 - 3D model of trash screen grate at 1m depth on the western wall of the outlet tower ([click here](#) or on the figure above to launch).

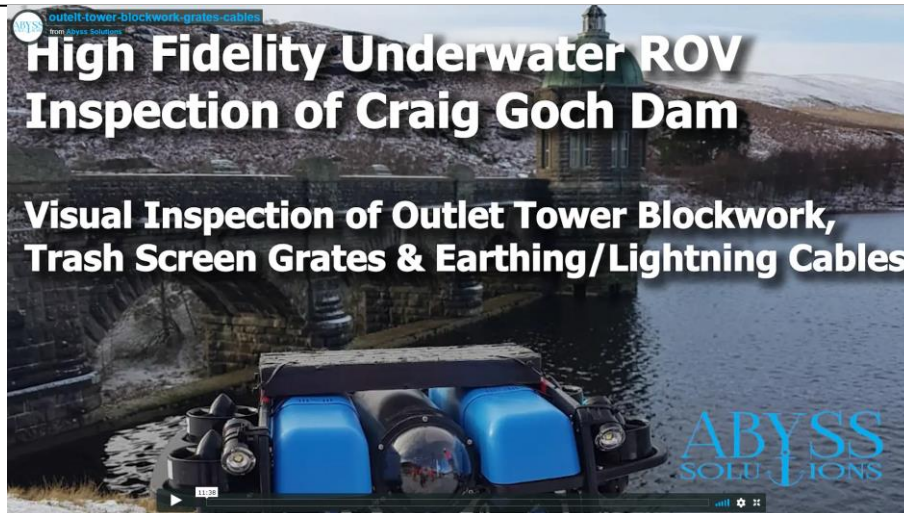
Figure 35 - Inspection video of outlet tower trash screen grates ([click here](#) or on the image above to launch).

Four rectangular trash screen grates were observed on each of the western, south western, south eastern and eastern walls of the outlet tower. The grates had dimensions of 2.1m(H) x 0.6m(W). The grates consisted of 5 vertical bars with a single cross member at mid-height. The grates were observed to be heavily corroded with significant material loss. Nevertheless, the grates and bars remained in place. The surrounding blockwork appeared intact. material obstructing 10% of the grate at 8m depth on the western wall was observed. The grates are judged to be in poor condition as major deficiencies have been noted. These elements will require repair to continue to operate as designed.

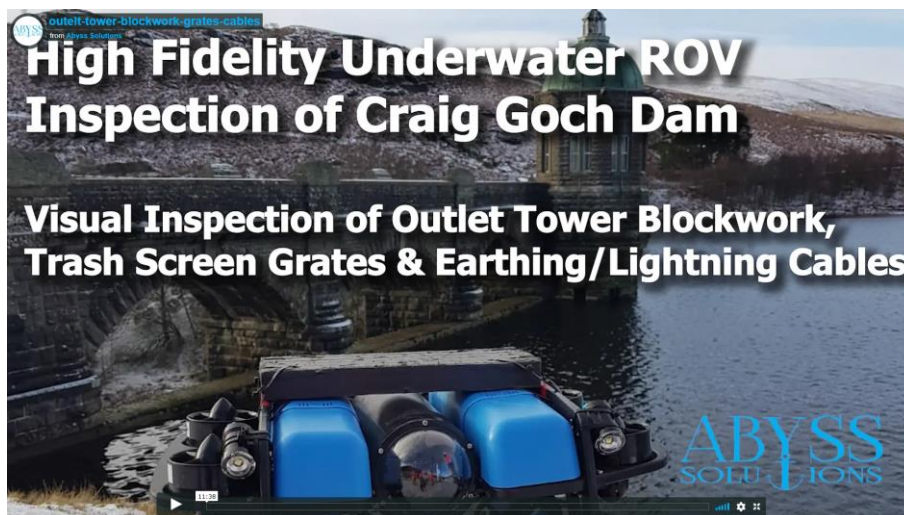
Figure 40 - Inspection video of outlet tower earthing and lightning cables ([click here](#) or on the image above to launch).

The earthing cable was found to track down the south western wall of the outlet tower unsecured to approximately 8m. The cable was found to be unterminated with the termination device likely missing. Similarly, the lightning cable was found to track along the southern wall of the outlet tower unsecured to 8m. The cable was again found to be unterminated with the termination device likely missing. Both cables appeared intact with no obvious deterioration. However, termination devices at the ends of the cables appeared to be missing.

Moderate deficiencies have been identified which include the missing terminators. These elements will require repair to continue to function as designed. The cables are judged to be in adequate condition.

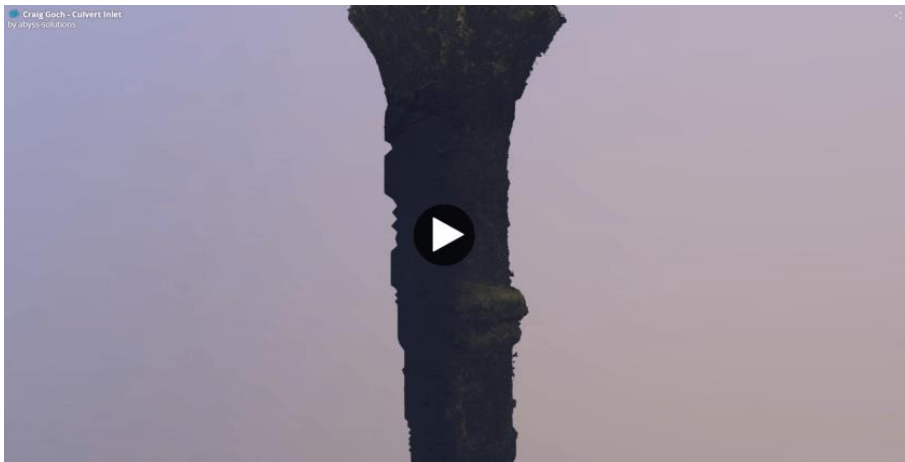
The culvert inlet pipework, supports and bellmouth were found to be intact and covered in heavy fouling. Surface deterioration of the pipework is likely. The bellmouth appeared to be free of obstructions. The I-beam supports appeared to be intact and heavily fouled. The culvert headwall and I-beam interface appeared intact and free of major spalling. Overall the condition of the culvert inlet is judged to be adequate.

Figure 44 - 3D model of Culvert inlet pipework and bellmouth ([click here](#) or on figure above to launch).

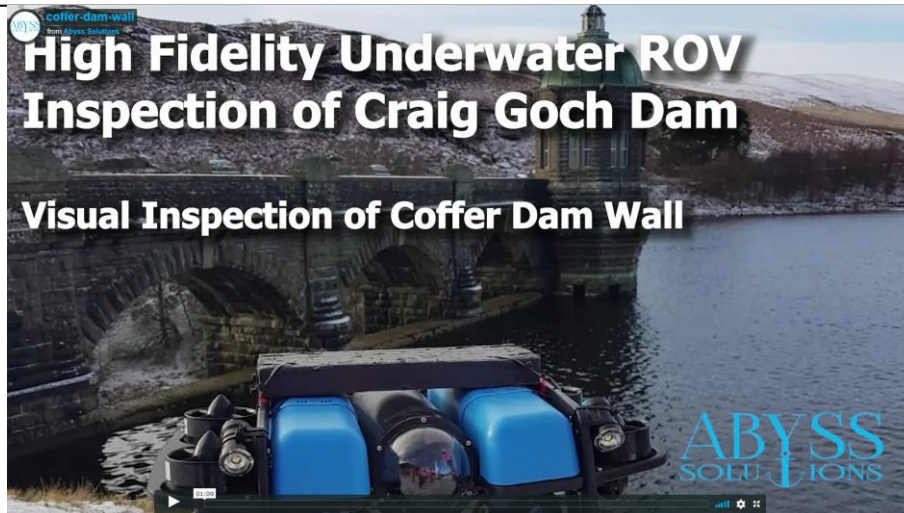
Figure 57 - Inspection video of downstream coffer dam wall ([click here](#) or on the figure above to launch).

Figure 56 - North eastern end of coffer dam wall. The concrete coffer dam wall appeared intact with no sign of major cracking or spalling.
