# Dam Inspection Report

*Craig Goch Dam*

Welsh Water  
Pentwyn Road  
Nelson, Treharris  
Mid Glamorgan CF46 6LY

Abyss Solutions Pty. Ltd.  
Unit 35 11-21 Underwood Rd  
Homebush NSW 2140  
Australia

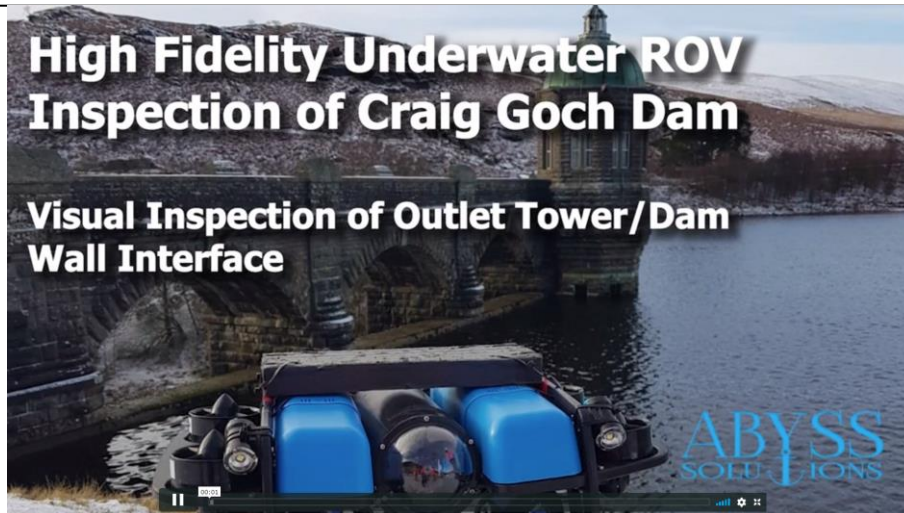
Figure 6 - Inspection video of outlet tower/dam wall interface ([click here](#) or on the image above to launch).

**Figure 5 - Eastern interface of outlet tower and dam wall at maximum depth. No obvious separation between the outlet tower and dam wall was detected.**

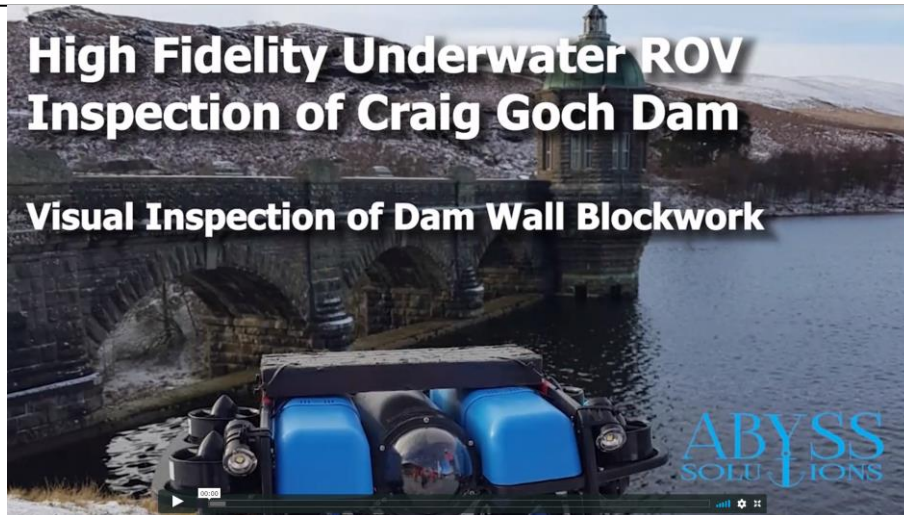
Figure 15 - Inspection video of dam wall blockwork ([click here](#) or on the image above to launch).

The exterior of the unreinforced concrete dam wall was found to be clad in stone blockwork. Blockwork junctions appeared to be grouted. The outlet tower was constructed with an octagonal profile, with 5 of the walls on the upstream face of the dam. The outlet tower was observed to be constructed of grouted stone blockwork. Condition - The blockwork was found to be intact with no signs of major cracking observed. Grouting appeared to be in place with no instances of missing grout identified. Stone lintels above trash screen grate penetrations appeared intact. The blockwork appeared to be in good condition.

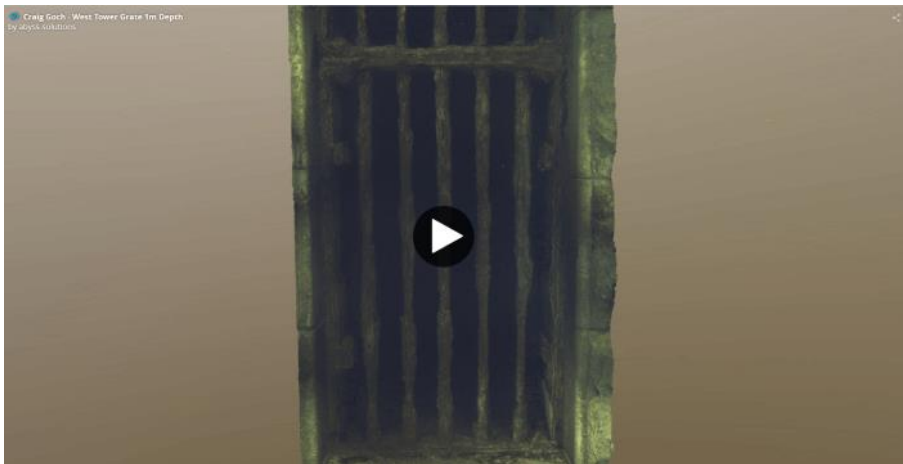
**Figure 18 - 3D model of trash screen grate at 1m depth on the western wall of the outlet tower ([click here](#) or on the figure above to launch).**

Four rectangular trash screen grates were observed on each of the western, south western, south eastern and eastern walls of the outlet tower. The grates had dimensions of 2.1m(H) x 0.6m(W). The grates consisted of 5 vertical bars with a single cross member at mid-height. The grates were observed to be heavily corroded with significant material loss. Nevertheless, the grates and bars remained in place. The surrounding blockwork appeared intact. material obstructing 10% of the grate at 8m depth on the western wall was observed. The grates are judged to be in poor condition as major deficiencies have been noted. These elements will require repair to continue to operate as designed.

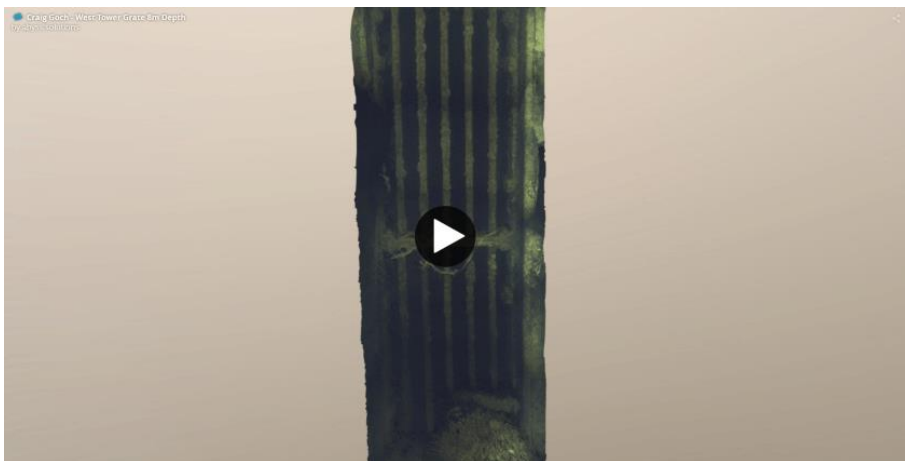
**Figure 22 - 3D model of trash screen grate at 1m depth on the western wall of the outlet tower ([click here](#) or on the figure above to launch).**

**Figure 21 - Trash screen grate at 8m depth on the western wall of the outlet tower. The grate is heavily corroded with significant material loss. Material obstructing 10% of the grate was observed.**

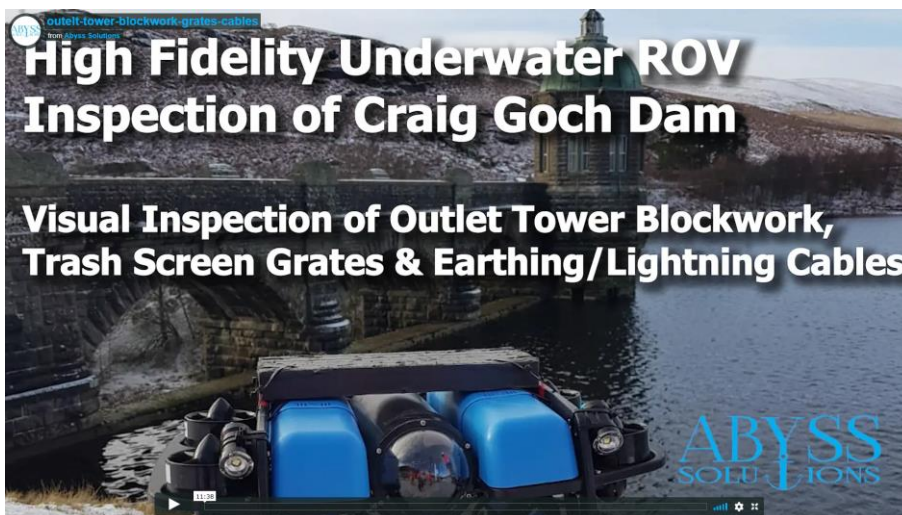
Figure 40 - Inspection video of outlet tower earthing and lightning cables ([click here](#) or on the image above to launch).

The earthing cable was found to track down the south western wall of the outlet tower unsecured to approximately 8m. The cable was found to be unterminated with the termination device likely missing. Similarly, the lightning cable was found to track along the southern wall of the outlet tower unsecured to 8m. The cable was again found to be unterminated with the termination device likely missing. Both cables appeared intact with no obvious deterioration. However, termination devices at the ends of the cables appeared to be missing.

Moderate deficiencies have been identified which include the missing terminators. These elements will require repair to continue to function as designed. The cables are judged to be in adequate condition.

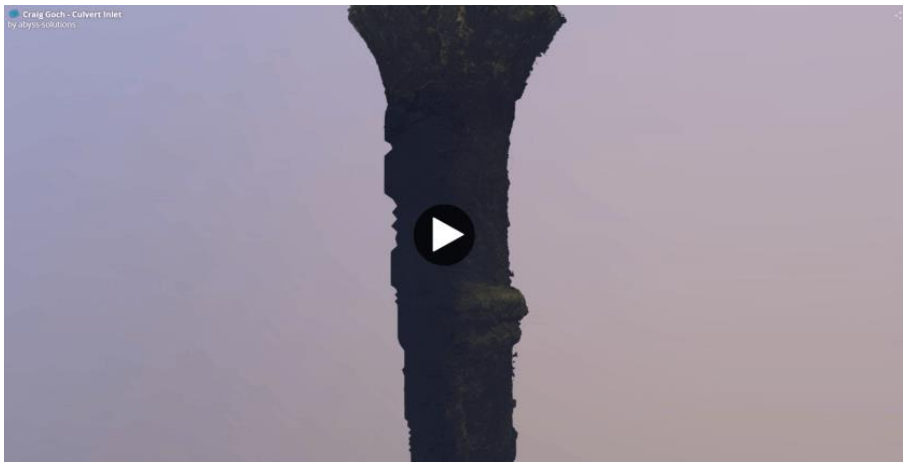
**Figure 44 - 3D model of Culvert inlet pipework and bellmouth ([click here](#) or on figure above to launch).**

The culvert inlet pipework, supports and bellmouth were found to be intact and covered in heavy fouling. Surface deterioration of the pipework is likely. The bellmouth appeared to be free of obstructions. The I-beam supports appeared to be intact and heavily fouled. The culvert headwall and I-beam interface appeared intact and free of major spalling. Overall the condition of the culvert inlet is judged to be adequate.

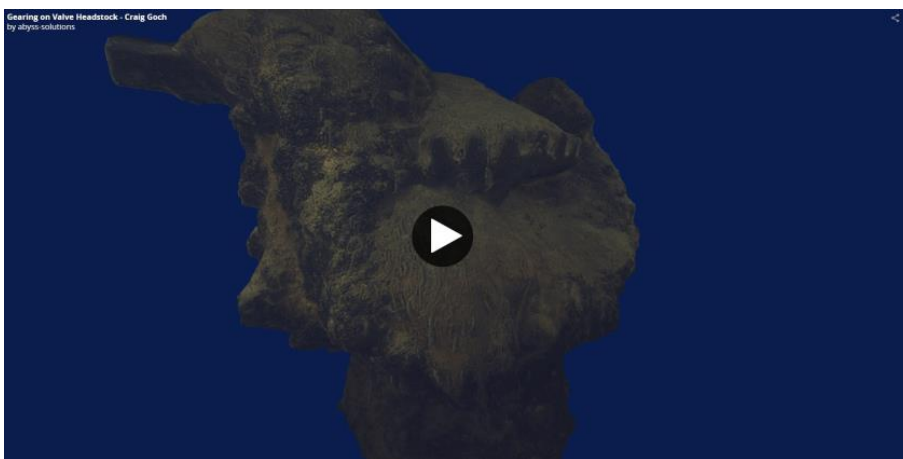
**Figure 51 - 3D model of scour outlet valve headstock gearing ([click here](#) or on the figure above to launch).**

**Figure 50 - Scour outlet valve headstock gearing. The gearing appears intact however is heavily fouled and likely to have experienced surface corrosion.**

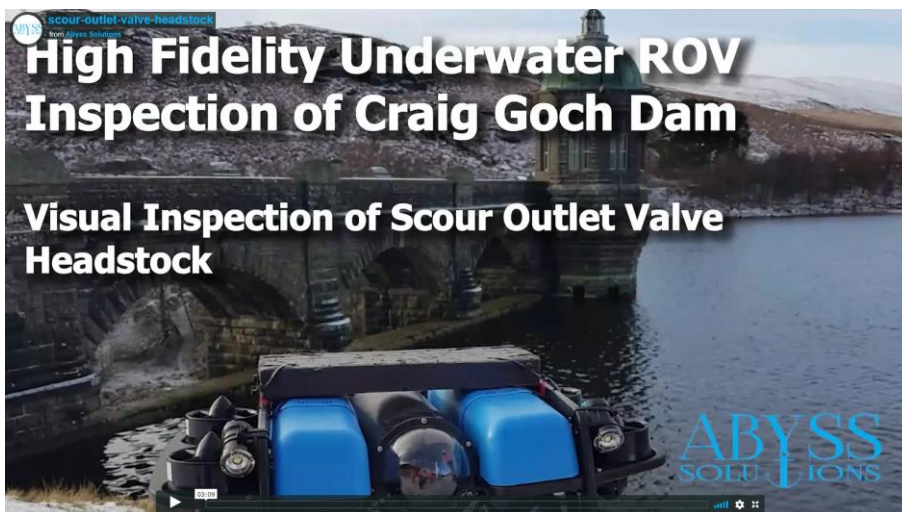
Figure 53 - Inspection video of scour outlet valve headstock ([click here](#) or on the figure above to launch).

Figure 52 - Scour outlet valve operation rod. The rod appears intact however is heavily fouled and likely to have experienced surface corrosion.
