Dam Inspection Report

Craig Goch Dam

Welsh Water
Pentwyn Road
Nelson, Treharris
Mid Glamorgan CF46 6LY

Abyss Solutions Pty. Ltd.
Unit 35 11-21 Underwood Rd
Homebush NSW 2140
Australia

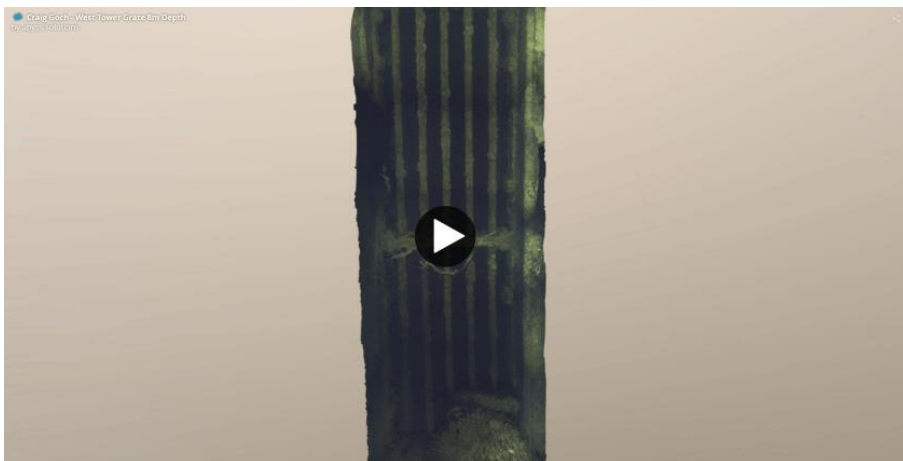
Figure 22 - 3D model of trash screen grate at 1m depth on the western wall of the outlet tower ([click here](#) or on the figure above to launch).

Figure 21 - Trash screen grate at 8m depth on the western wall of the outlet tower. The grate is heavily corroded with significant material loss. Material obstructing 10% of the grate was observed.

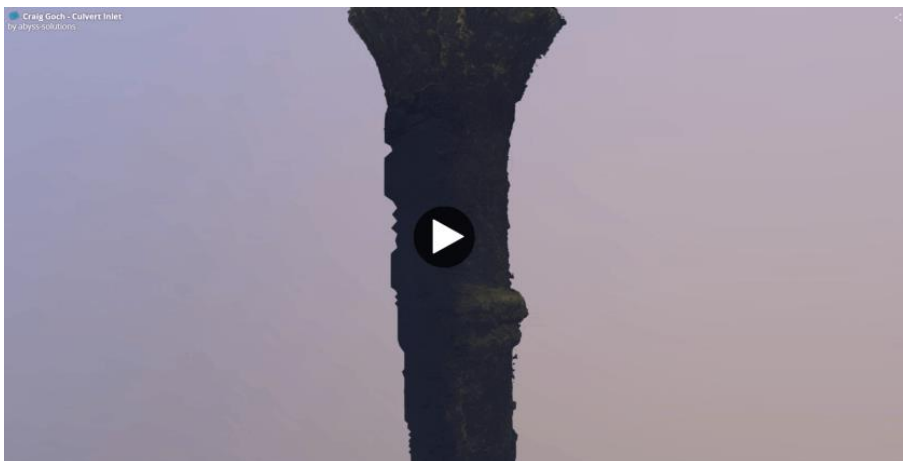
Figure 44 - 3D model of Culvert inlet pipework and bellmouth ([click here](#) or on figure above to launch).

The culvert inlet pipework, supports and bellmouth were found to be intact and covered in heavy fouling. Surface deterioration of the pipework is likely. The bellmouth appeared to be free of obstructions. The I-beam supports appeared to be intact and heavily fouled. The culvert headwall and I-beam interface appeared intact and free of major spalling. Overall the condition of the culvert inlet is judged to be adequate.

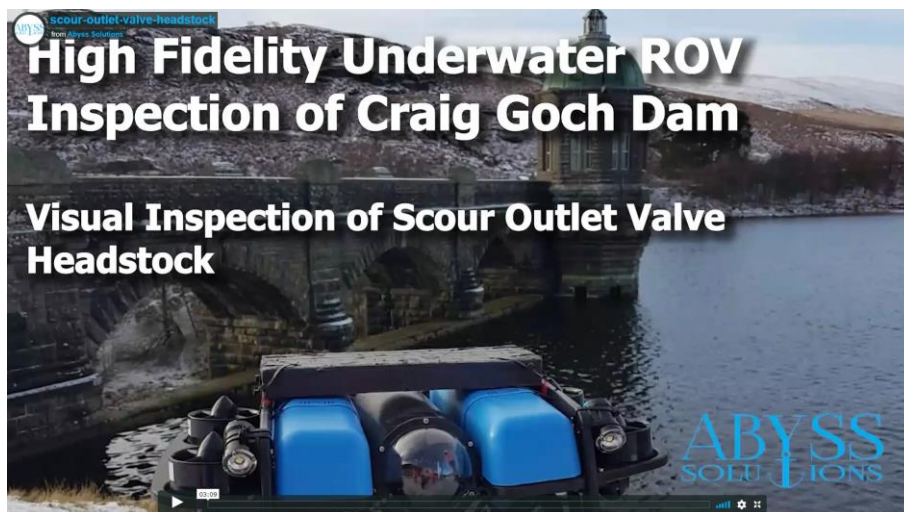
Figure 53 - Inspection video of scour outlet valve headstock ([click here](#) or on the figure above to launch).

Figure 50 - Scour outlet valve headstock gearing. The gearing appears intact however is heavily fouled and likely to have experienced surface corrosion.

Figure 52 - Scour outlet valve operation rod. The rod appears intact however is heavily fouled and likely to have experienced surface corrosion.
