CanSat 2025 Post Flight Review (PFR) Outline

Team #3114
Robotics for Space eXploration (UofT)

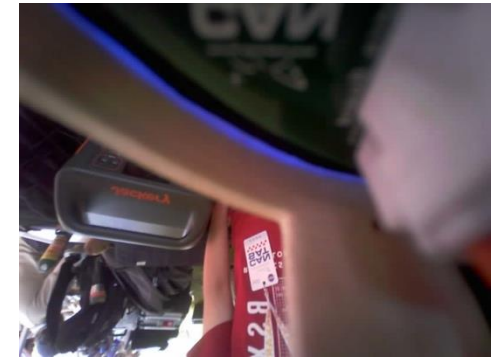
Unfortunately, our camera sensors failed to record videos. Our assessment is that due to the extreme air temperature of $\sim 40^{\circ}\text{C}$ in the CanSat Payload, the already thermally stressed sensors overheated, resulting in the destruction of the Payload Release Camera, as well as the Ground Camera to crash. This is supported by the steep decline in recording quality during testing as seen in the two recordings attached as well as the significantly worse camera quality in the Ground Camera footage, further discussed in the next slide.

Signs of eminent sensor failure were present when conducting a postmortem of launch day:

The cameras failed mid mission – this demonstrates need for better thermal management and better overall cameras.
