The Therac 25

A case study in safety failure

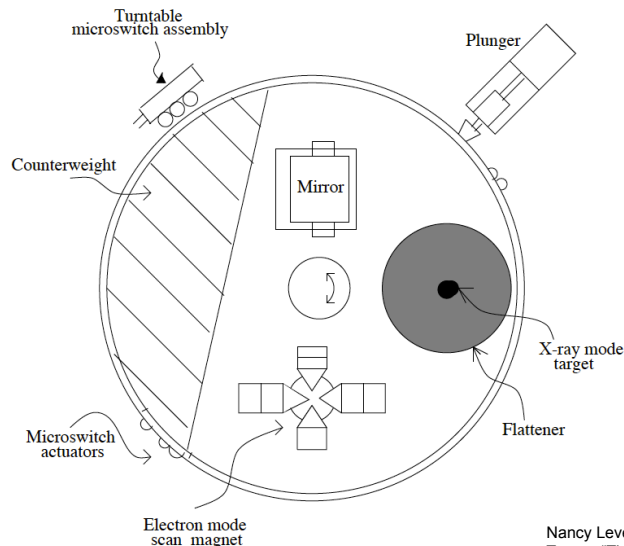
Figure 1: Upper turntable assembly.

- Electron mode
 - 5-25 MEV
 - Magnets scan and spread beam
 - Ion chamber monitor
- X-ray mode
 - 25 MEV electrons hit target
 - “Beam flattener” attenuates
 - 100x beam current
 - Ion chamber monitor
- Field-light mode
 - No current
 - Mirror & light used to check alignment
 - No ion chamber (since not treating)
