**Investigation of wireline failure**  
**Reference: Dimension Bid – CWR-1280**

**Danum Well Services Ltd**

The Laboratory was commissioned by Danum Well Services to assess wireline break that occurred during operational use by Dimension Bid.

Well : LARUT A-27L

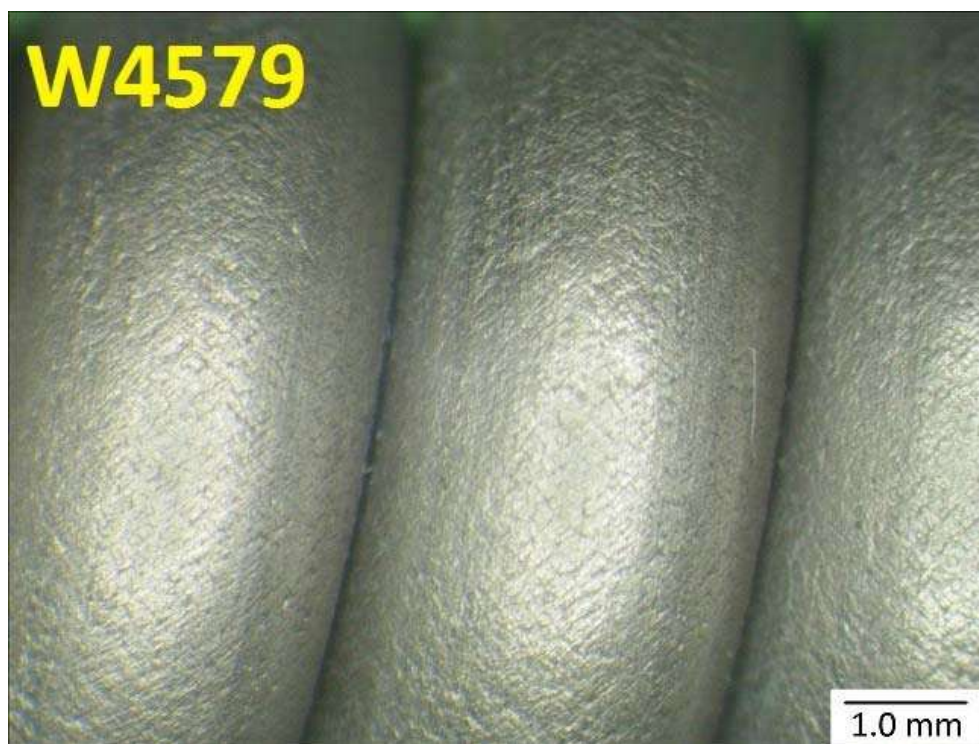
Figure 16, archived wrap sample of CWR-1280

For reference the original test wrap performed by the Laboratory during initial certification is presented in Figure 16. The sample revealed a typical surface without cracks or ruptures present.
