**CUSTOMER SUPPORT
ASSOCIATION**
Sponsored by Freightliner LLC

S60, MBE4000 & MBE900 Engine Updates

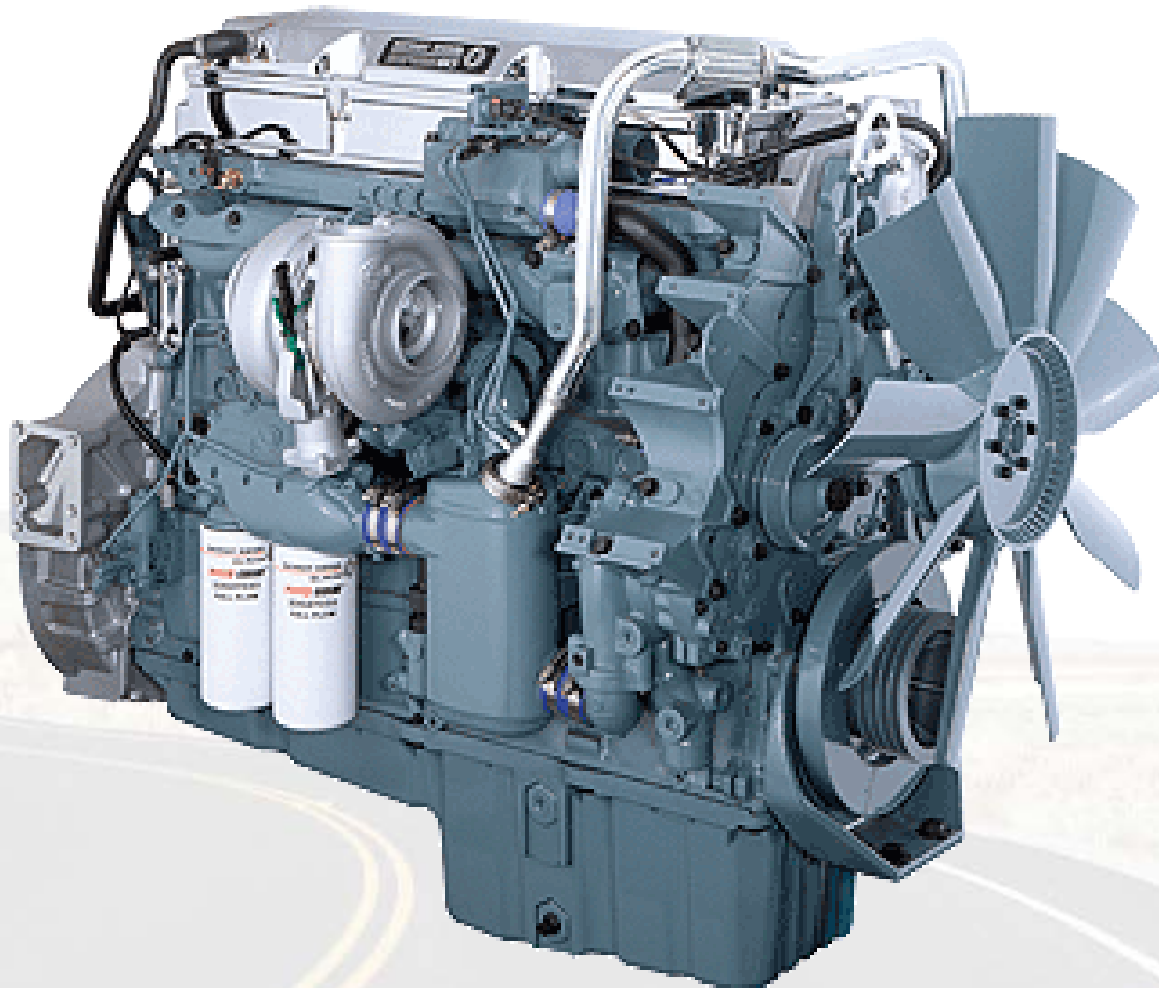
S60 EGR Broken Delta P Sensor Mounting Bracket – Ref 05 TS-53

- Hose Connection Points Crack or Break Due to Improper Repair Procedures or People Stepping on it (cleaning windshield, etc.)
 - To save time, technicians will pull tubes off the bracket & bend them
 - The tubes will then be pushed back onto the bracket, which creates a stress point on the bracket & subsequent failure
- Proper Repair Procedures for Removing the Delta P Tubes
 - Loosen the four hose clamps
 - Remove the P-clips to the exhaust manifold heat shield
 - Loosen the tubes at the venturi
- S60 Service Manual was incorrect & has been fixed
- Stronger bracket new p/n 23536986 replaced p/n 23535850 effective with s/n 06R0926421 on 6/30/06

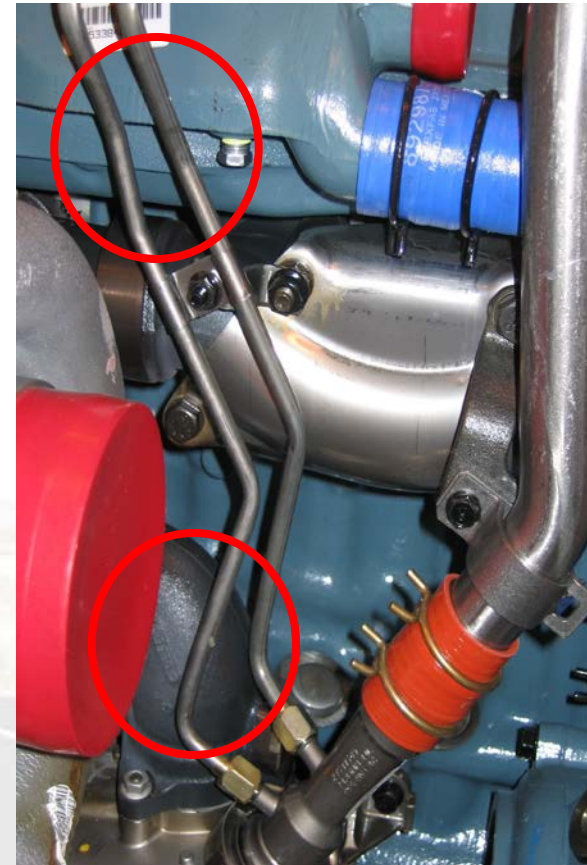
- High Number of No Trouble Found on Returned Sensors.
- SIB's 1-DDECV-05, 2-DDECV-05, & 2-SECM-05 Lists New DPS Counts to be 86-118 with Key On Engine Off (KOEO).
- For High DP Counts, Check for Undercoating Beneath Cab Ground Cable.
- Sensors with Moisture in Them Should be Cleaned, Dried & Reused.

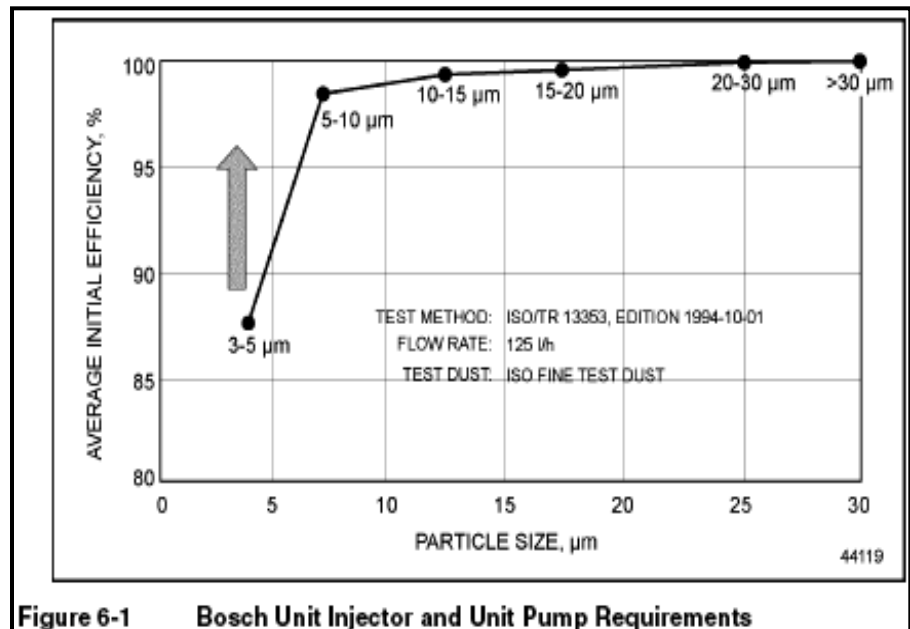
Figure 6-1 Bosch Unit Injector and Unit Pump Requirements

- N3 Injectors Require The Use Of Lower Micron Fuel Filters For 200,000 Mile Warranty Coverage
- Refer to 7SE270 "Lubricating Oil, Fuel & Filters" For Filtration Requirements
- Maintenance Interval Is 15,000 miles - Refer To S60 Operators Guide 6SE484
- Check For Plugged Fuel Filters
 - Poor Quality Of Fuel From Post Hurricane Distribution Problems, etc.
 - May Not Last 30-50,000 Miles To Coincide With Oil Changes.
 - Plugging Issues Before 15,000 Miles Primarily Involve Secondary Spin-On Filter – New Filter Released – Estimated Effectivity 3Q06
- DDC Power Guard Filter Part Numbers
 - Primary Spin-On Fuel/Water Separator P/N 23512317
 - Secondary Spin-On Filter P/N 23533726
 - Davco Fuel Pro Filter P/N 23533816

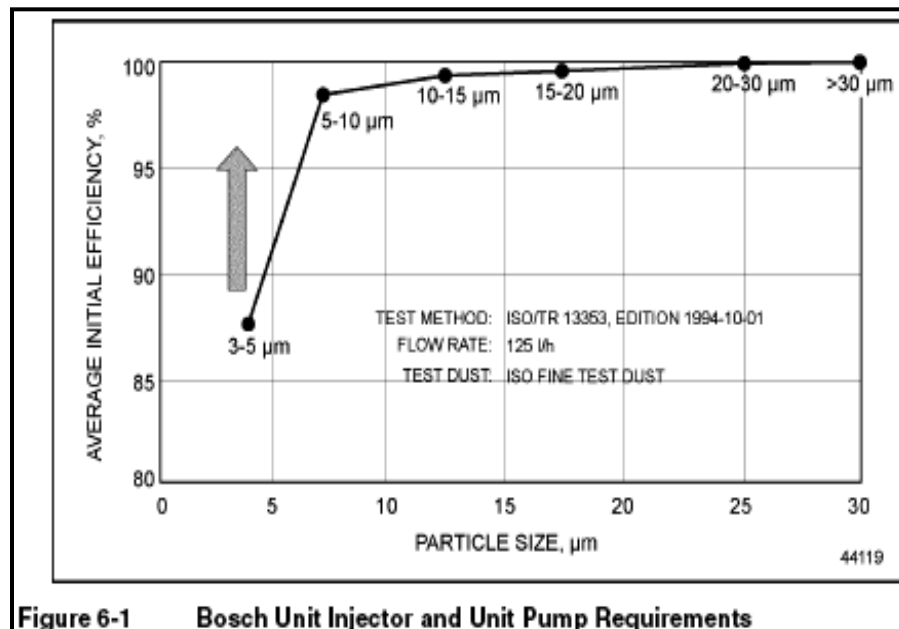
- Alliance/Racor filters also suffering short life
- Standard filter option from Freightliner
- Filters were TOO efficient – trapping more material than necessary
- New filters released by Freightliner – reference F/L Service Bulletin 47-19
 - New filter F/L p/n ABP N122 R50416 replaces p/n ABP N122 R50406
 - New filter F/L p/n ABP N122 R50417 replaces p/n ABP N122 R50407

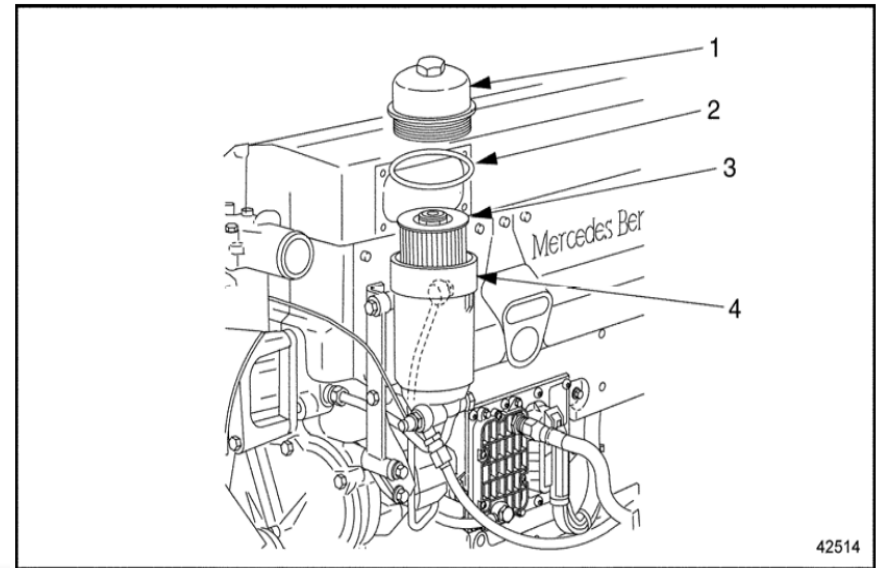
- Non-EGR engines use a Hengst filter & housing.
- EGR engines use a Mann filter & housing.
- MBE has standardized on the Hengst filter p/n 5410900151 for all MBE 4000 engines effective with s/n 0460837675 on 25-Nov-05.
- Problems with using the wrong filters were traced to improper replacement procedures – Reference 05 TS-22.
 - Install filter.
 - Fill with fuel.
 - Install cap.

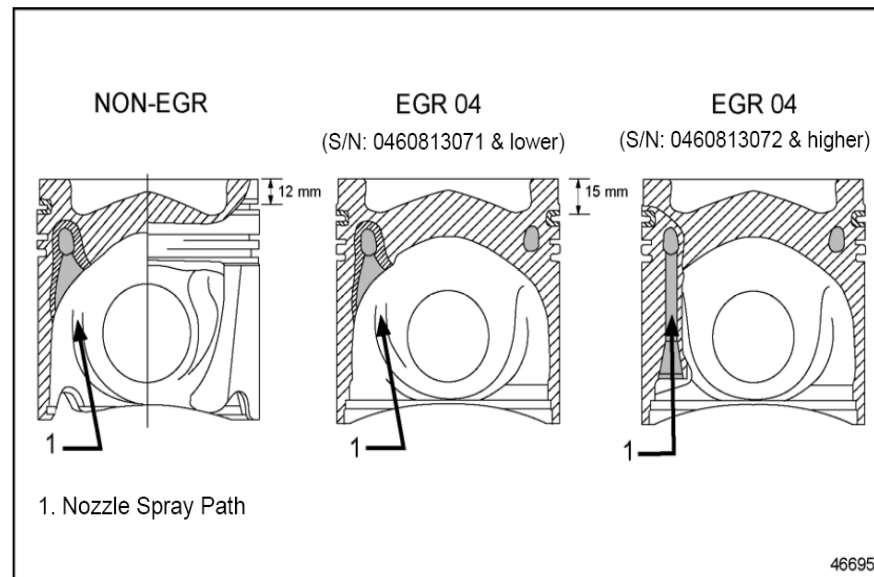
- **Spray Nozzle to Piston Alignment is Critical. If Alignment is Not Correct, Engine Damage May Occur.**
- **When Servicing Spray Nozzles, Pistons, or any Component within the Crankcase where Accidental Damage to the Spray Nozzle can Occur, Slowly Rotate the Engine. If Resistance is Felt during Engine Rotation, inspect Spray Nozzles for Interference. Correct if Necessary.**

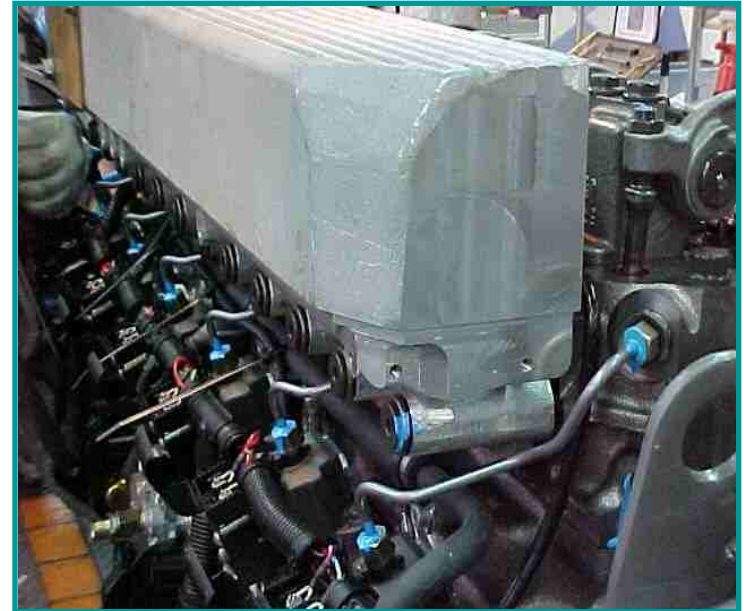
- Changed Internal Radius & Coating Effective with S/N 0460784382 On 24-Jun-04 – new p/n 4570701033 - **Significant Reduction In Leaks**
- Nut Material Change Effective With S/N 0460818087 On 25-May-05 – new p/n 4570701333
- Tube Material Change Effective With S/N 0460836880 on 11-Nov-05 – new p/n 4570701533
- Tube Dimensional Change Effective With S/N 0460847831 on 21-Feb-06 – new p/n 4570701733

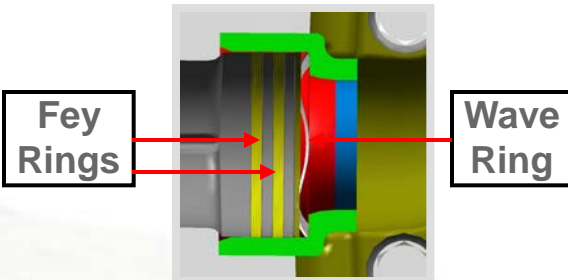
Wave Ring - p/n 0001428257
Fey Ring - p/n 0001427657
Change Point: 5-May-06, s/n 0460855340

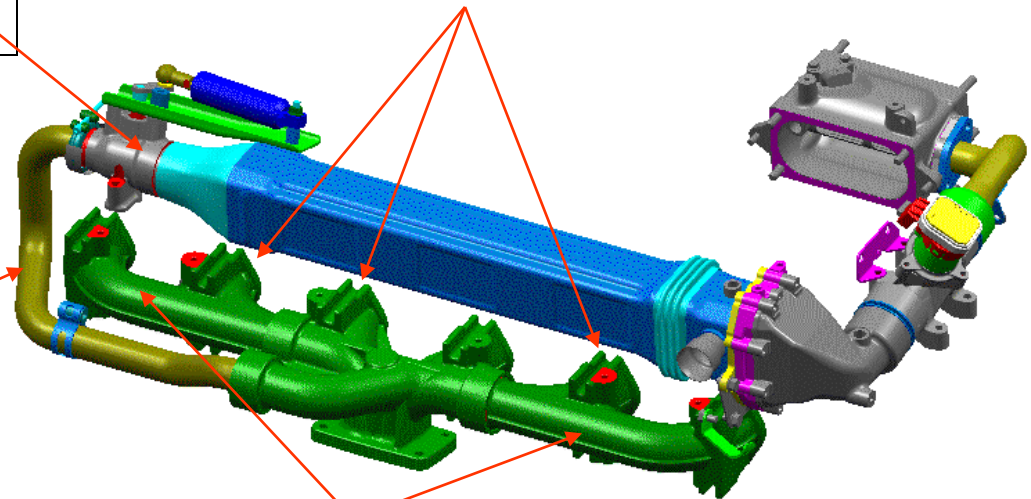
End Exhaust Manifold – (2) p/n 4601420801
Change Point: 11-Nov-05, s/n 0460836656

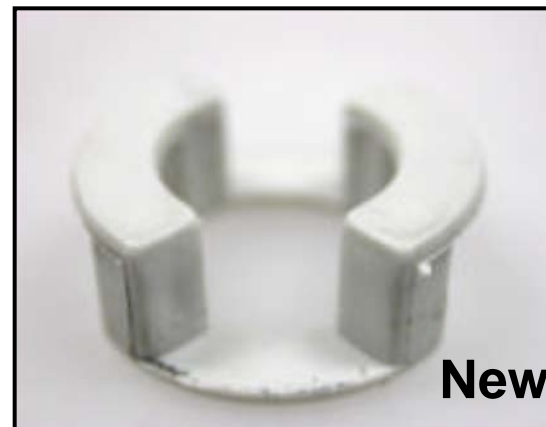
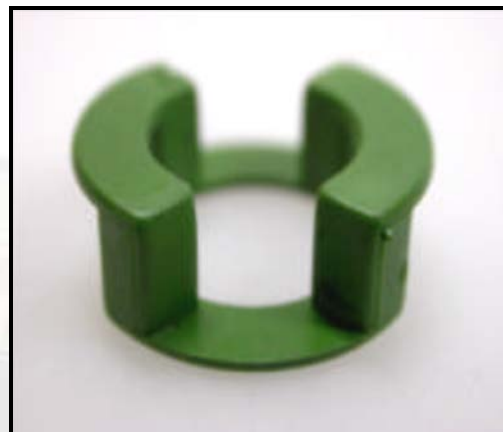
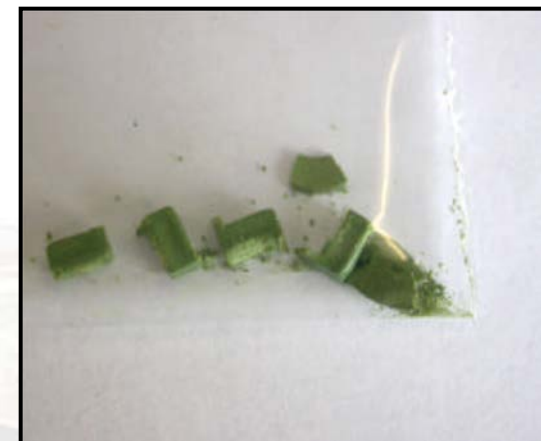
- **New EGR valve with new clutch material and software change.**
 - New clutch material holds up to high EGR temperatures.
 - Software changes within EGR valve corrects sensitivity trouble codes.

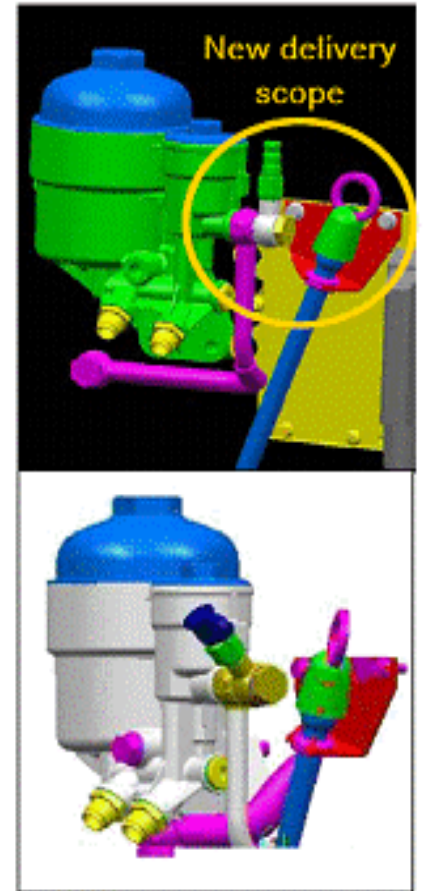
Fuel Priming Valve on Engine

- Priming valve added to the fuel filter housing allowing OEM plants and field service the capability to pressurize the fuel system to eliminate “Hard Start” Problems
- Implementation date at NAFTA modification centers – May 23rd, 2005
- Implementation date at Mannheim – June 15th, 2005, effective with serial number 0906494959
- Parts to be released for Service for retrofits
