# **Detroit Diesel Engine Updates**

## **Dale Allemang and Rick Dziadzio**

September 9, 2008

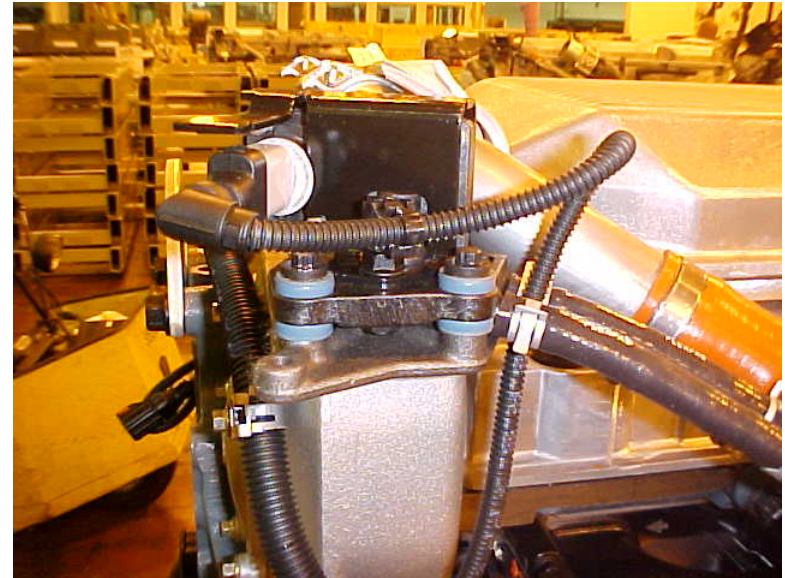
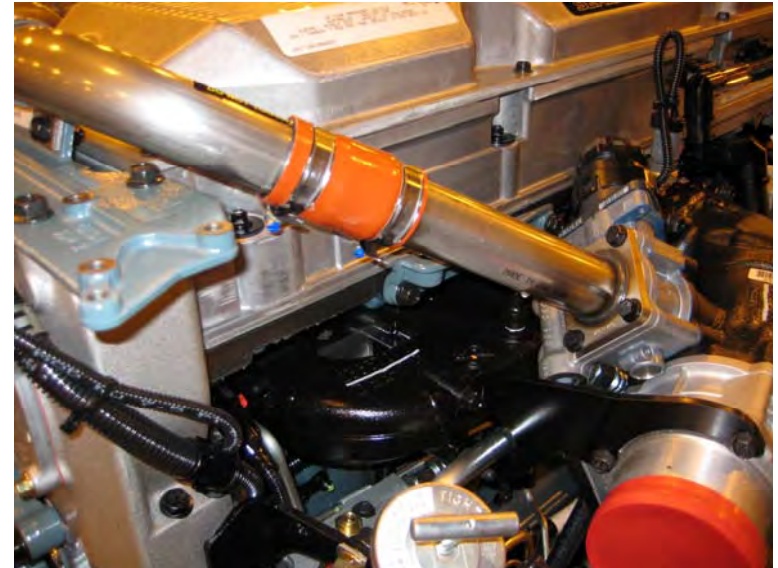
## Intake Throttle Valve

- Failed ITV is from connector pin fretting resulting in code SPN 51.

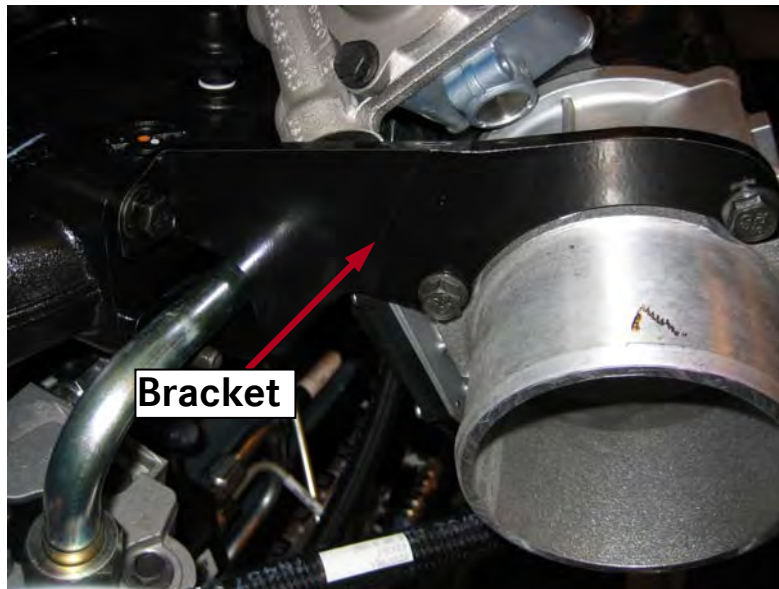
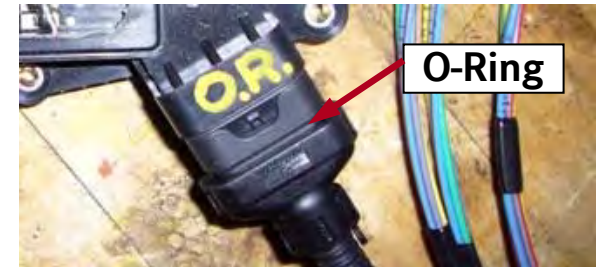
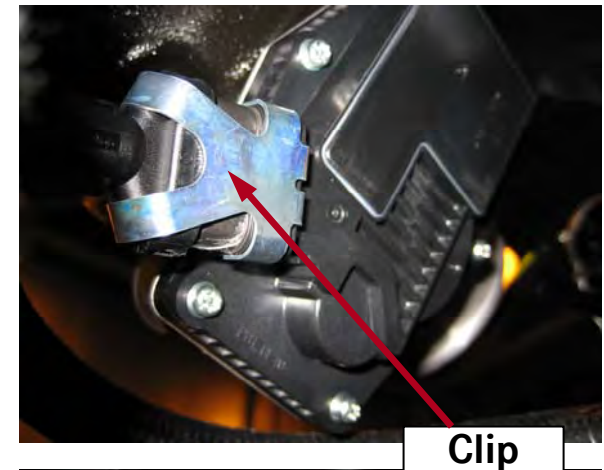
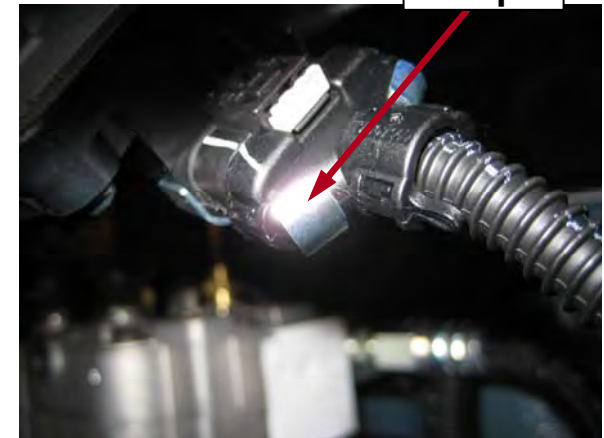
## Intake Throttle Valve

- Terminal lube became effective on 7-Nov-07 with approximate engine s/n 06R0988524.
- New clip & o-ring seal became effective on 14-Nov-07 with engine s/n 06R0988726.
- New ITV support bracket became effective on 28-Nov-07 with approximate engine s/n 06R0989102.

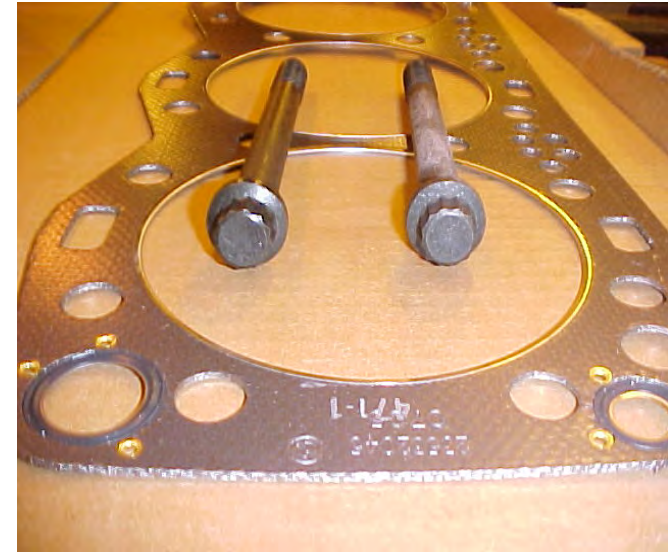
## Cylinder Head Gasket

- Head gasket being updated.
- Current gasket is made by Federal Mogul.
- New gasket is from Dana-Victor Reinz.
- New gasket p/n 23538406 replaced former gasket p/n 23532045 on 1-Aug-08 with engine s/n 06R1012531.

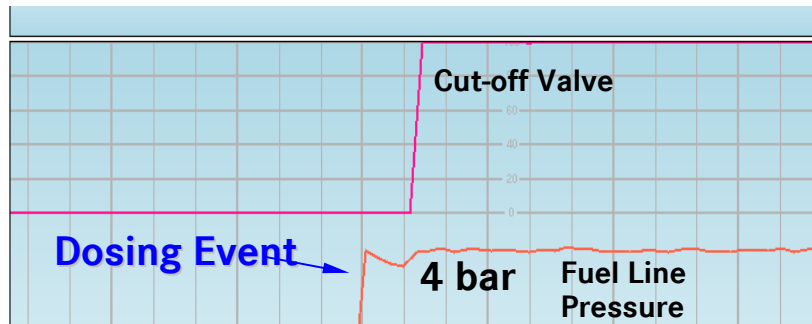
**Fuel Priming Pump Un-stowed Position**

- Designed to Prime the Fuel System
- Designed to hold 4 Bar of Pressure
- When handle is not stowed air is drawn into fuel system and lowering fuel pressure
- Fuel pressure reduction can impact particulate filter regeneration

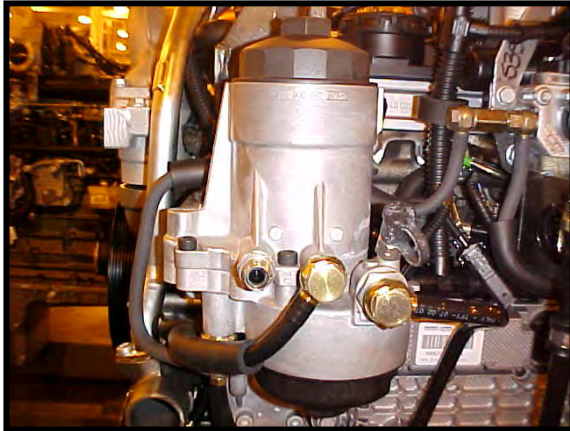
## Secondary Fuel Filter

- If the fuel pressure is found to be below the recommended level (70-80 psi) or regeneration fails due to low fuel pressure, perform steps 1-4

**Step #1 – Reseat or Replace Fuel Filter p/n A0000902751**

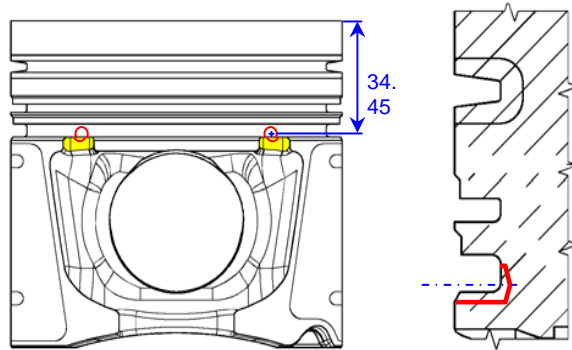
**Piston – Oil Drain Holes**

- The upgraded cylinder kit contains three elements to reduce oil consumption:
  1. Added drain holes to the Piston oil ring groove
  2. Sharp bottom scraping edge added to the top piston ring
  3. Increased spring tension added to the oil ring
- Became effective with engine s/n 926961S0013420.

For engines in the field that require repair to improve the oil consumption, we are pleased to announce that a new piston and ring kit has been identified as the corrective action to repair these engines. Parts availability to begin work on engines requiring field updates will be available to repair locations in June.
