# Roadranger®

## Eaton® Fuller® Clutches

Failure Analysis Guide  
All Clutch Models

Troubleshooting Guide CLTS-1271 June 2003

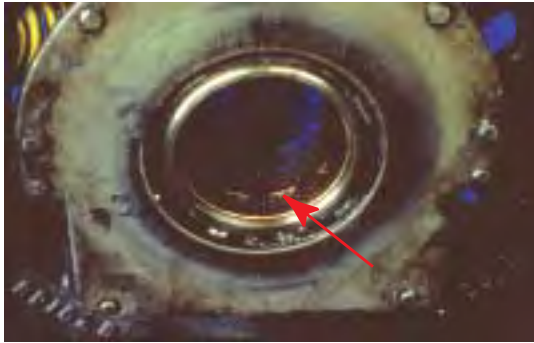
Fig 11

Failure to center the input shaft with the sleeve of the release bearing assembly, when installing the transmission, can cause this failure. If the transmission hangs up during installation, investigate the cause before proceeding as excessive force can damage the bushing (see arrow in Figure 12). Allowing the transmission to hang unsupported in the sleeve bushing can damage the bushing. The arrow in Figure 11 shows another example of sleeve bushing damage on a heavy duty clutch.

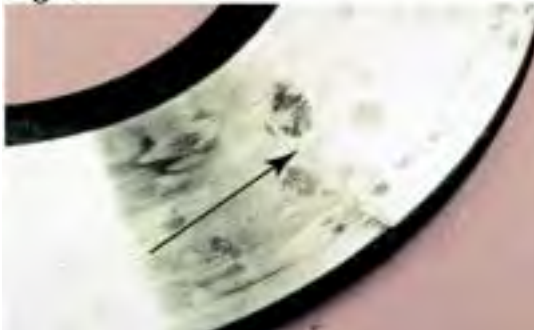
Fig 13

Figures 13 - 16 depict damaged clutch plates which resulted from an abnormal amount of clutch slippage/heat. Some causes of this abnormal slippage/excess heat can be one or more of the following:

Figure 13 is an example of a cracked pressure plate. The heat flow was so great that the metal could not dissipate it quickly enough.

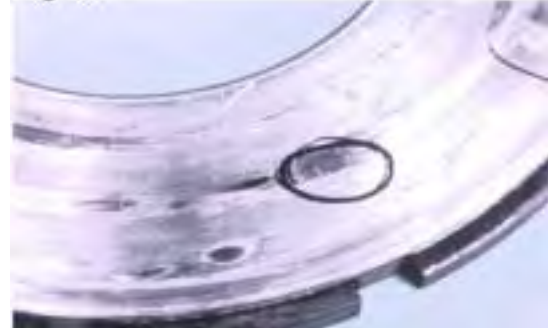
Fig 15

In Figure 15, an area of the intermediate plate has been circled to reveal the damage of heat checks. These heat checks are actually small cracks with raised ridges that are capable of shaving off the facings of the driven disc.

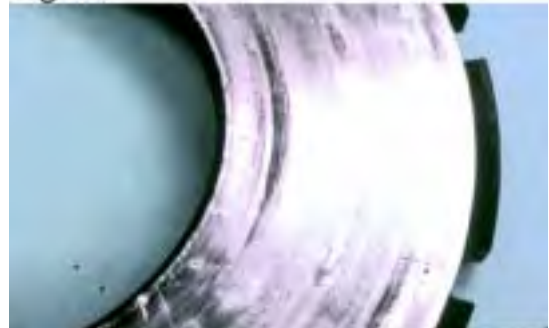
Fig 16

Finally, Figure 16 reveals an example of a burned or scorched intermediate plate in which the metal became so hot that it began to flow. The typical evidence of such a failure will be one or more of the following:

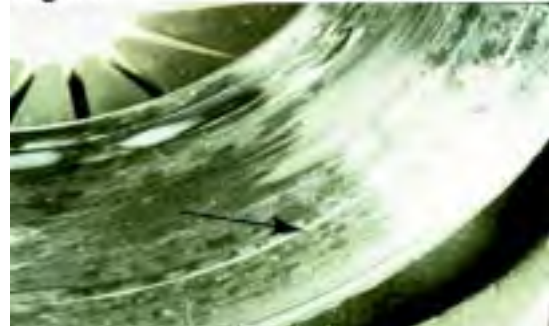
Fig 17

The groove (see arrow in Figure 17) worn into the face of this pressure plate was caused by the rivets of the driven disc facing. (For the related disc failure, see the description under Figure 70). The same damage can occur on both the intermediate plate and flywheel. A surface that is grooved can damage the new driven discs that are installed. As a result, a new clutch assembly should be installed. Refer to the OEM service manual concerning flywheel resurfacing.

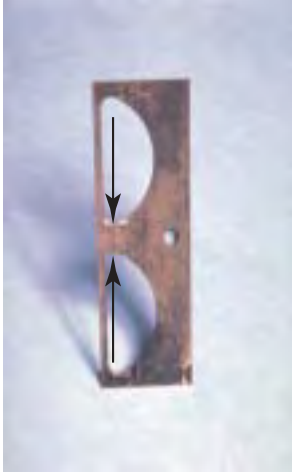
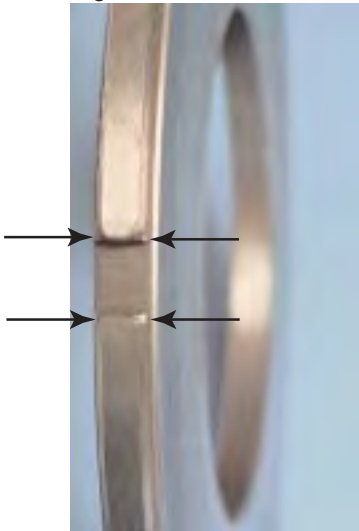
As shown in Figures 23 and 24, the intermediate plate was “hanging up” at the corners of the open sections of the anti-rattle springs. The driver’s complaint was a clutch that would not release. It is important that the rounded sections of the anti-rattle springs be installed TOWARDS the flywheel/ engine.

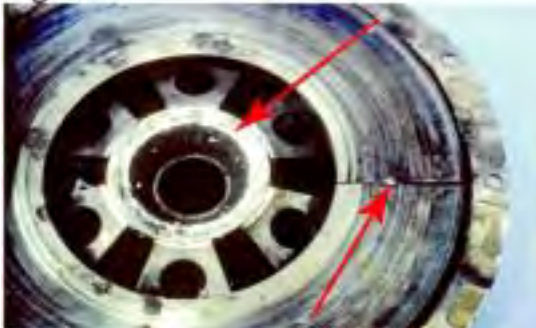
Fig 25

Figure 25 shows the damage done to the nose of the retainer assembly (see arrow) due to contact with the disc rivets. Figure 57 shows the resulting damage done to the rear disc. Adjusting the clutch externally (with the linkage) instead of internally (rotation of adjusting ring) will cause the retainer sleeve/release bearing assembly to move too far forward as the clutch wears, leading to this failure.

An additional result from the above failure is that while the clutch is engaged, it can begin to slip due to the unloading condition created by the disc and retainer interference. This, in turn, will create excessive heat and can cause the pressure plate to break (see Figure 25, black arrow on pressure plate) and /or the ceramic buttons to separate from the disc (see Figure 58). The above failure may also be preceded by a noise complaint.

Rivets of the rear disc are interfering with the retainer assembly (see Figures 25 and 57)

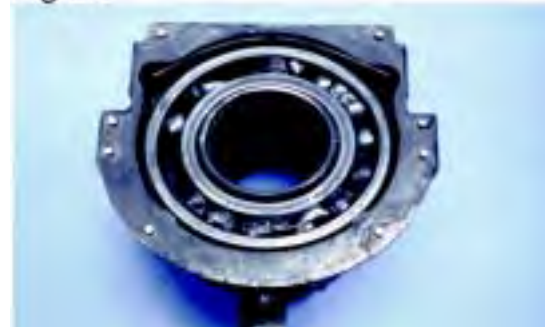
Fig 28

A failed release bearing (see Figure 28) can usually be attributed to one or more of the following situations:

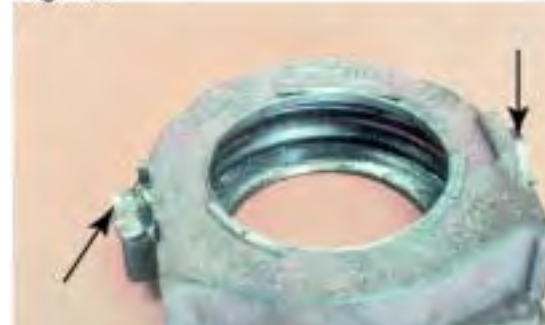
Fig 29

- A dry release bearing due to lack of periodic lubrication (does not apply to sealed bearings).
- Failure to fully release or riding the clutch pedal will place a constant thrust load on the bearing, (see arrows in Figure 29) leading to higher temperatures and consequential loss of lubricant. Failure to maintain free play up in the cab can also cause this condition. Not only will the bearing begin to fail, constant contact in this area will cause both the release yoke fingers (Figure 79), and the wear pads (Figure 29), to wear excessively.

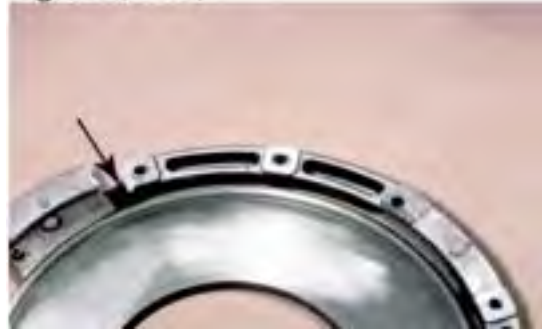
Fig 34 (SAS)

As shown in Figure 34 (see arrow), the aluminum spacer ring broke when it was bolted up backwards onto the flywheel.

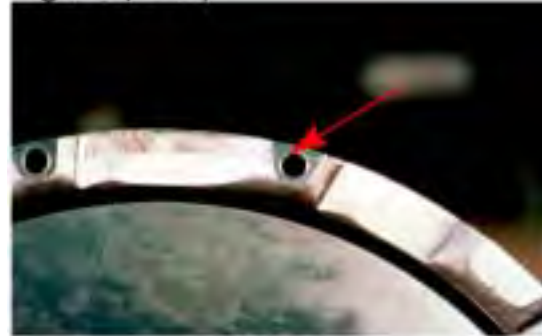
Fig 35 (SAS)

**Note:** The cover assembly mounting hole pads (see arrow in Figure 35) have made an indentation (see arrow in Figure 36) onto the spacer ring mounting hole pads (flywheel side). This evidence will confirm that the spacer ring/intermediate plate assembly was indeed installed backwards. The words "Flywheel side" (refer to Figure 37) will face the flywheel when properly installed. Mishandling of this assembly during installation and/or removal can also cause the spacer ring to break. Some results of installing the intermediate plate backwards are as follows:

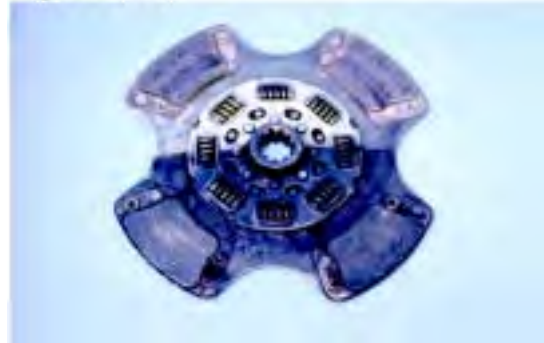
Fig 41 (AR)

A leaking transmission or a leaky rear main engine seal can coat the clutch cover with oil, as indicated in Figure 30. Figure 41 shows the disc which was run with this cover.

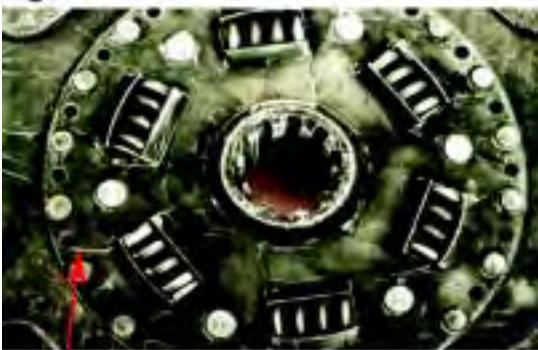
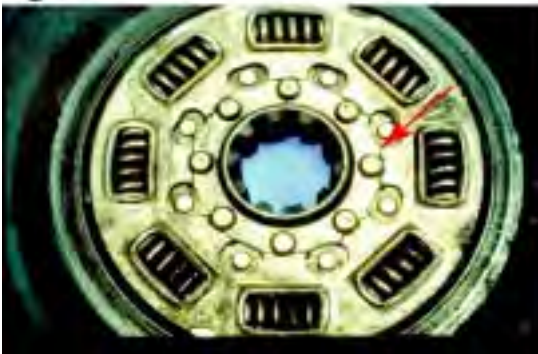
The cracks shown in Figures 59 and 60 (see arrows) can result from:

- A severe shock load, such as engaging the clutch while coasting down a hill.
- Misalignment between the transmission bell housing and engine housing due to loose transmission mounting bolts and/or worn mating faces of either housing.
- Misapplication—a rigid disc should not have been used, but rather a dampened disc assembly (D.D.A.).
- Torsional vibrations from the engine.
- Excessive flywheel runout.
- Allowing the transmission to hang unsupported in the driven disc during installation.

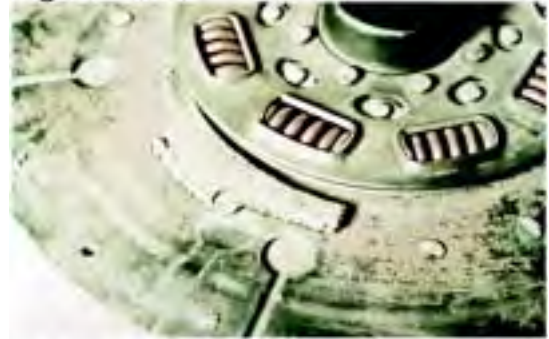
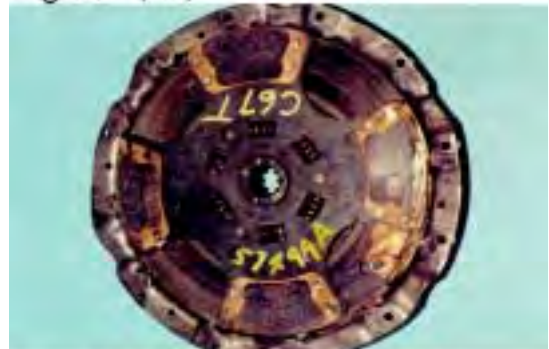
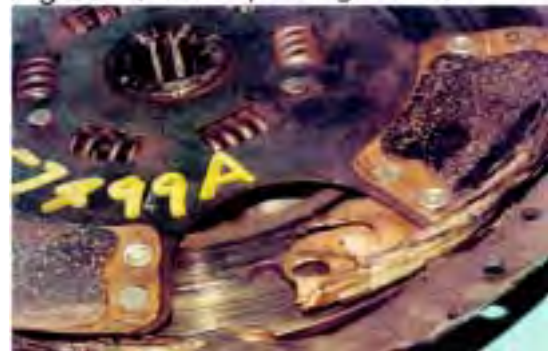
Example: Coasting a tractor down an unloading ramp can burst a driven disc. See Figures 67, 68, and 69.

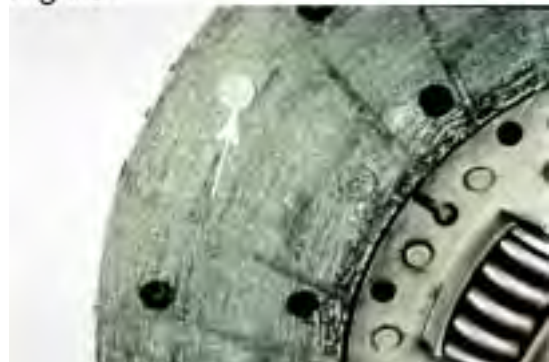
Fig 70

When the rivets (those which secure the facing material to the driven disc) begin to contact either the pressure plate, intermediate plate, or flywheel, then the entire clutch assembly is ready for replacement. Referring to the arrow in Figure 70, this rivet has been making contact with the pressure plate shown in Figure 17. Note the "shiny" appearance of the rivet and also the resulting "groove" on the pressure plate.

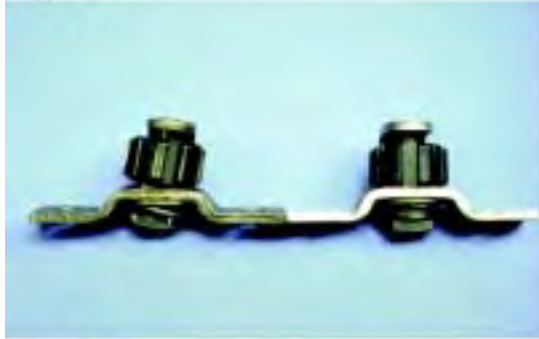
Fig 71

Referring to Figure 71, the kwik-adjust mechanism at the right is a normal and properly functioning adjuster while the one at the left has been damaged, as evidenced by the bent mounting bracket. The one pictured in Figure 72 also has a bent mounting bracket in addition to some broken gear teeth (see arrow). Some causes of these failures can be:

- Forgetting to depress the kwik adjuster while attempting to rotate the gear.
- Only partially depressing the mechanism while attempting to rotate the gear.
- Attempting to rotate the gear while the clutch pedal is in the up position (clutch is not released).

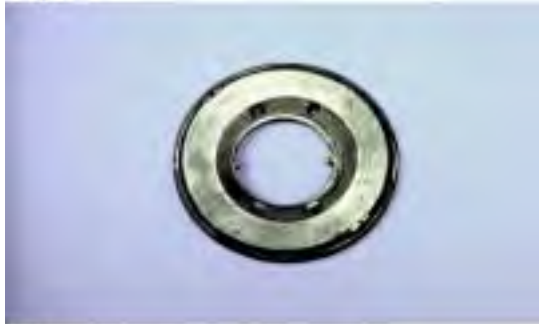
Fig 73

As shown in Figure 73, the facing material on this clutch brake is completely worn away. Figure 74 shows a clutch brake that is partially worn (see arrows). Both types of failures can be attributed to one or more of the following:

- A clutch that is releasing poorly (for corrective action, see the troubleshooting section titled "Poor Release"), thus making it more difficult for the clutch brake to stop the transmission input shaft.
- "Hitting" or engaging the clutch brake when the transmission is in gear and the vehicle is in motion.
- The clutch brake was set too high.
- Installing the new clutch brake in front of a worn/rough transmission bearing retainer cap.
- Clutch brake is simply worn out.

**Note:** A worn clutch brake should be replaced. Be sure to always check the transmission bearing retainer cap for any wear and replace if necessary (see Figure 3).

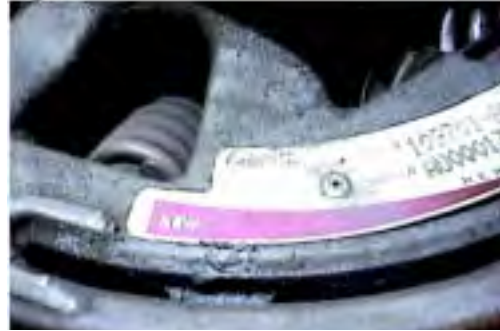
Fig 75

In Figure 75, the tab was broken when someone was attempting to change the adjustment of the clutch. The clutch cannot break the tab. Many times the tab is broken to change the bearing to clutch brake distance when it is in the proper position. Do not attempt to change the clutch adjustment before measuring the release bearing to clutch brake distance.

**Note:** Consult the troubleshooting guides for help. If the release bearing is set to the correct dimension, do not attempt to use the cam tab to change the adjustment to the wrong dimension and break off the tab. Troubleshooting guides: CLTS-1296 (Medium-Duty) and CLTS-1295 (Heavy-Duty).

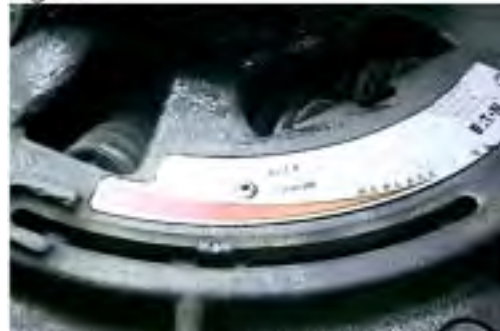
Fig 76

Measure the distance between the release bearing and clutch brake. Correct distance should be between .490" and .560" with the pedal up (Figure 76). If the bearing is close to the clutch brake and the clutch has not been removed and re-installed on the fly-wheel, then an overadjust might have occurred. Consult troubleshooting guides for help. Follow the fault tree for proper diagnosis and correction.

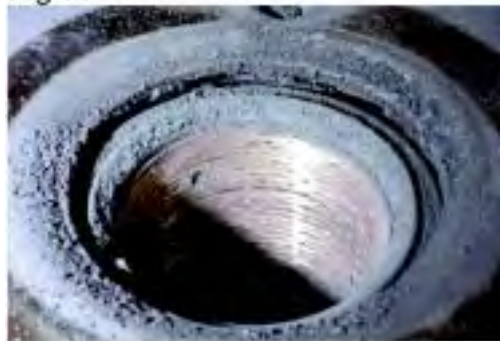
Fig 77

As shown in Figures 77 and 78, incorrect lube or not enough lube can cause a failure. External contamination will also cause wear to the bushing. The transmission input shaft may be rough and require replacement. Use approved/compatible lube. (High quality N.L.G.I #2 or #3 lithium soap grease with E.P. additives 325 degree operating temperature). Apply ample lube and let it flow out of the opening from the bearing housing. Apply additional lube onto the transmission shaft to ensure the bushing will have proper lube. Apply lube to the tips of the release yoke.

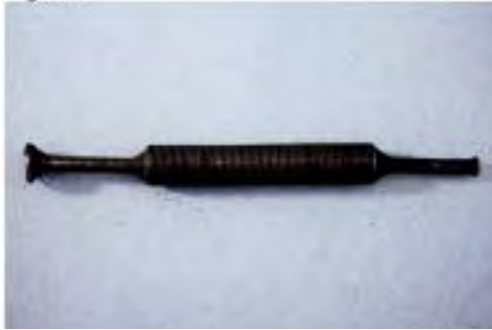
Fig 79

Consult troubleshooting guides for help. There will be no tension pulling the cam/wear indicator toward "replace." Troubleshooting guides: CLTS-1296 (Medium-Duty) and CLTS-1295 (Heavy-Duty).

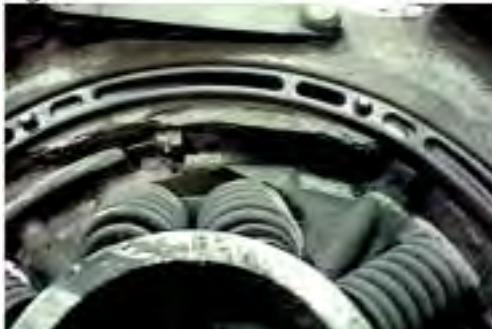
Fig 80

If there is excessive amounts of contamination allowed into the clutch housing, the Solo may stop adjusting and there will be a loss of free pedal in the cab (see Figure 80). Check to see if the inspection cover has been removed. In severe dust applications, it may be necessary to seal all openings in the clutch housing.

Eaton has created a tool that may help free up the clutch to allow it to continue adjusting. #CLPISOLOTOOL can be obtained by calling 800-826-HELP (4357).

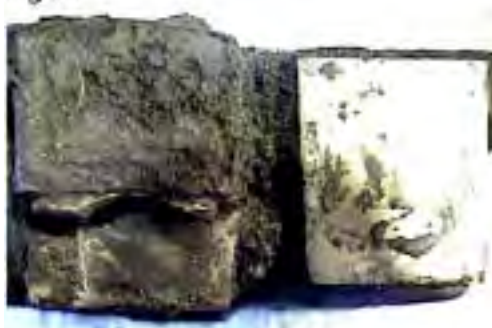
Fig 81

When the clutch is properly maintained, there should always be free pedal in the cab. This will prevent fork contact with the bearing wear pads and reduce the wear to the pads and the release fork (Figure 81). Follow adjustment instructions for correct clutch and linkage adjustment. Adjust the clutch before free pedal is lost. Apply grease to the yoke fingers to reduce friction when the clutch pedal is stroked.

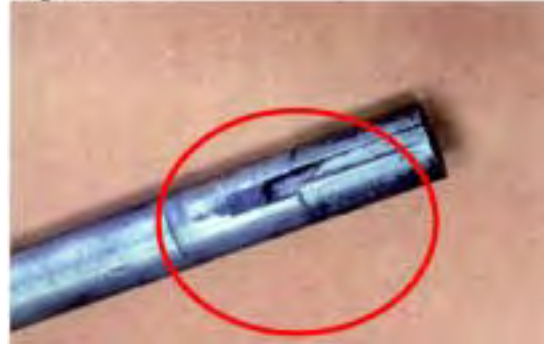
Fig 82

Figure 82 is an example of a worn cross shaft (release shaft). A worn cross shaft (see circle) will occur after high mileage and will be accelerated by a lack of lubrication. Some problems associated with worn cross shafts (and/or worn linkage systems) are:

- Sporadic changes in the amount of free play in the cab
- A binding condition in the linkage system
- Erratic engagement of the clutch
- Side loading of the release bearing housing

As a result, a typical complaint might be that it is impossible to maintain proper clutch adjustment. To prevent future clutch problems, always inspect the linkage system for excessive wear and/or binding conditions before installing the new clutch. Be sure to replace any worn components that might hinder clutch operation. Also, remember to lubricate the linkage pivot points.

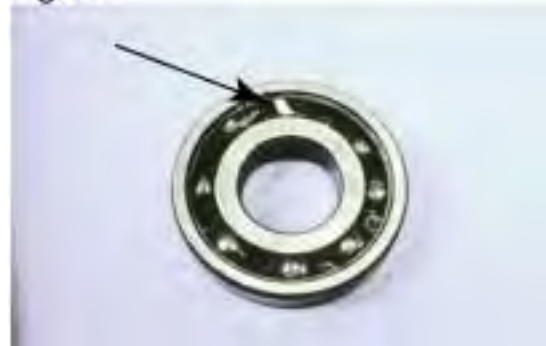
Fig 83

Once removed from the flywheel, a failed pilot bearing can be identified by one or more of the following conditions:

- The bearing is dry; it is difficult to turn (rough) or completely seized. Any condition which causes a dry bearing will have been accompanied by a noise complaint while it was in the vehicle.
- A damaged ball bearing cage (see arrow in Figure 83).
- A step is worn into the inner race. The step is caused when the input shaft spins within the inner race, a direct result of the seized pilot bearing.
- The seal is missing and/or damaged because of excessive heat generated by the dry bearing.

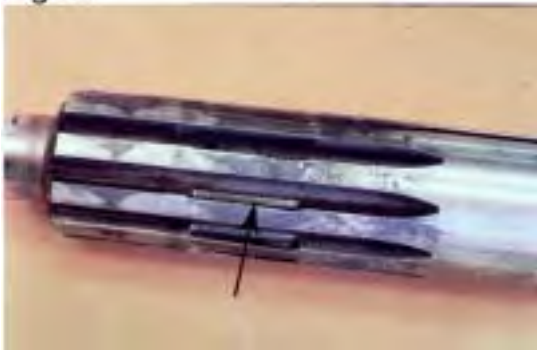
Fig 84

Drive gear spline wear will cause clutch release problems since the driven discs cannot slide freely on the splines. This is especially true if new driven discs are installed on a worn input shaft (Figure 84). Excessive spline wear can be attributed to torsional vibrations. This type of wear can be eliminated or lessened by the use of dampened driven discs. Spline wear will also occur on the mating driven disc hubs (see Figures 61-62). Misalignment can also be a factor in abnormal spline wear. It is important to always inspect the input shaft for wear before installing a new clutch. If worn, it is recommended that a new input shaft be installed to eliminate possible clutch problems later on.

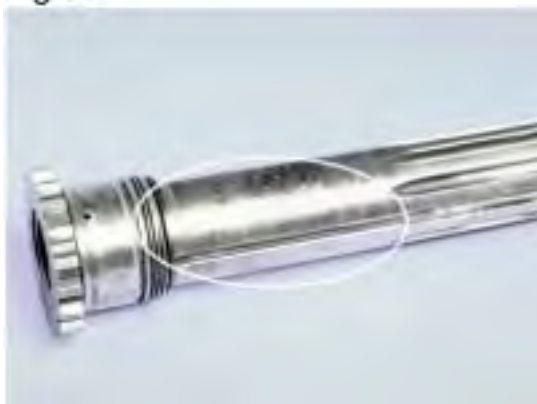
Fig 85

This failure resulted when the clutch's release sleeve was being "side loaded" onto the input shaft (Figure 85). A worn linkage system and/or excessive wear on the release bearing "wear pads" and "release yoke fingers" can cause this side loading condition.

A galled or rough input shaft (in the non-splined area) will damage the bushing(s) of not only the original clutch, but also that of the newly installed clutch. As a result, make sure you replace the input shaft and any worn linkage components to prevent the failure from being repeated.

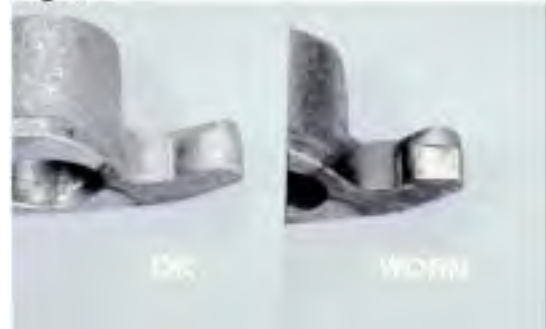
Fig 86

The yoke at the left is brand new. The yoke at the right is worn excessively and should be replaced. This wear can be the result of constant riding of the clutch pedal by the driver, and/or failure to maintain free play up in the cab (see Figures 28 and 29 for the resulting damage that can occur to the release bearing).

Consequently, there will be continual contact between the release yoke fingers and the release bearing wear pads. A yoke that is worn excessively may hinder the engagement/control of the clutch. See Figures 1, 5, and 10 for additional photos and descriptions of release yoke failures.
